INVESTIGATION NO. 2473
THE PENNSYLVANIA RAILROAD COMPANY
REPORT IN RE ACCIDENT
AT MIAMI CROSSING, OHIO, ON
JANUARY 7, 1941

Accident at Miami Crossing, Ohio, on January 7, 1941,
caused by failure properly to control speed of train
in compliance with interlocking signal indications.

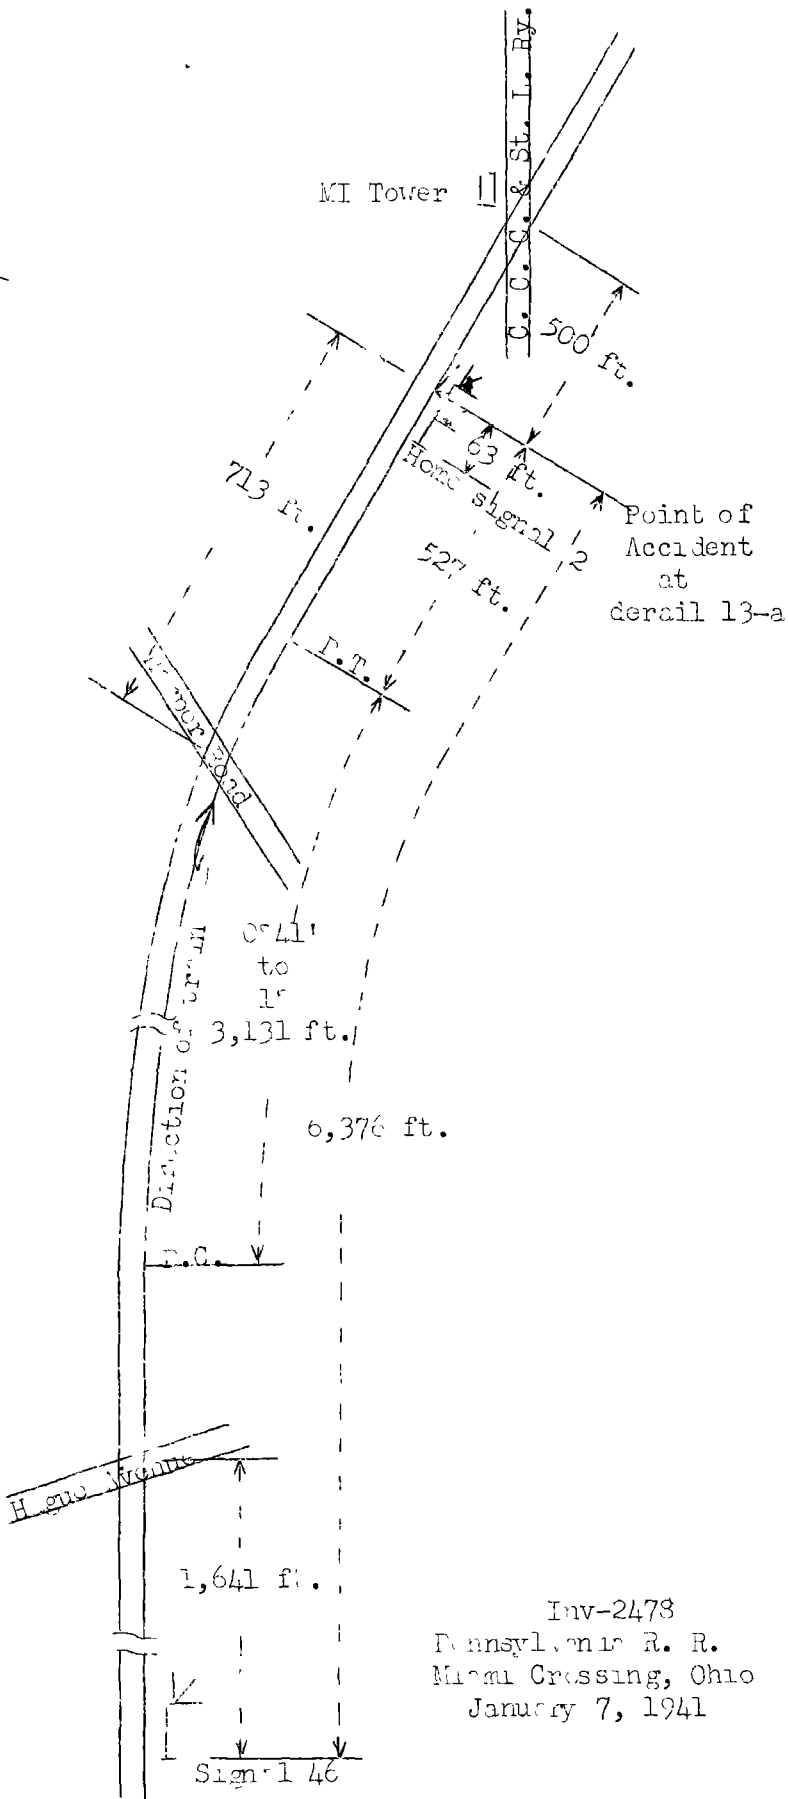
Inv-2478
 Pennsylvania R. R.
 Miami Crossing, Ohio
 January 7, 1941

- o Columbus, Ohio. 3.4 mi.
- o Miami Crossing X Point of accident 4.8 mi.
- o Alton 16.8 mi.
- o London 29.8 mi.
- o Xenia, Ohio
