ACCIDENT ON THE
PENNSYLVANIA RAILROAD

MILLBROOK, OHIO

OCTOBER 10, 1940

INVESTIGATION NO. 2453

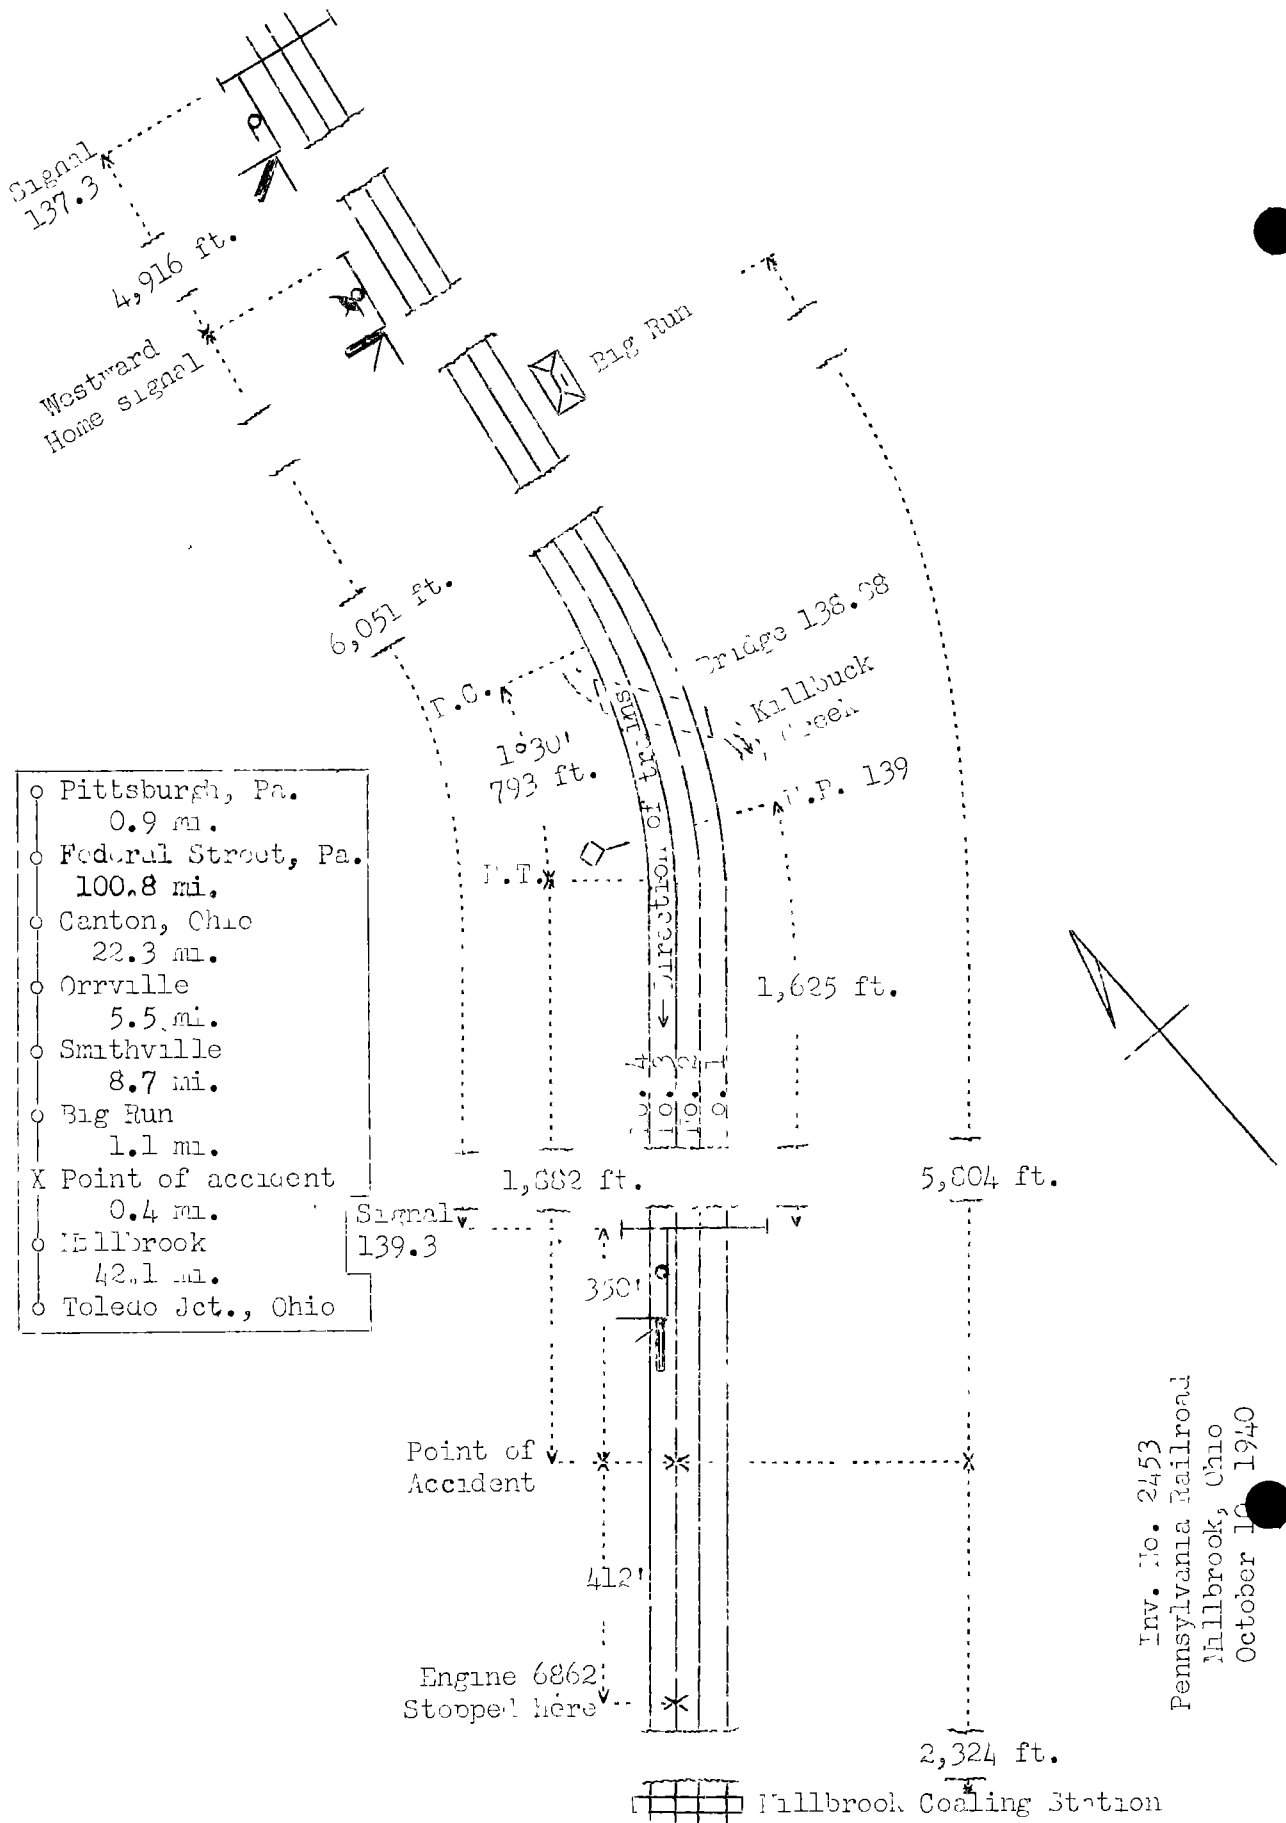
Inv. No. 2453
 Pennsylvania Railroad
 Millbrook, Ohio
 October 10, 1940

- Pittsburgh, Pa.
0.9 mi.
- Federal Street, Pa.
100.8 mi.
- Canton, Ohio
22.3 mi.
- Orrville
5.5 mi.
- Smithville
8.7 mi.
- Big Run
1.1 mi.
- X Point of accident
0.4 mi.
- Millbrook
42.1 mi.
- Toledo Jct., Ohio

Millbrook Coaling Station

Approach signal 137.3, the westward home interlocking signal at Big Run, and signal 139.3 are located, respectively, 11,317, 6,401, and 304 feet east of the point of accident; these signals are of the position-light type. Signals 137.3 and 139.3 are automatic and are located on signal bridges; the home interlocking signal is mounted on a mast to the right of track No. 3. Signal 137.3 and the home signal are 2-unit and signal 139.3 is 1-unit. The involved indications, names, and corresponding rule numbers are as follows:
