INVESTIGATION NO. 2701
THE PENNSYLVANIA RAILROAD COMPANY
REPORT IN RE ACCIDENT
NEAR MIMSON, N. J., ON
MAY 23, 1943

Railroad: Pennsylvania
Date: May 23, 1943
Location: Minson, N. J.
Kind of accident: Derailment
Train involved: Passenger
Train number: 1020
Engine number: 3806
Consist: 15 cars
Estimated speed: 15-30 m. p. n.
Operation: Interlocking
Track: Single; 14°30' curve; 0.8 percent descending grade westward
Weather: Clear
Time: About 10:03 p. m.
Casualties: 14 killed; 81 injured
Cause: Accident caused by excessive speed on sharp curve

Accident near Minson, N. J., on May 23, 1943, caused by
excessive speed on sharp curve.

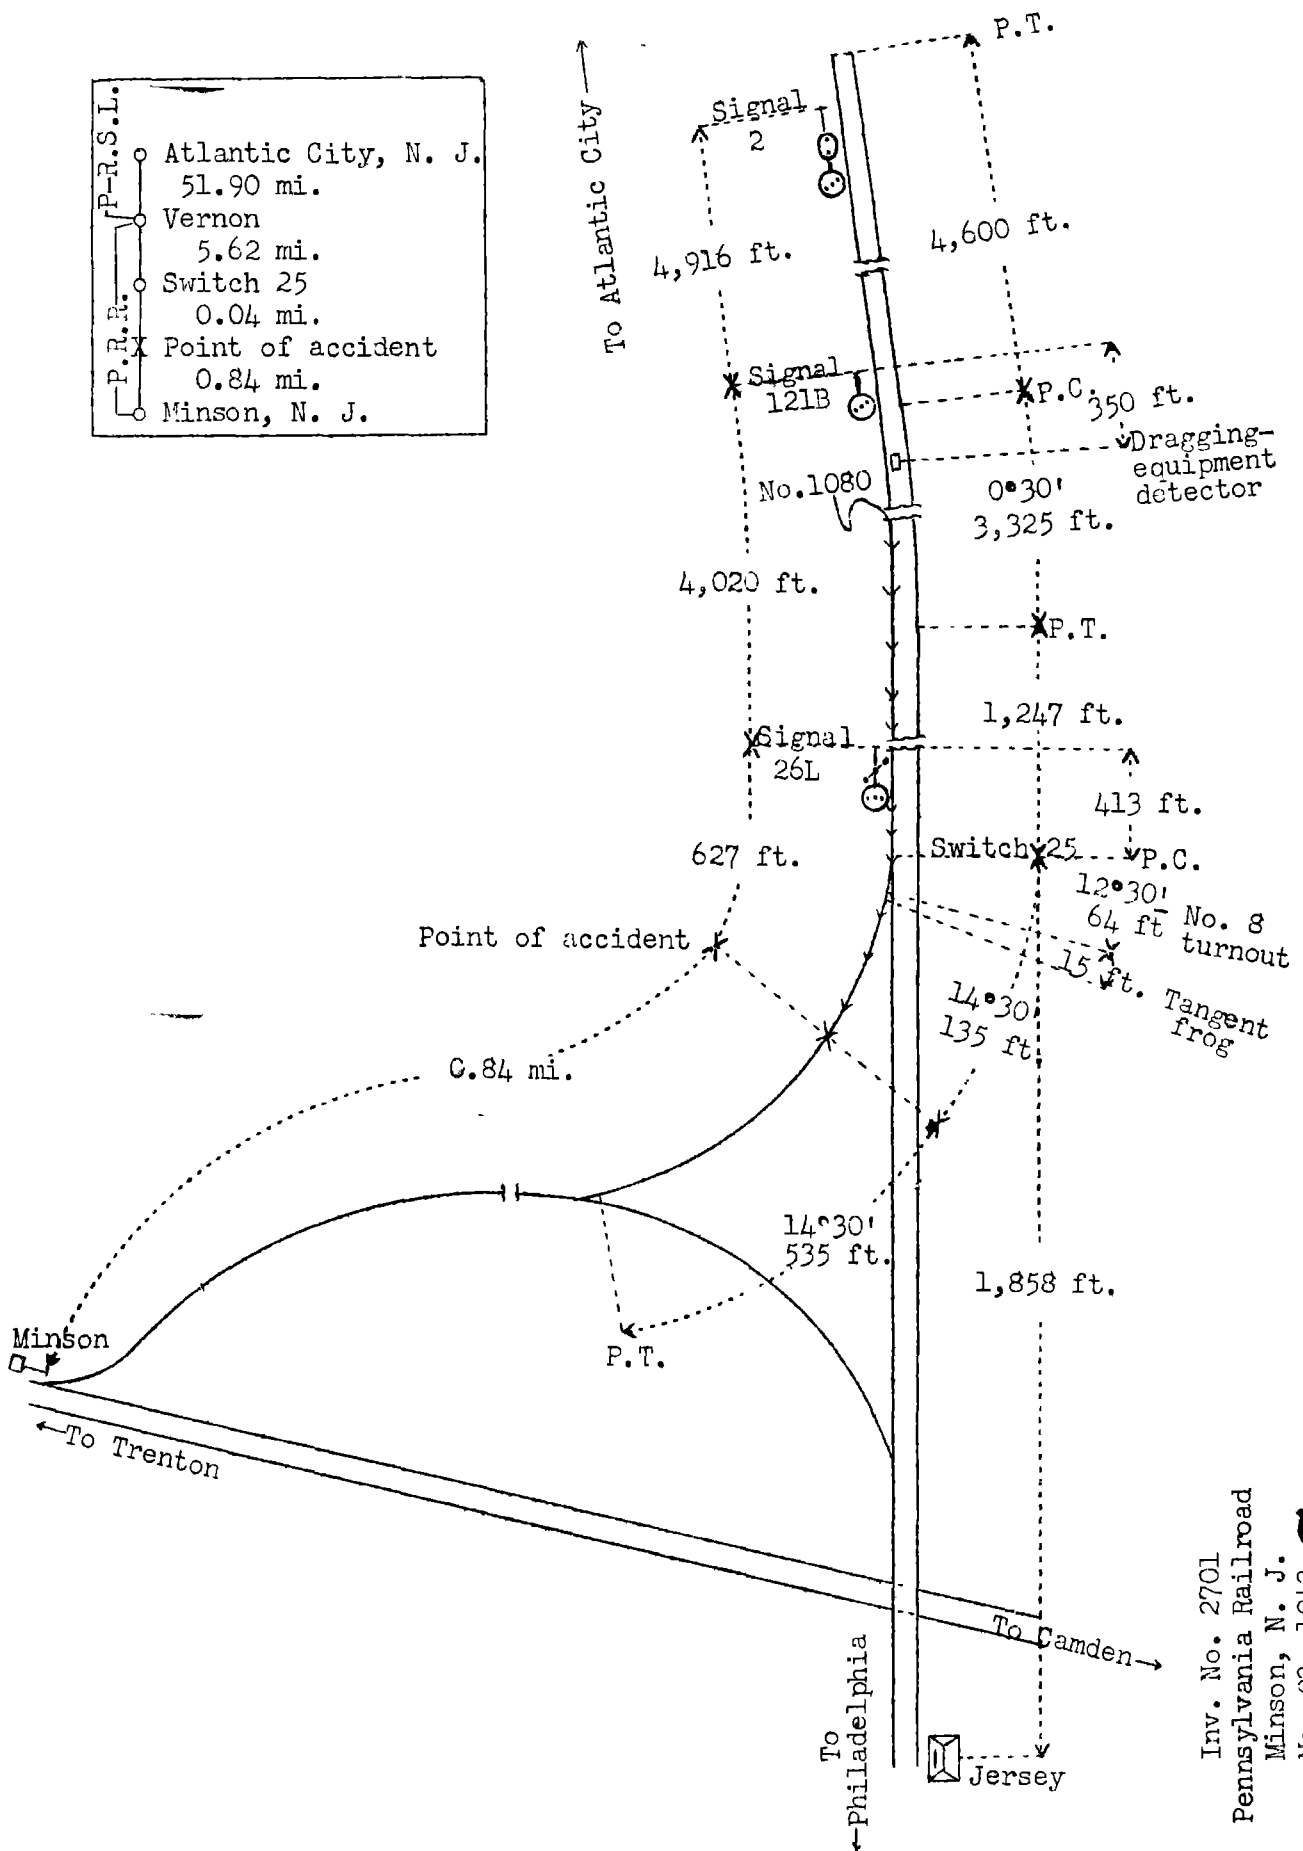
Inv. No. 2701
 Pennsylvania Railroad
 Minson, N. J.
 May 23, 1943

Location of Accident and Method of Operation

This accident occurred on that part of the Atlantic Division which extends between Vernon and Minson, N. J., 6.5 miles. Between Vernon and switch 25, located 5.6 miles west of Vernon, this is a double-track line over which trains moving with the current of traffic are operated by an automatic block and cab-signal system, the indications of which supersede time-table superiority. This double-track line extends westward from switch 25 to Philadelphia. At switch 25 a single-track line connects with the westward main track and extends 0.84 mile to Minson where it connects with the eastward main track of a double-track line extending between Camden and Trenton. The single-track line between switch 25 and Minson is within interlocking limits. The interlocking is controlled from the tower at Jersey, located adjacent to the first-mentioned double-track line at a point 1,858 feet west of switch 25. The accident occurred on the single-track line about 4,215 feet east of Minson and about 214 feet west of switch 25. Approaching from the east there are, in succession, a tangent 4,600 feet in length, a $0^{\circ}30'$ curve to the left 3,325 feet, a tangent 1,247 feet to switch 25, a No. 9 turnout to the right 64 feet in length, the curvature of which is $12^{\circ}30'$, a 15-foot tangent frog, and a $14^{\circ}30'$ curve to the right 670 feet. The accident occurred on the latter-mentioned curve at a point about 135 feet west of its eastern end. The grade for west-bound trains is, successively, level 1,285 feet, 0.4 percent descending 2,635 feet and 0.8 percent descending 159 feet to the point of accident and about 500 feet beyond.

Engine 3806 was derailed to the south and stopped on its left side down the embankment, with the front end about 175 feet west of the point of derailment and about 20 feet south of the track. The engine truck was detached, the cab was demolished, the steam and the water connections to the left water glass and to the right water column were broken, and the left wrapper sheet of the firebox was bent inward about 3 inches. The cistern of the tender was badly damaged and the rear-end sheet was pushed inward about 2 feet. The tender, remaining coupled to the engine, stopped upright, badly damaged, and at an angle of about 45 degrees to the engine. The first car became separated from the tender and the second car and stopped on its left side between the engine and the track, with the front end about 25 feet west of the front end of the engine. The second car stopped on its left side at an angle of about 80 degrees to the track, with the left front corner against the cistern of the tender. The third car stopped upright, practically parallel to the second car, and against it. The fourth car stopped upright, across the track and at an angle of about 20 degrees to it. The fifth car stopped upright, across the track and at an angle of about 45 degrees to it, with the front end against the right side of the third car. The sixth car stopped upright, north of the track and with the front left corner against the left back corner of the fifth car. The seventh car stopped upright, on the roadbed and in line with the track. The second, third, fourth and fifth cars were badly damaged and the first, sixth and seventh cars were considerably damaged.
