INVESTIGATION NO. 2459

THE PENNSYLVANIA RAILROAD COMPANY
REPORT IN RE ACCIDENT
NEAR NORTH SEBRING, OHIO, ON
OCTOBER 31, 1940

Accident near North Sebring, Ohio, on October 31, 1940, caused
by automobile being driven upon highway grade crossing
immediately in front of approaching train.

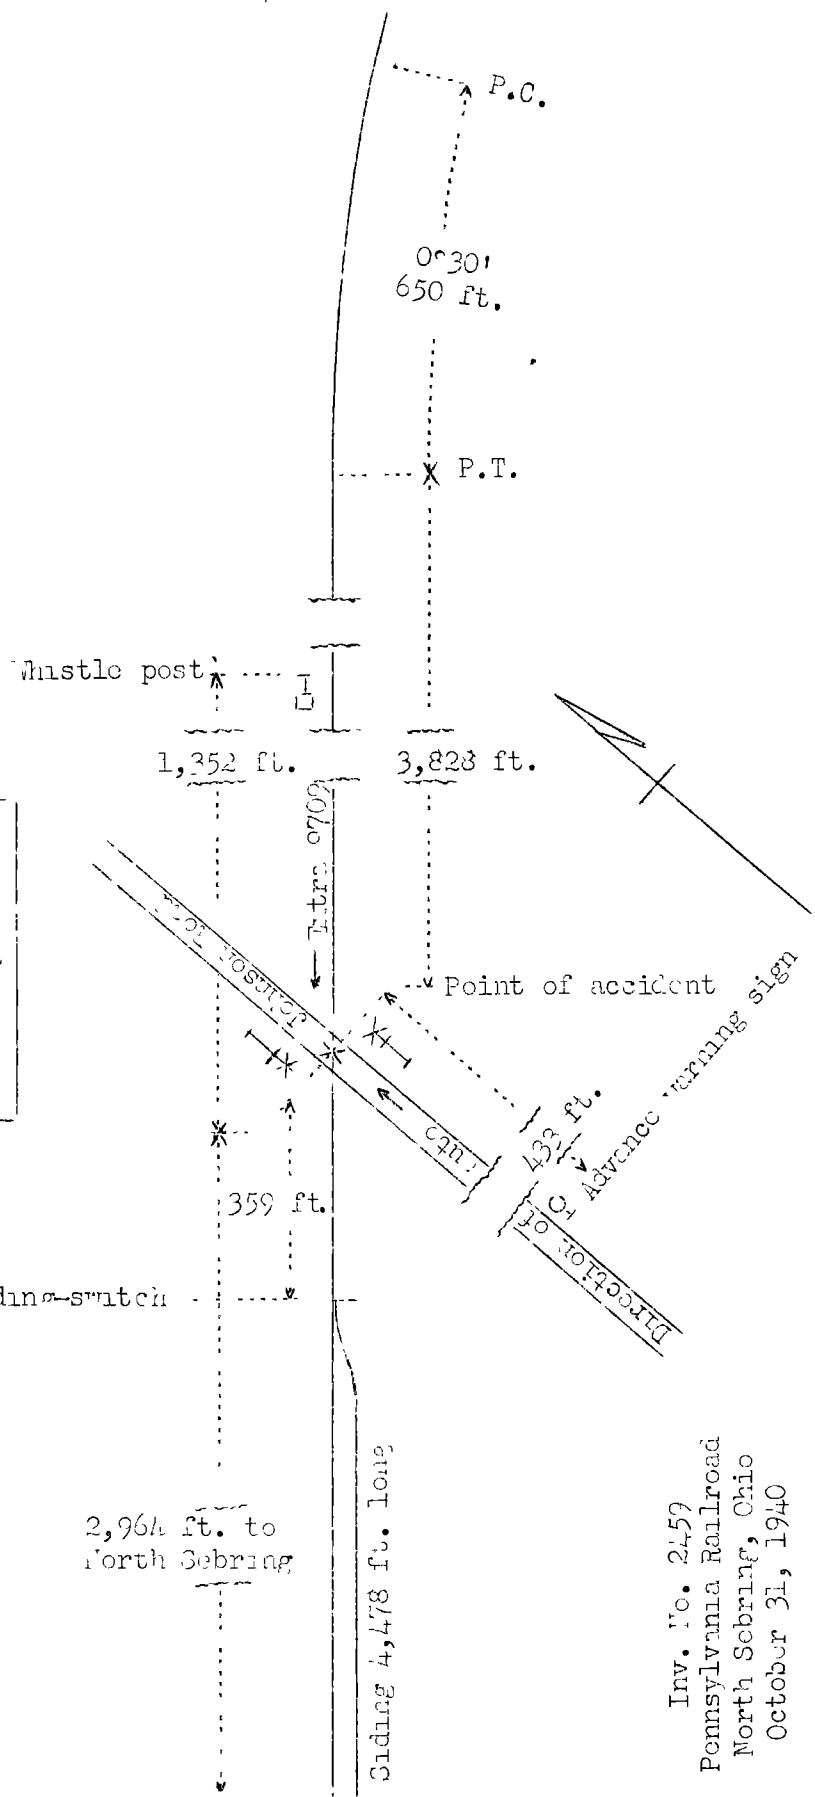
Inv. No. 2459
Pennsylvania Railroad
North Sebring, Ohio
October 31, 1940

2,964 ft. to
North Sebring

Siding 4,478 ft. long

The crossing was protected by a highway sign and by a standard cross-buck sign located, respectively, 433 and 13 feet south of the track. The weather was clear and there was no vehicle between the automobile involved and the crossing. At distances of 50, 40, and 30 feet south of the crossing a driver has a clear view of an approaching west-bound train for distances of 1,300, 2,300, and 4,000 feet, respectively. The state law requires that a driver of a vehicle shall operate such vehicle at a rate of speed with regard to any existing condition, and at a speed which will permit stopping within the assured clear distance ahead; however, the law does not require that a stop be made at a highway crossing at grade. Had the driver involved operated his car prepared to stop, if necessary, at the railroad track, he would have been able to see the train in time to avert the accident.
