INTERSTATE COMMERCE COMMISSION
WASHINGTON

REPORT OF THE DIRECTOR
BUREAU OF SAFETY

ACCIDENT OF THE
PENNSYLVANIA RAILROAD

INVESTIGATION NO. 2384

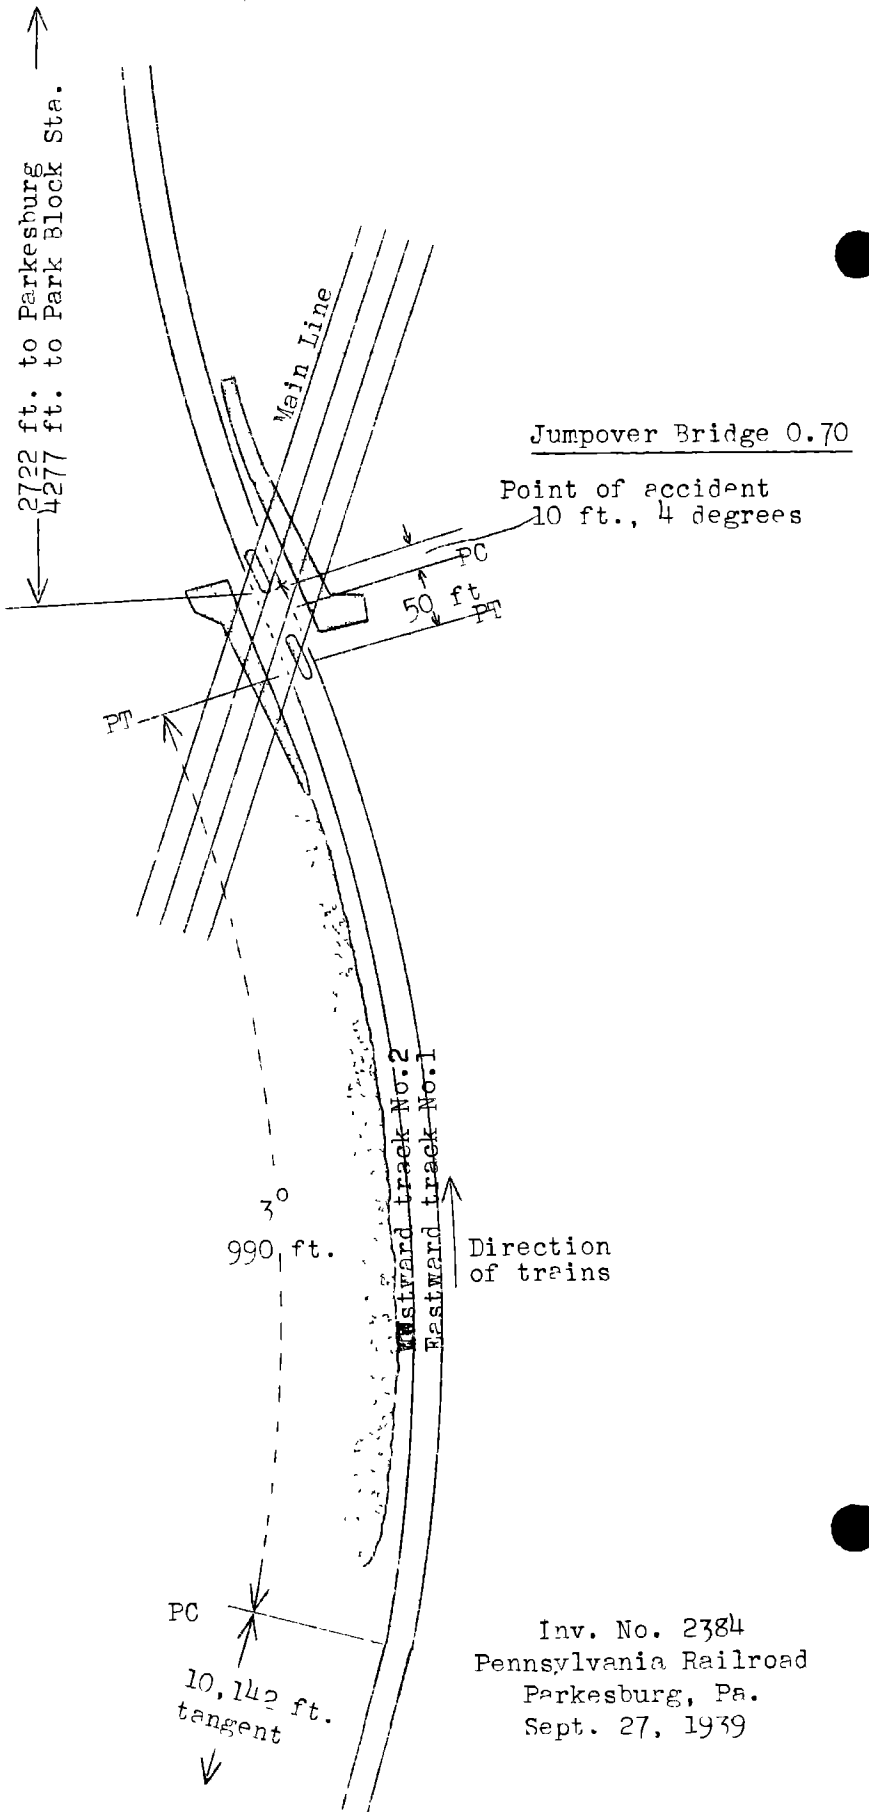
Inv. No. 2384
 Pennsylvania Railroad
 Parkesburg, Pa.
 Sept. 27, 1939

o	Park, Pa.
	0.2 mi.
o	Parkesburg
x	Point of accident
	22.2 mi.
o	Smith
	23.2 mi.
o	Shocks
	9.4 mi.
o	Cly
	15.9 mi.
o	Enola, Pa.
