INVESTIGATION NO. 2650
THE PENNSYLVANIA RAILROAD COMPANY
REPORT IN RE ACCIDENT
NEAR PENN, PA., ON
NOVEMBER 19, 1942

Accident near Penn, Pa., on November 19, 1942, caused by failure properly to provide flag protection for preceding train and by failure to operate following train in accordance with signal indication.

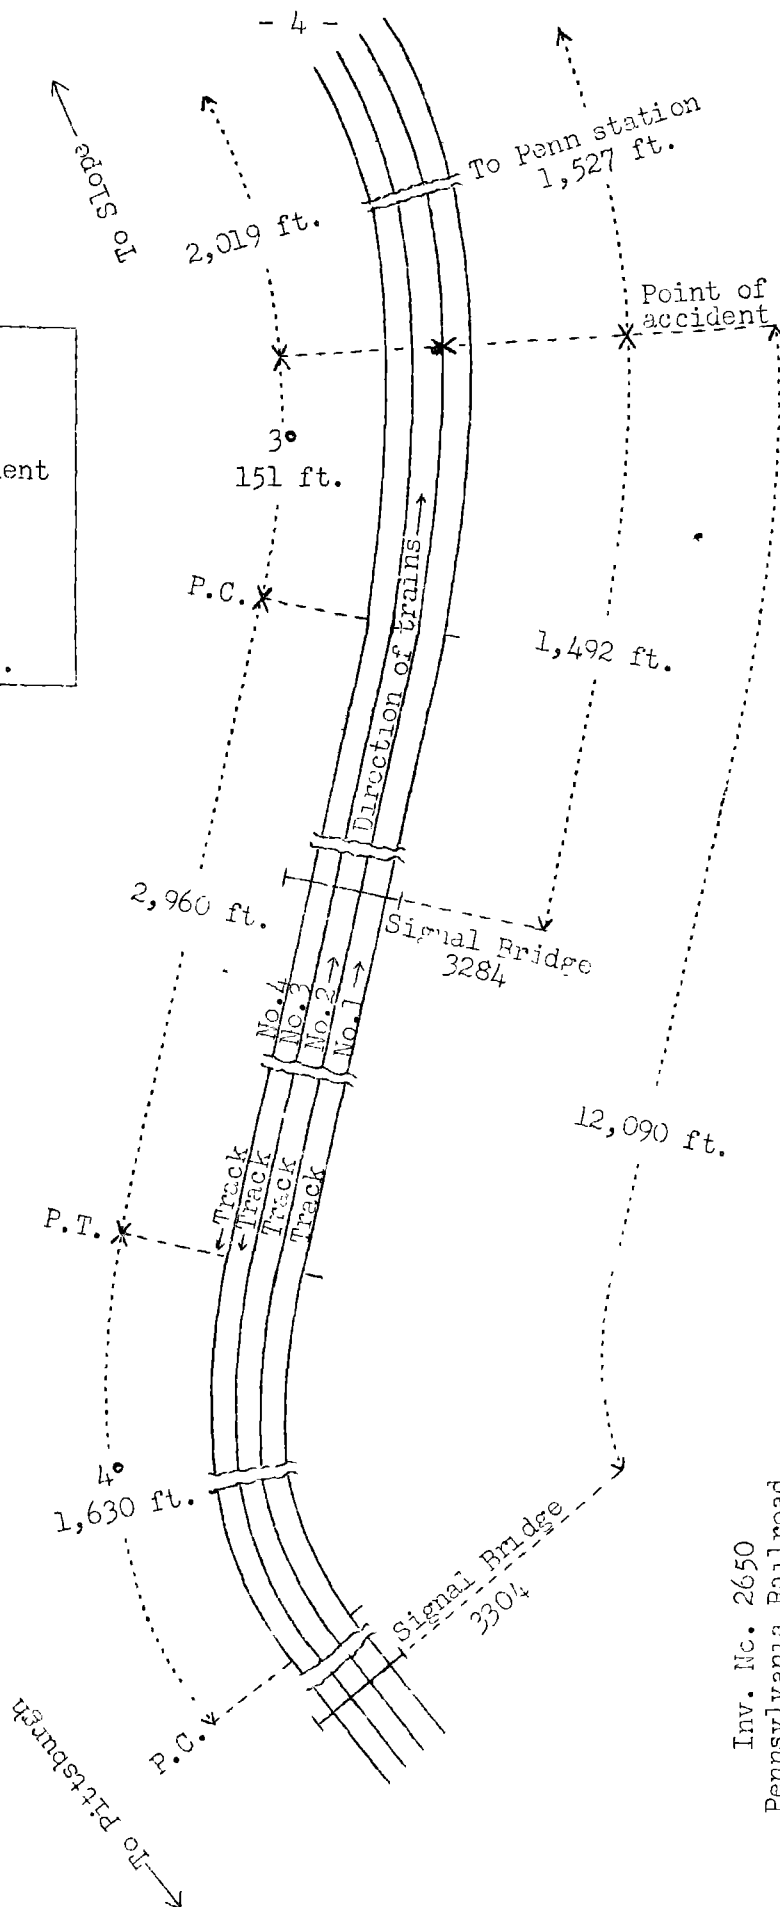
Inv. No. 2650
 Pennsylvania Railroad
 Penn, Pa.
 November 19, 1942

- Slope, Pa.
87.80 mi.
- Penn
0.29 mi.
- ✕ Point of accident
4.41 mi.
- CP
20.20 mi.
- UF
0.20 mi.
- Pittsburgh, Pa.

Location of Accident and Method of Operation
