REPORT OF THE DIRECTOR
BUREAU OF SAFETY

ACCIDENT ON THE
PENNSYLVANIA RAILROAD

PEQUEA, PA.

INVESTIGATION NO. 2396

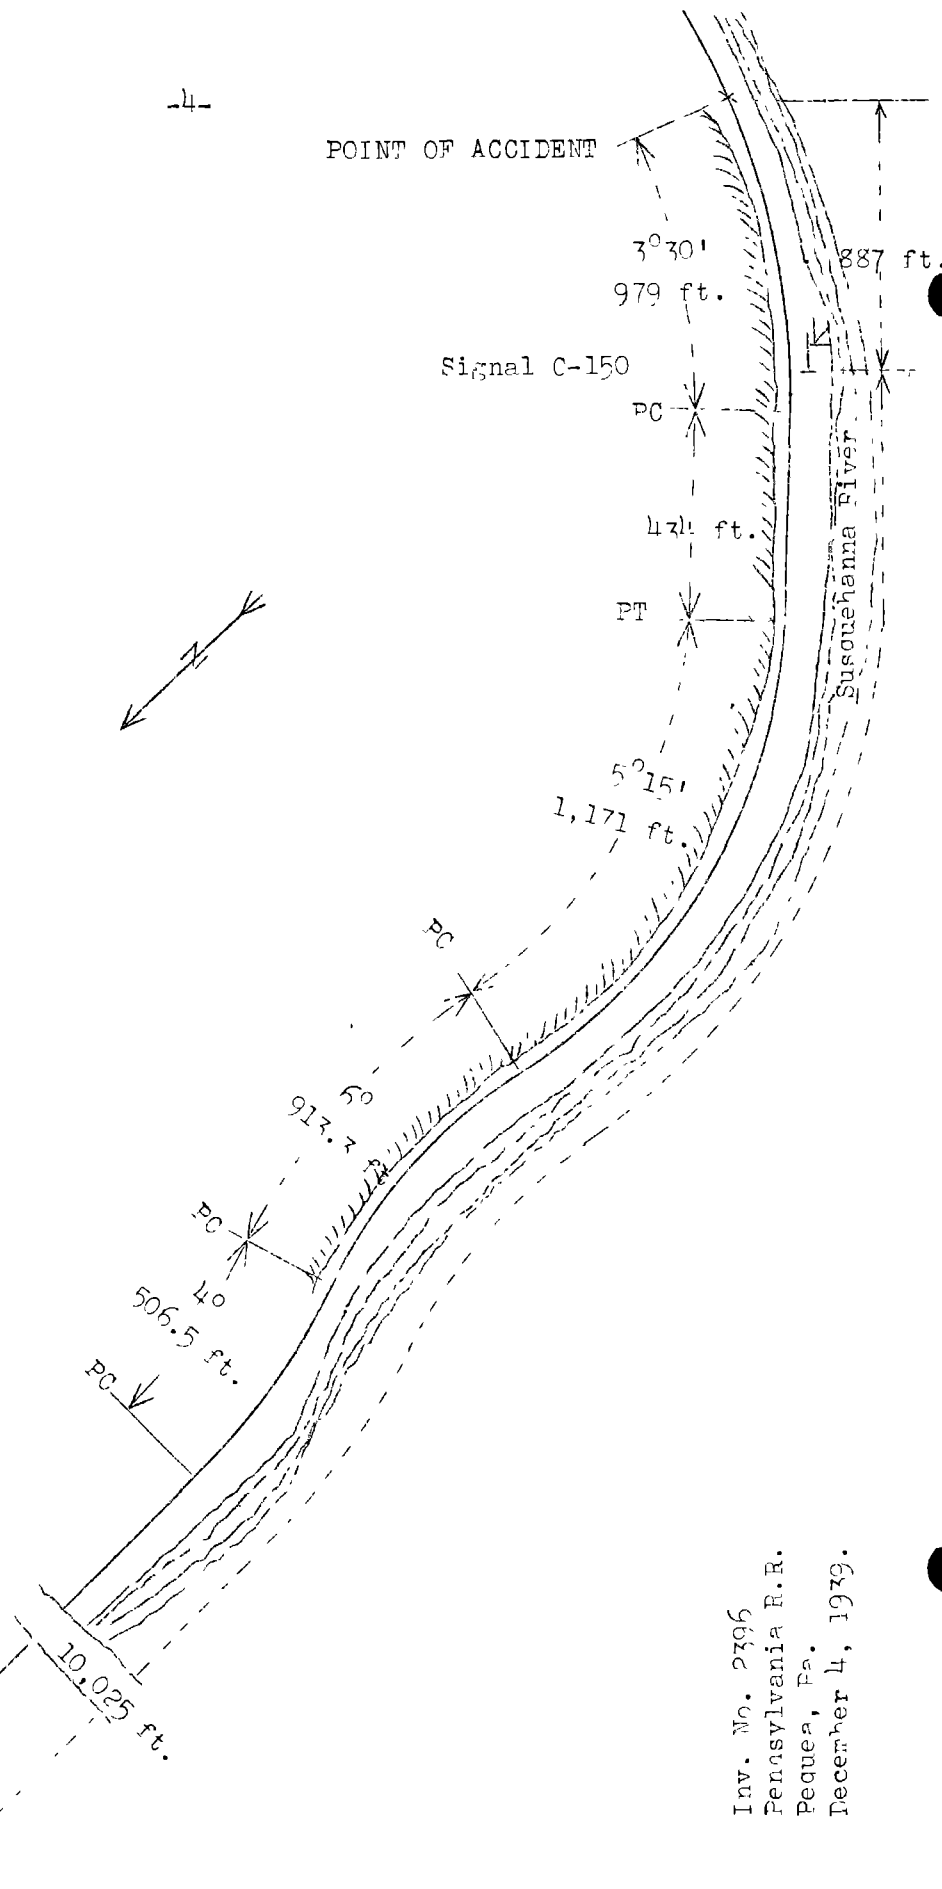
Inv. No. 2396
 Pennsylvania R.R.
 Pequea, Pa.
 December 4, 1939.

Automatic signals C-130 and C-150 are of position-light type, approach lighted; they govern eastward movements and are located 10,912 feet and 887 feet, respectively, west of the point of accident.

POINT OF ACCIDENT

Direction of
AB-10-MY EX 3686
Signal C-130

The Commission's inspectors observed that the view of signal G-150 from an approaching east-bound train was limited to a distance of about 713 feet because of a line of catenary poles and a nearly perpendicular bank 15 feet high on the inside of the curve. From an approaching east-bound train the point of accident can be seen a distance of about 340 feet.
