REPORT OF THE DIRECTOR
BUREAU OF SAFETY

ACCIDENT ON THE
PENNSYLVANIA RAILROAD

PHILADELPHIA, PA.

INVESTIGATION NO. 2189

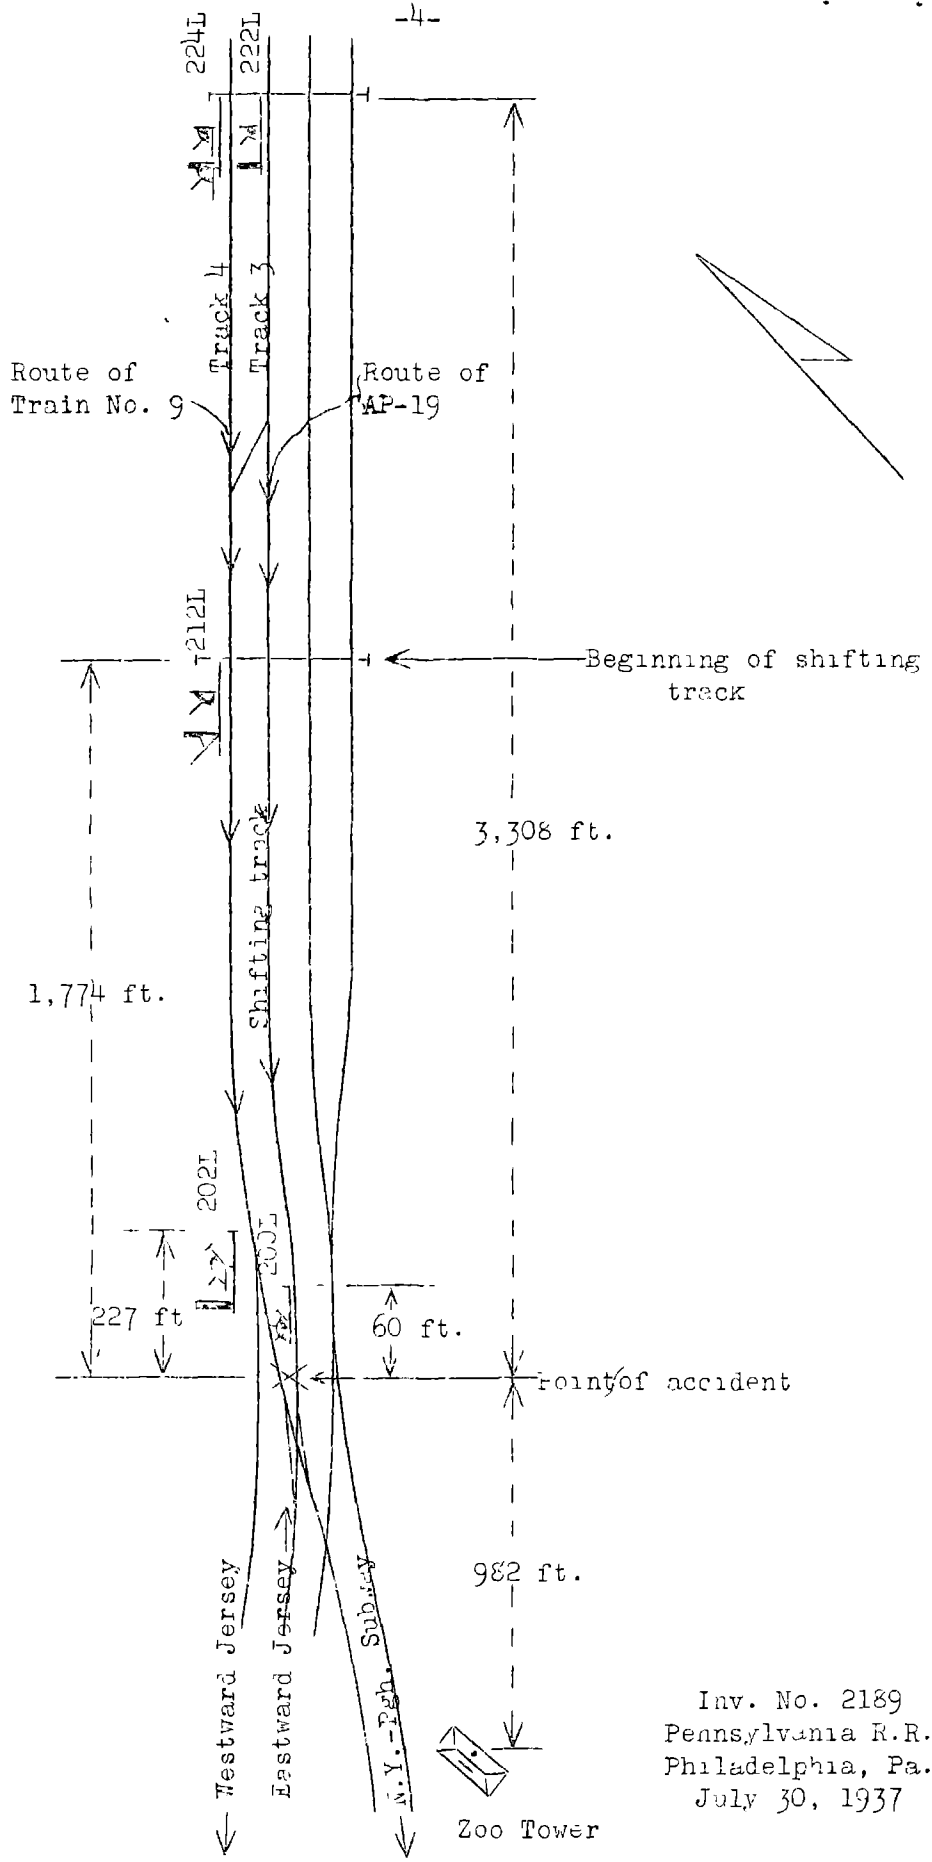
Inv. No. 2189
 Pennsylvania R.R.
 Philadelphia, Pa.
 July 30, 1937

- o Frankford Jct., Pa.
- 3.2 mi.
- o North Philadelphia
- 2.9 mi.
- x Point of accident
- o Zoo interlocking
- 2.4 mi.
- o Broad St. Station Philadelphia, Pa.

signals, but the shifting track is not so equipped for west-bound movements. The signals involved governing west-bound movements on track 4 are home signal 224L, and interlocking signals 212L and 202L, located 3,308 feet, 1,774 feet, and 227 feet, respectively, east of the point of accident. Signals 224L and 212L are located on signal bridges, while signal 202L is on a mast; these signals are 2-unit, position-light signals. For a movement through the plant from track 4 to the New York-Pittsburgh subway, home signal 224L displays a clear-restricting indication - "train proceed at not exceeding one-half its maximum authorized speed at point involved but not exceeding 30 miles per hour", - while signal 212L displays an approach-restricting indication - "train approach next signal at not exceeding one-half its maximum authorized speed at point involved but not exceeding 30 miles per hour", - and signal 202L displays a clear-restricting indication. The signals involved governing west-bound movements on track 3 and the shifting track, also of the position-light type, are home signal 222L, located on the same bridge as signal 224L, and dwarf signal 200L, located 60 feet east of the point of accident. With the route on track 4 lined, as described above, the most favorable indication signal 222L can display is a slow-speed indication - "train proceed at not exceeding 15 miles per hour prepared to stop at next signal"-, and dwarf signal 200L displays a stop indication.
