INVESTIGATION NO. 3190  
THE PENNSYLVANIA RAILROAD COMPANY  
REPORT IN RE ACCIDENT  
NEAR PLEASANT GAP, PA., ON  
JUNE 22, 1948

Accident near Pleasant Gap, Pa., on June 22, 1948  
caused by admitting an opposing train to an  
occupied manual block under clear-block  
authority.

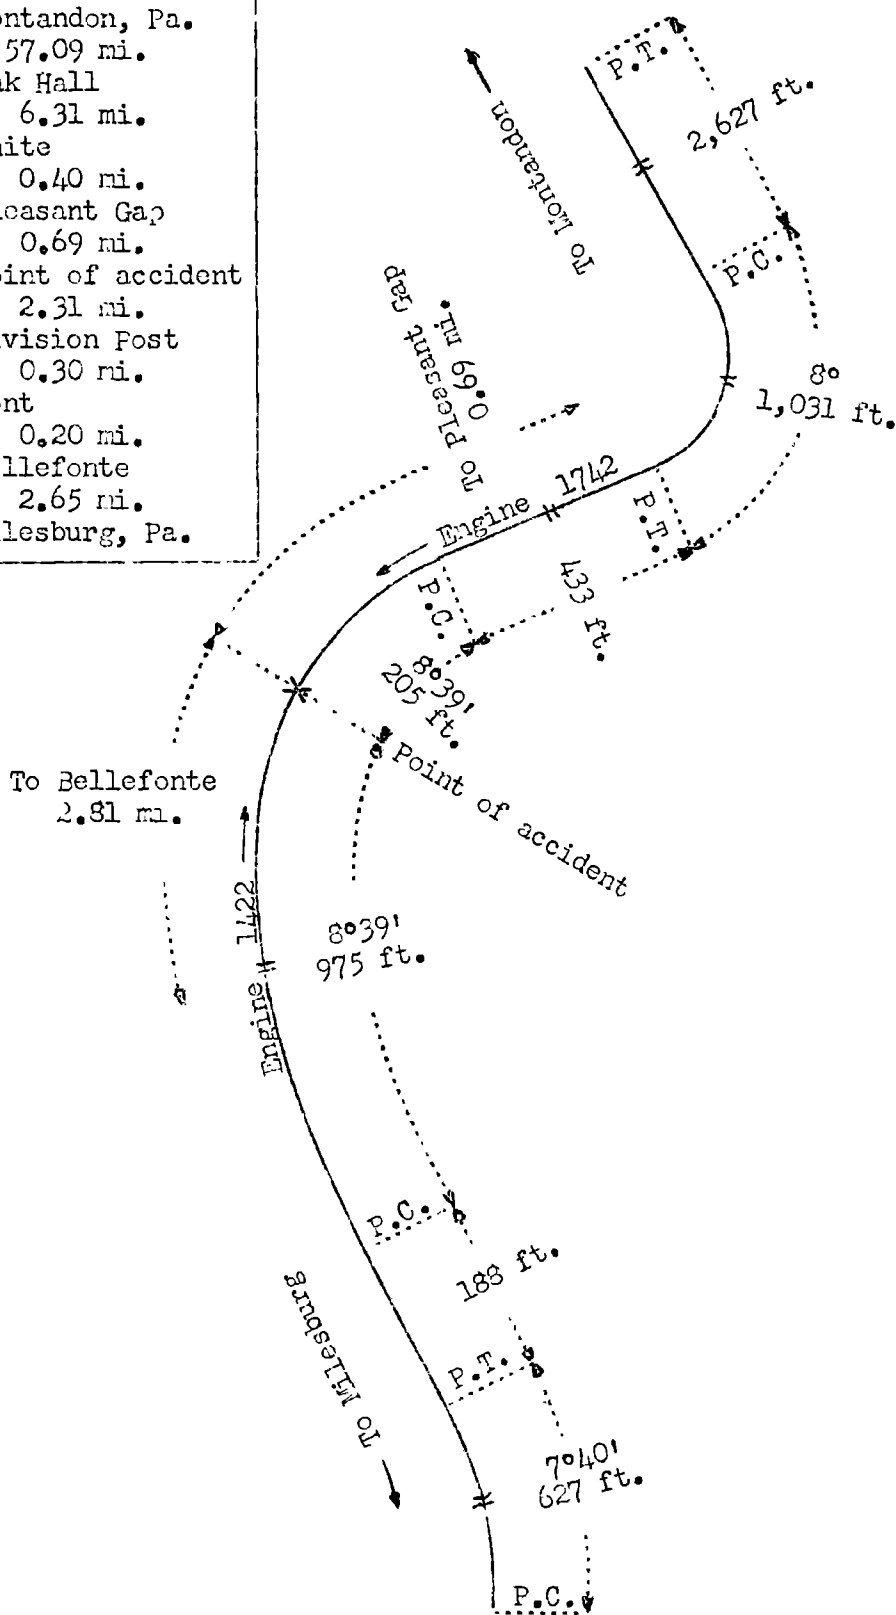
Inv. No. 3190  
 Pennsylvania Railroad  
 Pleasant Gap, Pa.  
 June 22, 1948

Location of Accident and Method of Operation
