INVESTIGATION NO. 2619  
THE PENNSYLVANIA RAILROAD COMPANY  
REPORT IN RE ACCIDENT  
NEAR PROSPECT, N. Y., ON  
AUGUST 22, 1942

Railroad:	Pennsylvania
Date:	August 22, 1942
Location:	Prospect, N. Y.
Kind of accident:	Derailment
Train involved:	Passenger
Train number:	914
Engine number:	3669
Consist:	6 cars
Speed:	15-20 m. p. n.
Operation:	Timetable, train orders and manual block system
Track:	Single; tangent; 1.48 percent descending grade northward
Weather:	Raining
Time:	About 6:38 a. m. .
Casualties:	1 killed; 5 injured
Cause:	Accident caused by wasnout

Accident near Prospect, N. Y., on August 22, 1942, caused  
by washout.

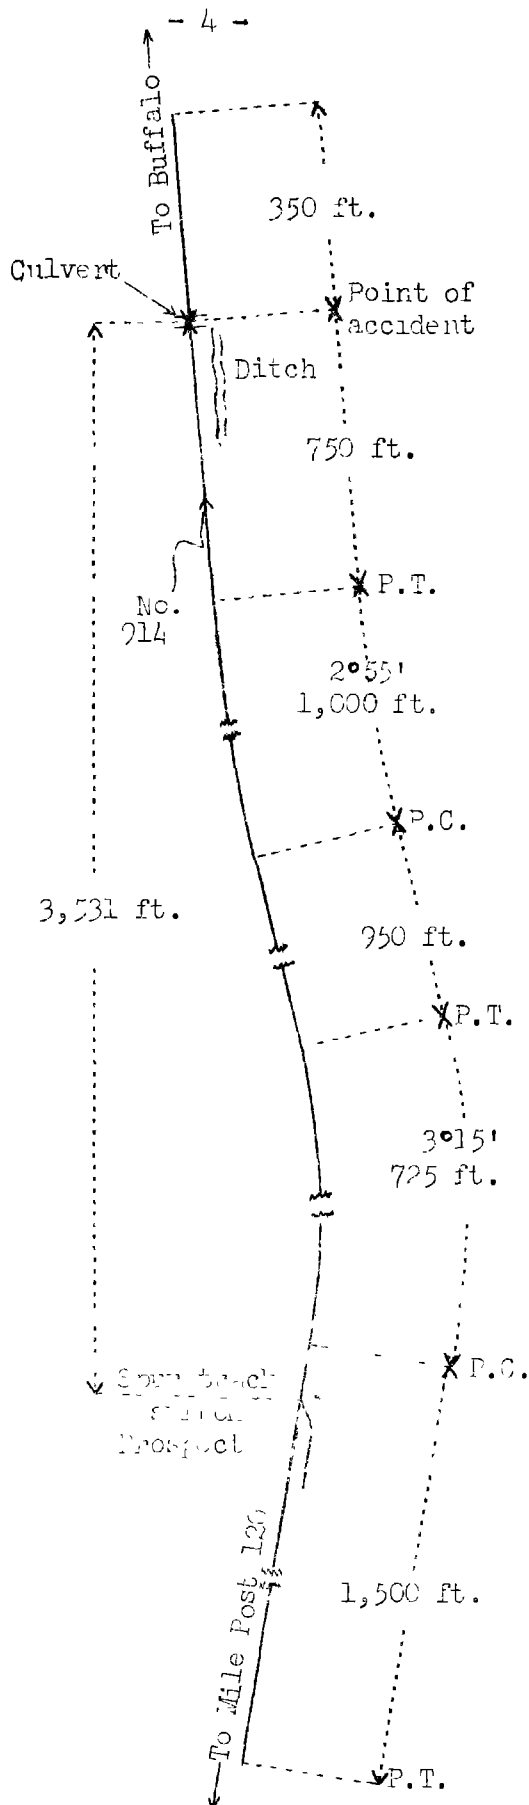
Inv. No. 2619  
 Pennsylvania Railroad  
 Prospect, N. Y.  
 August 22, 1942

○	Buffalo, N. Y.	50.20 mi.
○	BM	0.60 mi.
○	Brocton	7.10 mi.
×	Point of accident	0.67 mi.
○	Prospect	6.53 mi.
○	Mayville, N. Y.	73.60 mi.
○	Oil City, Pa.	13.20 mi.
○	Mile Post 120, E. Sandy, Pa.
