INVESTIGATION NO. 2995
THE PENNSYLVANIA RAILROAD COMPANY
REPORT IN RE ACCIDENT
NEAR ROYALTON, PA., ON
MAY 27, 1946

Railroad: Pennsylvania
Date: May 27, 1946
Location: Royalton, Pa.
Kind of accident: Derailment
Train involved: Passenger
Train number: Passenger Extra 3727 East
Engine number: 3727
Consist: 3 cars
Speed: Approximately 60 m. p. h.
Operation: Automatic block and cab-signal systems
Track: Double; 6° curve; level
Weather: Cloudy
Time: 2:52:30 p. m.
Casualties: 3 killed; 50 injured
Cause: Excessive speed on a curve on which track was not properly maintained

Accident near Royalton, Pa., on May 27, 1946, caused by
excessive speed on a curve of which the track was
not properly maintained.

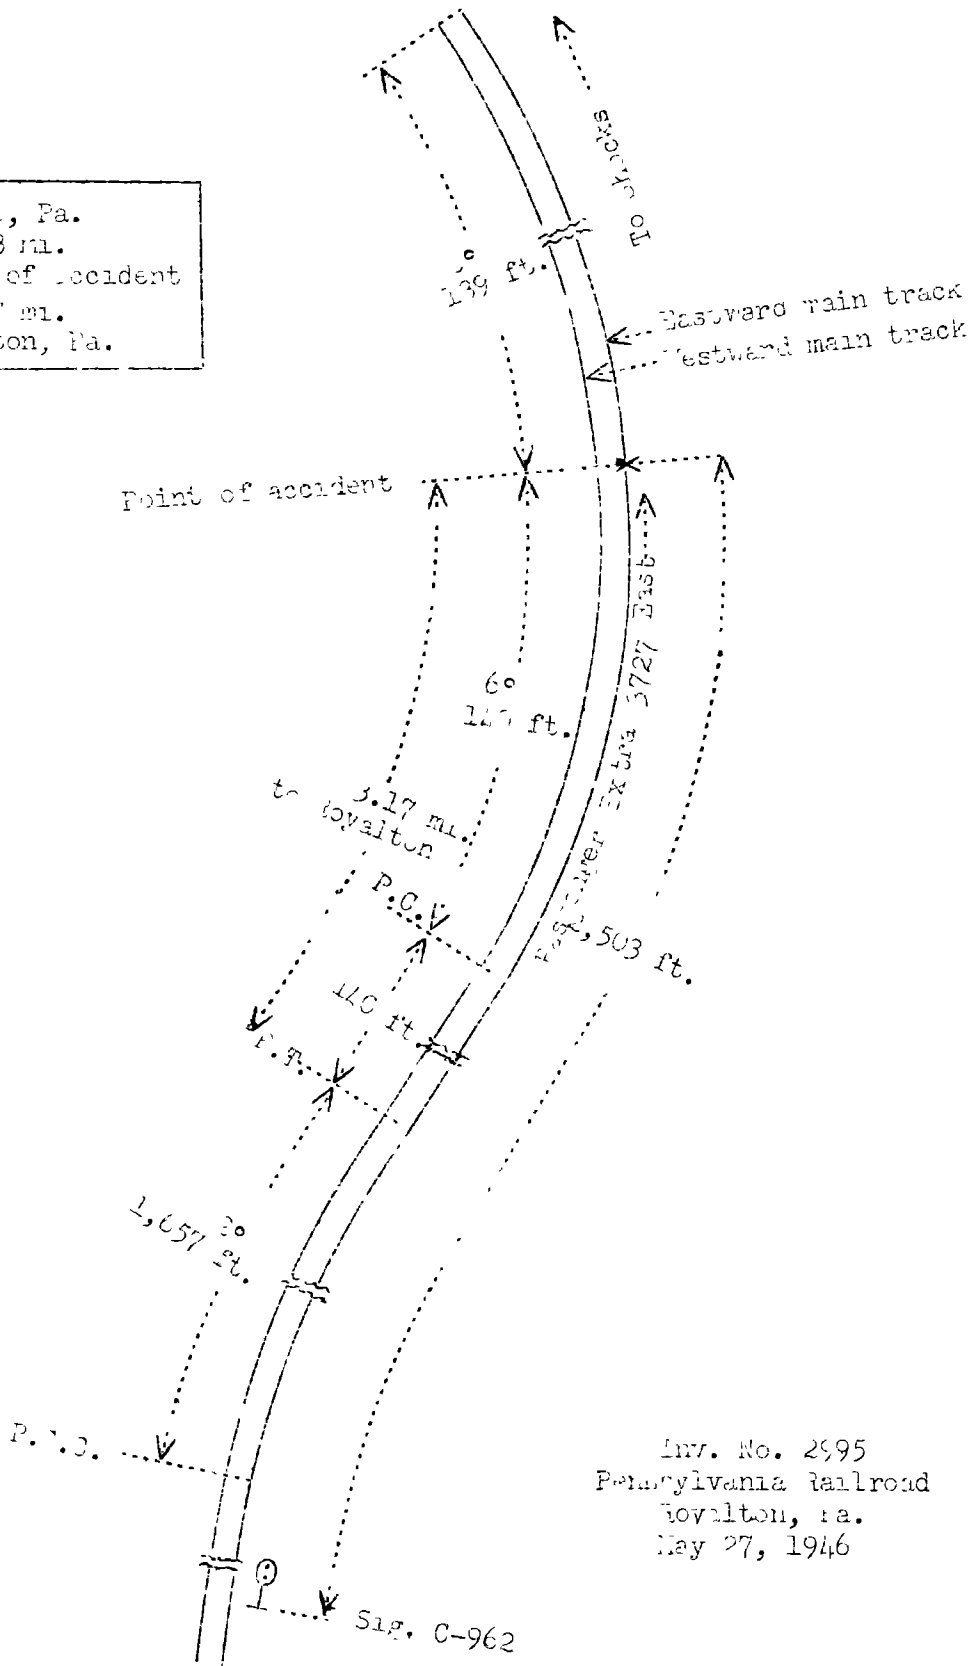
Inv. No. 2895
Pennsylvania Railroad
Roylton, Pa.
May 27, 1946

○ Shocks, Pa.
8.43 mi.
X Point of accident
3.17 mi.
○ Roylton, Pa.

Automatic signal C-962, governing east-bound movements on the eastward main track, is 2,503 feet west of the point of accident. This signal is of the position-light type, and is continuously lighted. The cab signals are of the four-indication, position-light type.

The engine stopped in a general tangential line, on its right side, about 35 feet south of the eastward main track, down an embankment and with the front end 423 feet east of the point of derailment. The right side of the engine was badly damaged, and the cab was demolished. The engine truck was torn loose from the engine, and stopped about 130 feet east of the engine. Breaks in the safety chains of the engine-truck assembly were new, which indicated that the chains broke as a result of the derailment. The tender remained coupled to the engine, and stopped on its right side at the rear of the engine and in line with it. The first car became separated from the tender and the second car, and stopped 28 feet east of the front end of the engine, down the embankment and at right angles to the tracks. Both trucks were detached. The second and third cars stopped between the engine and the eastward main track, down the embankment and at angles of about 30 degrees to the main tracks, with the front end of the second car 16 feet east of the engine. The fourth and fifth cars remained upright on the roadbed. The engine and the first three cars were badly damaged. The fourth and fifth cars were slightly damaged.
