REPORT OF THE DIRECTOR

ACCIDENT ON THE

PENNSYLVANIA RAILROAD

RUSHVILLE, IND.

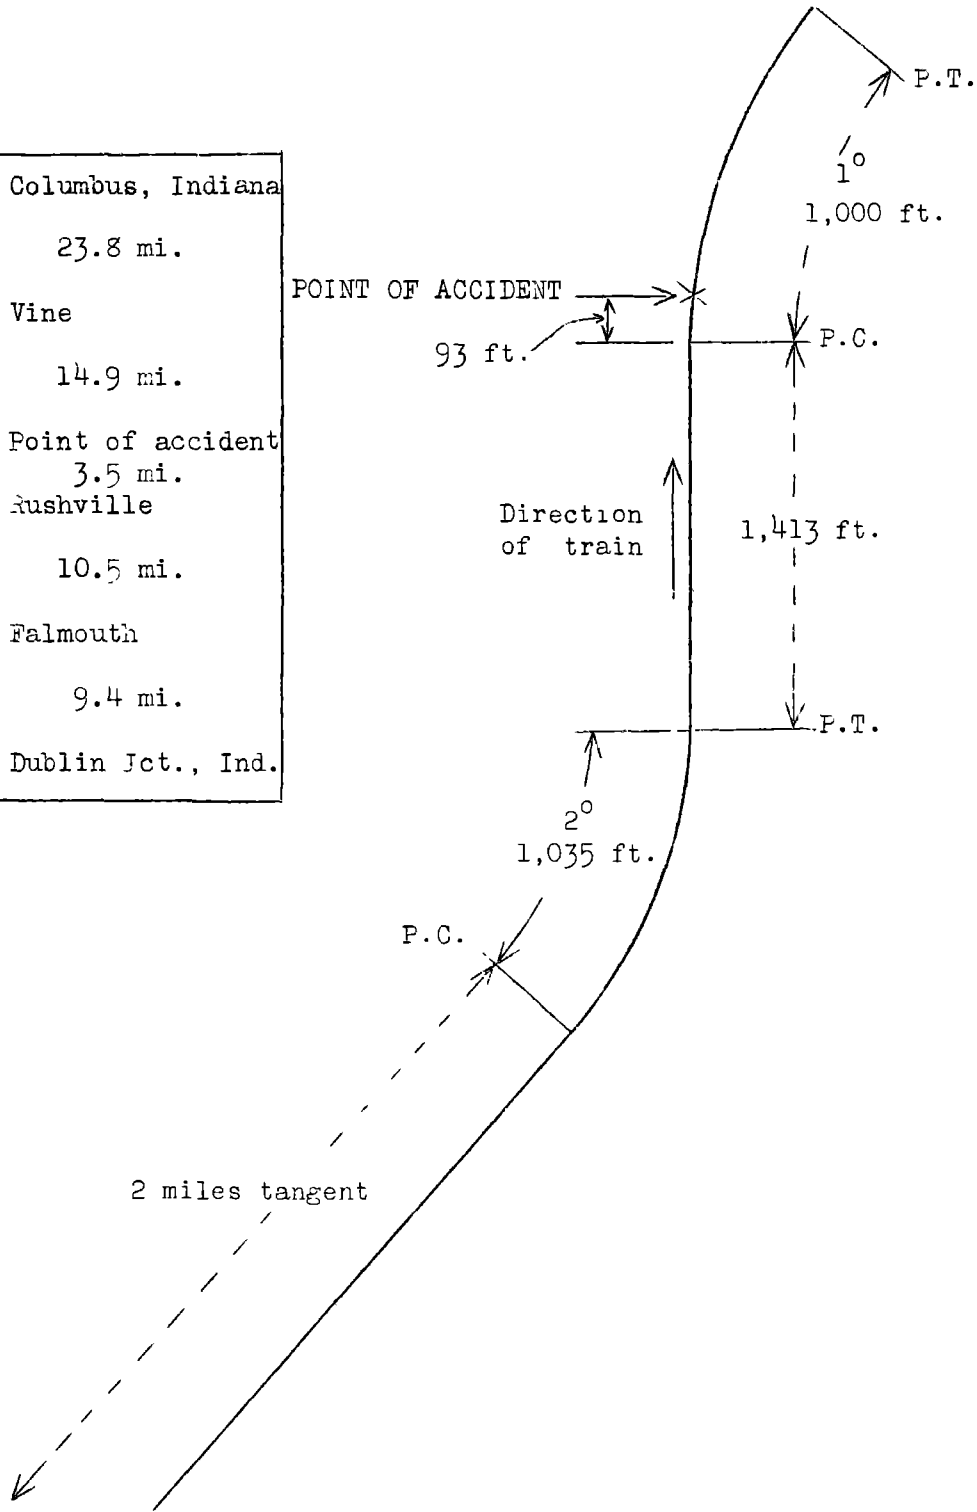
Inv. No. 2169  
Pennsylvania Railroad  
Rushville, Indiana  
April 16, 1937

o	Columbus, Indiana	
		23.8 mi.
o	Vine	
		14.9 mi.
X	Point of accident	
		3.5 mi.
o	Rushville	
		10.5 mi.
o	Falmouth	
		9.4 mi.
o	Dublin Jct., Ind.
