INVESTIGATION NO. 3132
THE PENNSYLVANIA RAILROAD COMPANY
REPORT IN RE ACCIDENT
NEAR SCIO, OHIO, ON
SEPTEMBER 30, 1947

Accident near Scio, Ohio, on September 30, 1947, caused
by failure to operate the following train in
accordance with signal indication.

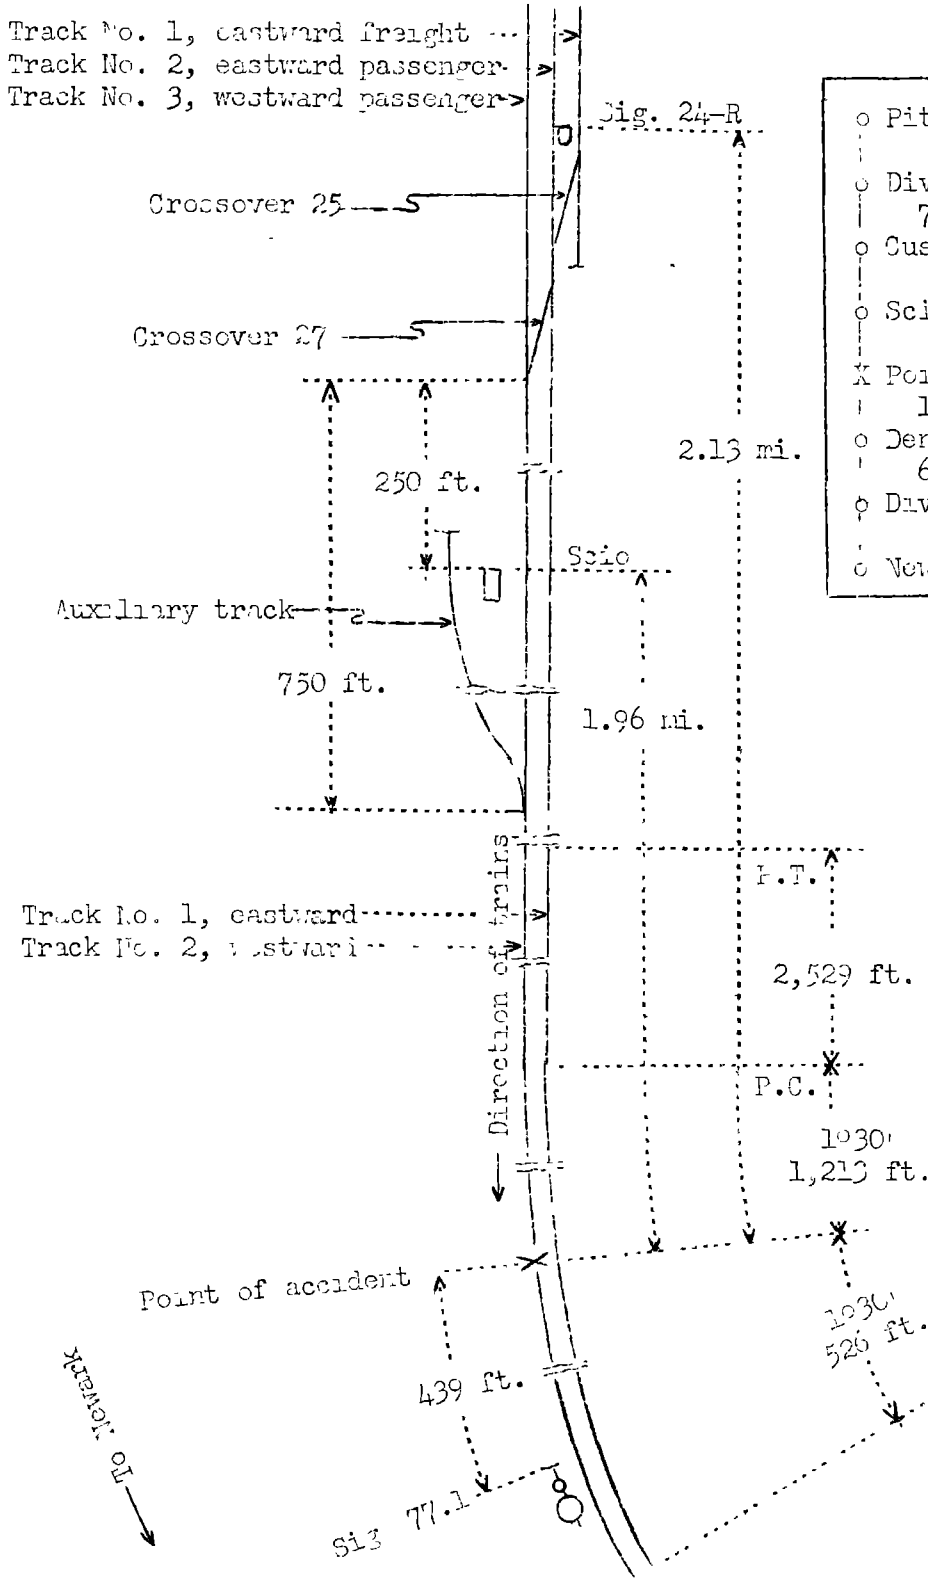
Fig. 24-R

Track No. 1, eastward freight →
 Track No. 2, eastward passenger →
 Track No. 3, westward passenger →

o	Pittsburgh, Pa.	0.20 mi.
	Division Post	70.90 mi.
o	Custer, Ohio	4.00 mi.
o	Scio	1.90 mi.
X	Point of accident	13.44 mi.
o	Dennison	67.10 mi.
o	Division Post	0.20 mi.
o	Newark, Ohio
