INTERSTATE COMMERCE COMMISSION

REPORT OF THE DIRECTOR OF THE BUREAU OF SAFETY IN RE
INVESTIGATION OF AN ACCIDENT WHICH OCCURRED ON THE
PENNSYLVANIA RAILROAD NEAR STAR ROCK, PA., ON
JUNE 16, 1931.

Inv. No. 1711
 Pennsylvania R.R.,
 Star Rock, Pa.
 June 16, 1931

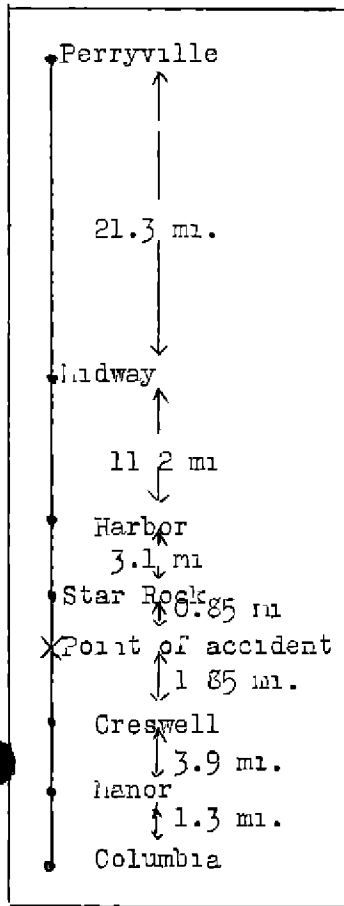
Approaching from the west on the C&PD Branch, the track is tangent for a distance of 813 feet, followed by a 9° curve to the left for a distance of 150 feet and then a 1° 52' curve to the right for a distance of 513 feet, the accident occurring on the 9° portion of the reverse curve and the east end of the bridge being approximately 115 feet from the west end of the curve. The grade is practically level. The track is laid with 130-pound rails, 33 feet in length, with about 18 ties to the rail-length and fully tie-plated, ballasted with stone, and well maintained.

The C&PD Branch in this vicinity is laid on a side cut in the hill at a point about 40 feet above the Susquehanna River and about 60 feet distant from it, while the A&S Branch, a double-track line, is laid about 35 feet above the C&PD Branch and about 80 feet from it. Reconstruction work was in progress in this vicinity, the roadbed and bridge being made wide enough for double-tracking; the bridge had been widened on the side toward the river and decked with a reinforced concrete slab, and the reconstructed bridge had the same length of span as the old bridge, 13 feet 7 inches, although the concrete waterway under the bridge was increased to 7 feet 1 inch in height by virtue of the bridge seats having been raised 14 inches at the time the track was raised, entirely on stone ballast, a month previously. On June 9, the track immediately adjacent to Mann's Run had been lined over to the new concrete slab preparatory to imposing a concrete slab on the remaining portion of the deck, and the supports for the slab were placed on the afternoon of June 15, consisting of four tiers of uprights in the channel of the stream and one tier flush against each abutment. These tiers of uprights were so located that there were five spaces in the water course, namely, one space of 4 feet, in the middle; two spaces of 2 feet 6 inches, one being on each side of the 4-foot middle space, and two spaces of 2 feet 1 inch, these extending from either side of the 2-foot 6-inch spaces to the bridge abutments. At the time of the accident trains were being operated on the temporary alinement of the track on the river-half of the bridge, with the forms and supports in place on the hillside-half, preparatory to pouring the concrete, which it was intended to do on the day of the accident.

Engine 266 came to rest in an upright position and in line with the track, with the front end down in the hole that had been scoured out by the washout, the top of the smoke stack being several feet below track level; the rear end of the engine rested on the east abutment of the bridge and north of the wing wall, which wall was not disturbed. The tender was derailed, but remained coupled to the engine

Examination of conditions immediately after the accident and before anything was removed disclosed that the basin between the bridge and the foot of the rock slope was full of stone, sand, gravel, tree stumps, and other debris, that had washed down from the hillside so that the water course at the entrance to the bridge was entirely closed; in fact, in looking through the water course under the
