INTERSTATE COMMERCE COMMISSION
WASHINGTON

INVESTIGATION NO. 2930
THE PENNSYLVANIA RAILROAD COMPANY
REPORT IN RE ACCIDENT
AT TIRO, OHIO, ON
SEPTEMBER 12, 1945

Accident at Tiro, Ohio, on September 12, 1945, caused by
an automobile becoming stalled on a highway grade
crossing.

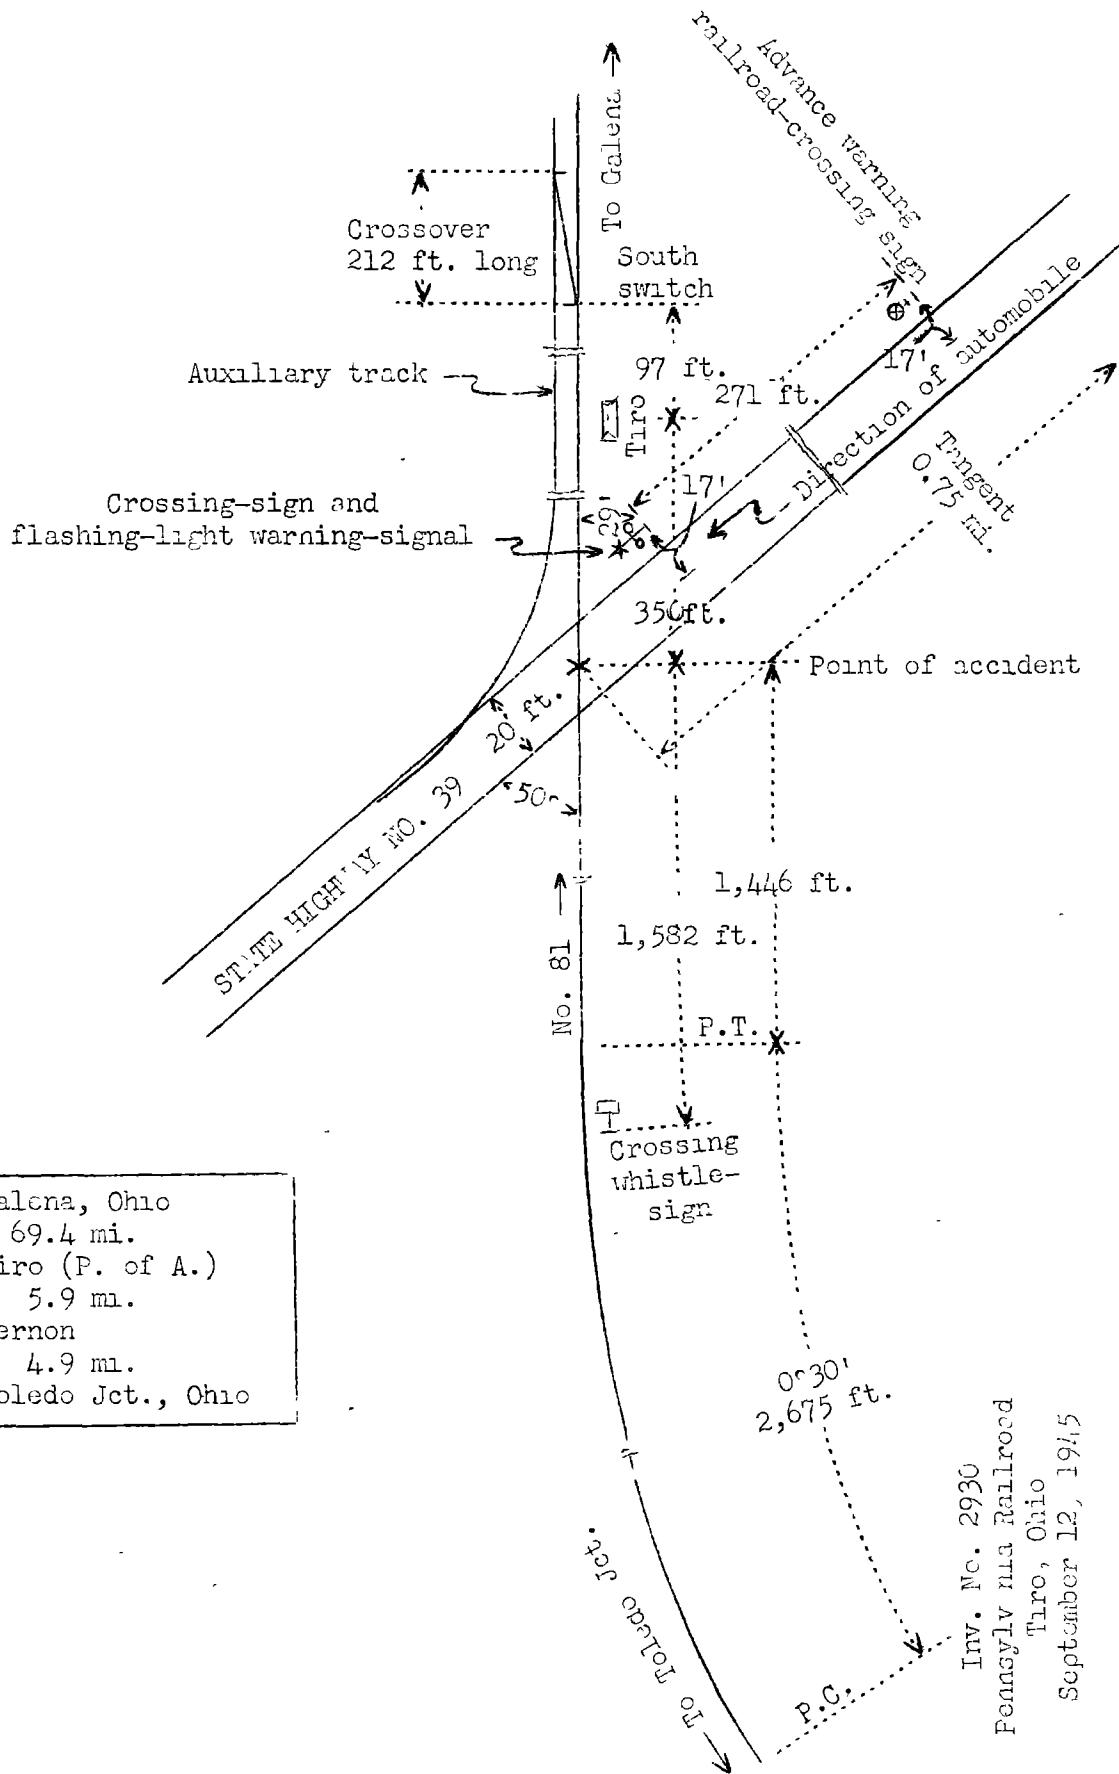
This accident occurred on that part of the Toledo Division extending between Toledo Jct. and Galena, Ohio, 80.2 miles, a single-track line in the vicinity of the point of accident, over which trains are operated by timetable, train orders and an automatic block-signal system. The accident occurred 10.8 miles north of Toledo Junction, at a point 350 feet south of the station at Tiro, where the railroad is crossed at grade by State Highway No. 39. The south switch of a facing-point crossover 212 feet long, which connects the main track and an auxiliary track located on the west side of the main track, is 97 feet north of the station. From the south on the railroad there is a $0^{\circ}30'$ curve to the right 2,675 feet in length, which is followed by a tangent 1,446 feet to the point of accident and a considerable distance northward. The grade is 0.66 percent descending northward.

State Highway No. 39 intersects the railroad at an angle of 50° . The highway is tangent throughout a distance of 0.75 mile east of the crossing and a considerable distance westward. The grade is level. The crossing is about 20 feet wide and is surfaced with asphaltum. The level of the crossing between the rails is about 1 inch below the tops of the rails.

The engine stopped on its right side, across the auxiliary track and at an angle of about 15 degrees to it, with the front end 417 feet north of the south crossover-switch. The first three cars stopped, practically upright, across the track and at right angles to it. The fourth to the seventh cars, inclusive, stopped practically upright, east of the track and in line with it. The front truck of the eighth car was derailed. The engine and the first car were badly damaged, and the second, third and fourth cars were considerably damaged.
