INTERSTATE COMMERCE COMMISSION
WASHINGTON

REPORT OF THE DIRECTOR
BUREAU OF SAFETY

ACCIDENT ON THE
PENNSYLVANIA RAILROAD

VANPORT, PA.

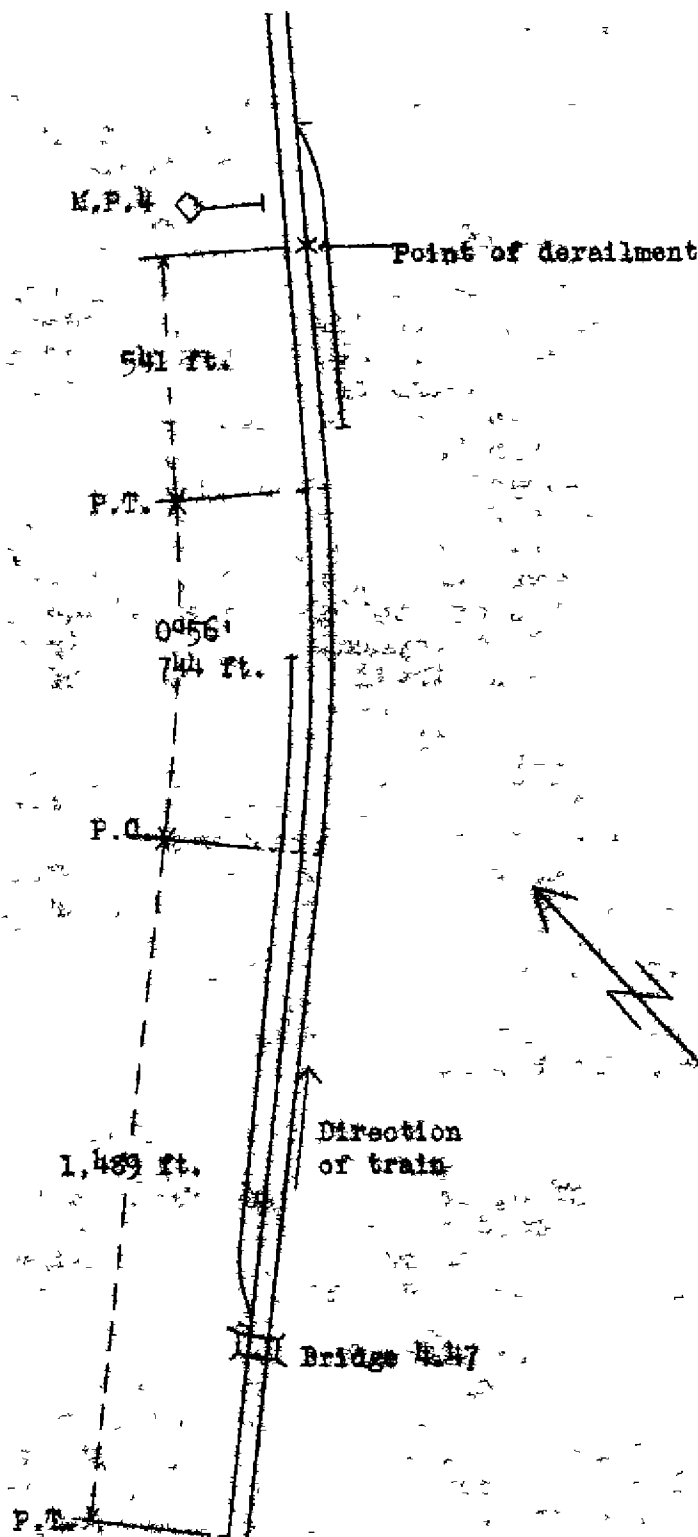
- o Rochester, Pa.
3.5 mi.
- o Vancott, Pa.
2 (Point of accident)
8.5 mi.
- o Hindsteel, Pa.
7.2 mi.
- o Jethro, Ohio
4.2 mi.
- o Wellsville, Ohio
8.8 mi.
- o New Salisbury, Ohio
5.4 mi.
- o Salineville, Ohio
3.2 mi.
- o Fairhope, Ohio

This accident occurred on the Bayard Cut-off and River Branch of the Eastern Division, extending between Fairhope, Ohio, and Rochester, Pa., a distance of 68.7 miles, in the vicinity of the point of accident this is a double-track line over which trains are operated by time-table, train orders and an automatic block-signal system. The point of derailment was on the east-bound main track approximately 4,338 feet west of the station at Vanport; approaching this point from the west the track is tangent for a distance of 1,489 feet, then there is a 0°56' curve to the left 744 feet in length, followed by 541 feet of tangent to the point of accident and for a distance of about 445 feet beyond. The grade in this vicinity is slightly undulating, being level at the point of derailment.

Train CW-b, an east-bound freight train, consisted at the time of the accident of 9 cars and a caboose, hauled by engine 6861, and was in charge of Conductor Sloven and Engineman Wiegol. This train departed from Fairhope at 11 34 p.m., August 31, according to the train sheet, and on reaching Wellsville, 45.3 miles beyond, several cars were picked up, including Maine Centr 1 35020, a steel underframe box car, stops were made to set out cars at Jethro and Midsteel, located 4.2 and 11.4 miles, respectively, east of Wellsville. The train departed from Midsteel, the last open office and located 8.5 miles west of Vanport, at 2 45 a.m., September 1, according to the train sheet, and while approaching Vanport it was derailed while traveling at a speed estimated to have been between 30 and 40 miles per hour.
