INVESTIGATION NO. 2681  
THE PENNSYLVANIA RAILROAD COMPANY  
REPORT IN RE ACCIDENT  
NEAR WILMINGTON, DEL., ON  
FEBRUARY 23, 1947

Accident near Wilmington, Del., on February 23, 1943, caused  
by failure properly to control speed of the following  
train in accordance with signal indication.

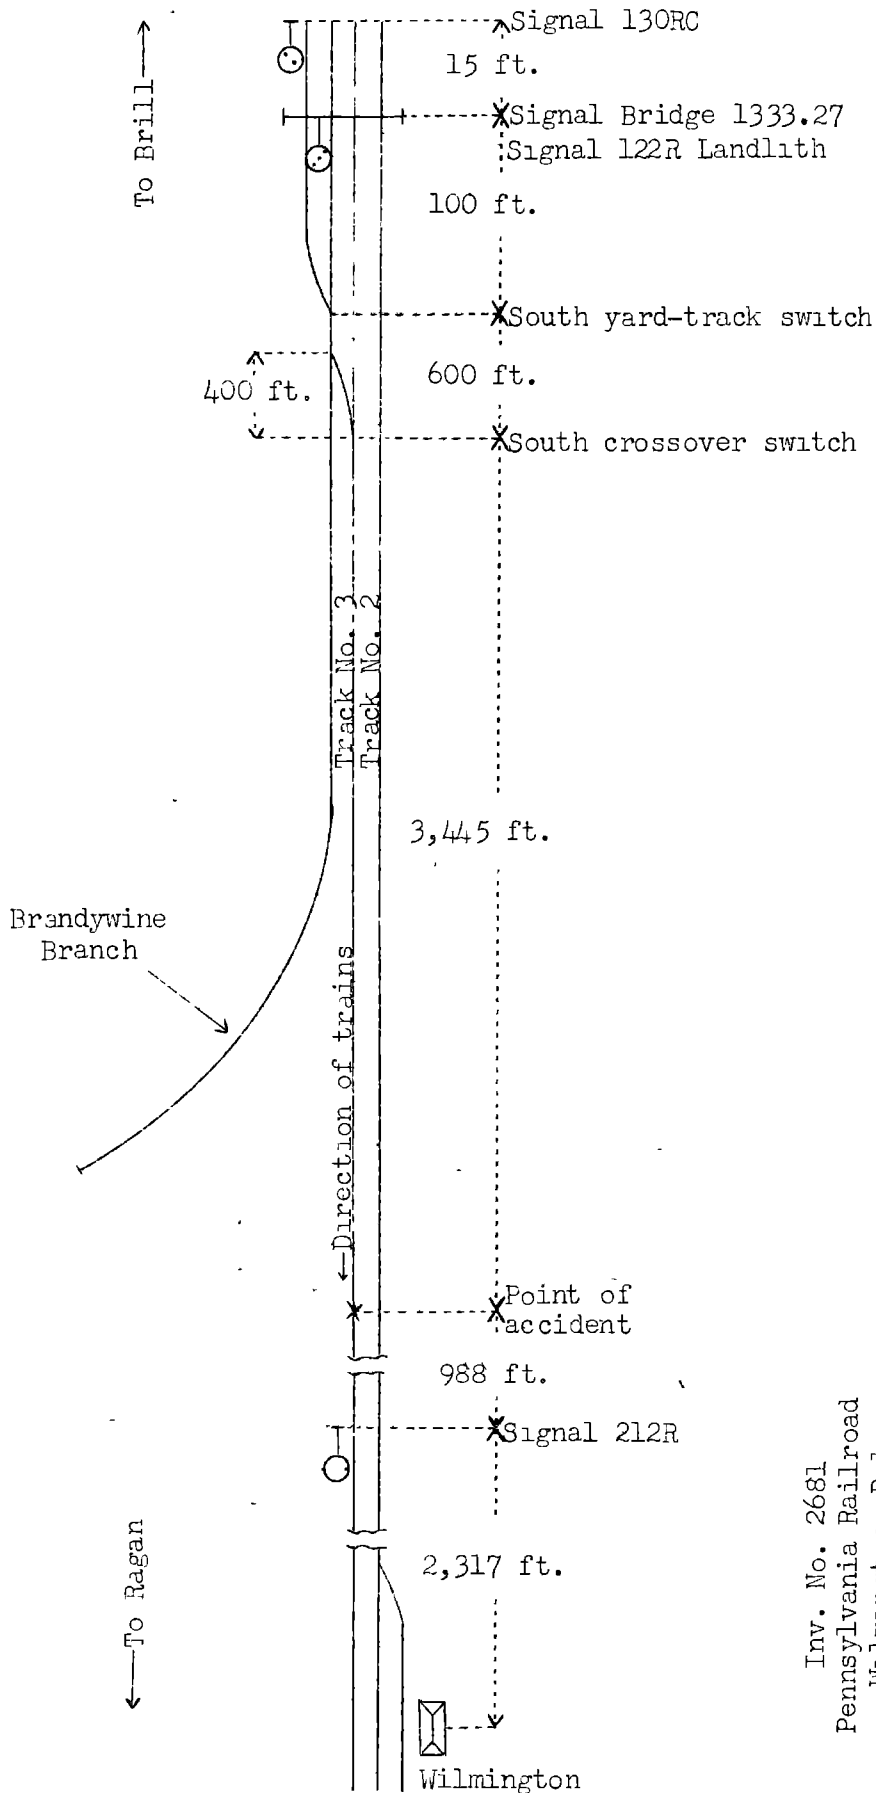
- o Brill, Pa. 17.9 mi.
- o Bellevue, Del. 3.2 mi.
- o Landlith 0.8 mi.
- X Point of accident 0.6 mi.
- o Wilmington 2.7 mi.
- o Ragan, Del.

Inv. No. 2681  
 Pennsylvania Railroad  
 Wilmington, Del.  
 February 23, 1943
