REPORT NO. 3339
THE PENNSYLVANIA RAILROAD COMPANY
IN RE ACCIDENT
NEAR WINDFALL, IND., ON
JULY 10, 1950

Accident near Windfall, Ind., on July 10, 1950, caused
by broken joint bars.

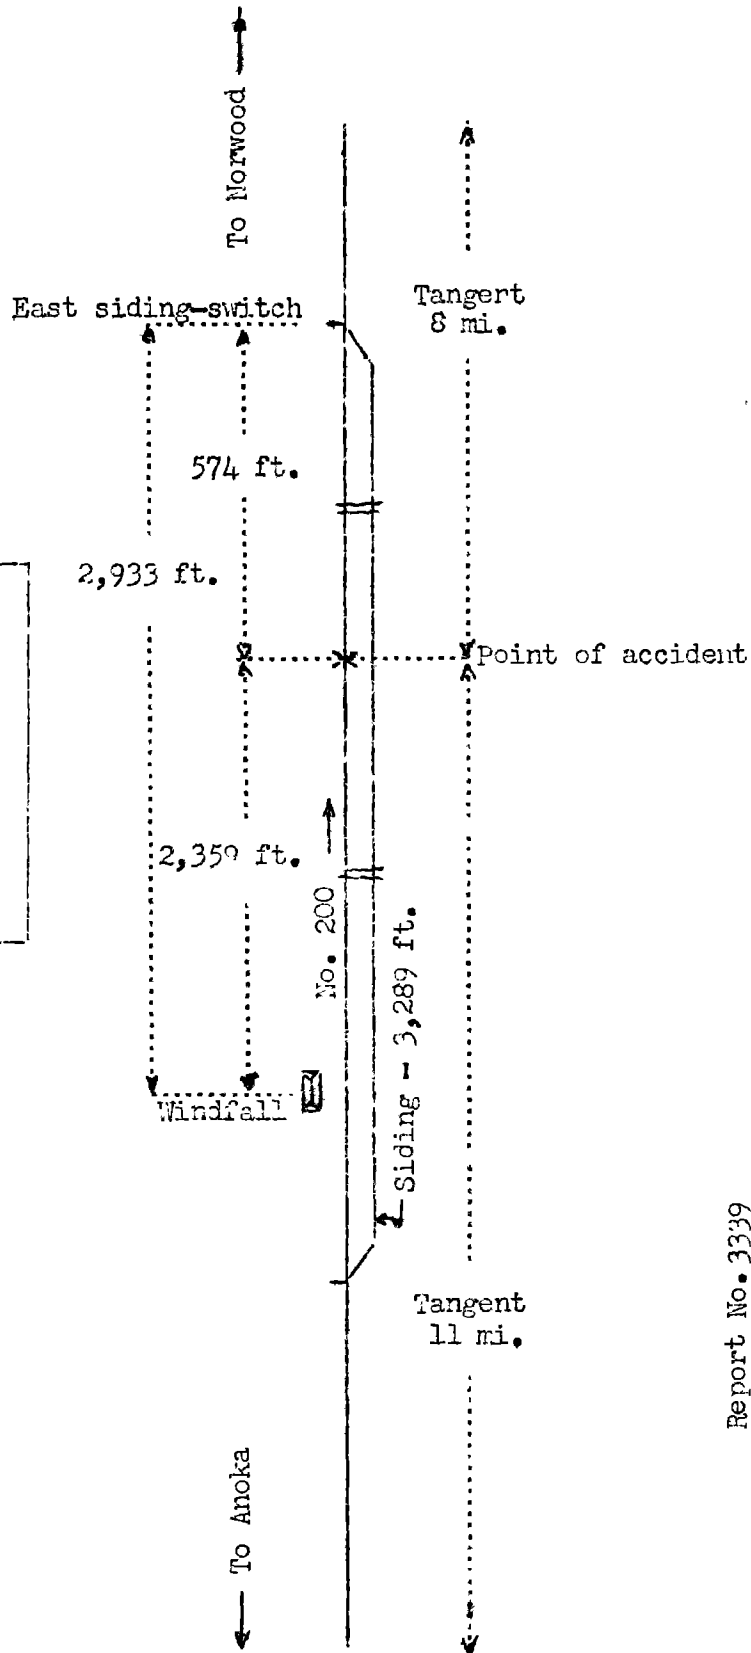
Report No. 3339
 Pennsylvania Railroad
 Windfall, Ind.
 July 10, 1950

- o Norwood, Ohio
- | 135.95 mi.
- X Point of accident
- | 0.45 mi.
- o Windfall, Ind.
- | 13.10 mi.
- o Kokomo
- | 17.50 mi.
- o Division Post
- | 0.40 mi.
- o Anoka, Ind.

This accident occurred on that part of the Cincinnati Division extending between Division Post, 0.4 mile east of Anoka, Ind., and Norwood, Ohio, 167 miles. In the vicinity of the point of accident this is a single-track line, over which trains are operated by timetable, train orders and a manual-block system. At Windfall, 30.6 miles east of Division Post, a siding 3,289 feet in length parallels the main track on the south. The east switch of this siding is 2,933 feet east of the station at Windfall. The accident occurred on the main track 2,359 feet east of the station at Windfall and 574 feet west of the east switch of the siding. The main track is tangent throughout a distance of 11 miles immediately west of the point of accident and approximately 8 miles eastward. The grade is level.
