INVESTIGATION NO. 2705

THE PENNSYLVANIA RAILROAD COMPANY

REPORT IN RE ACCIDENT

AT WORKS, PA., ON

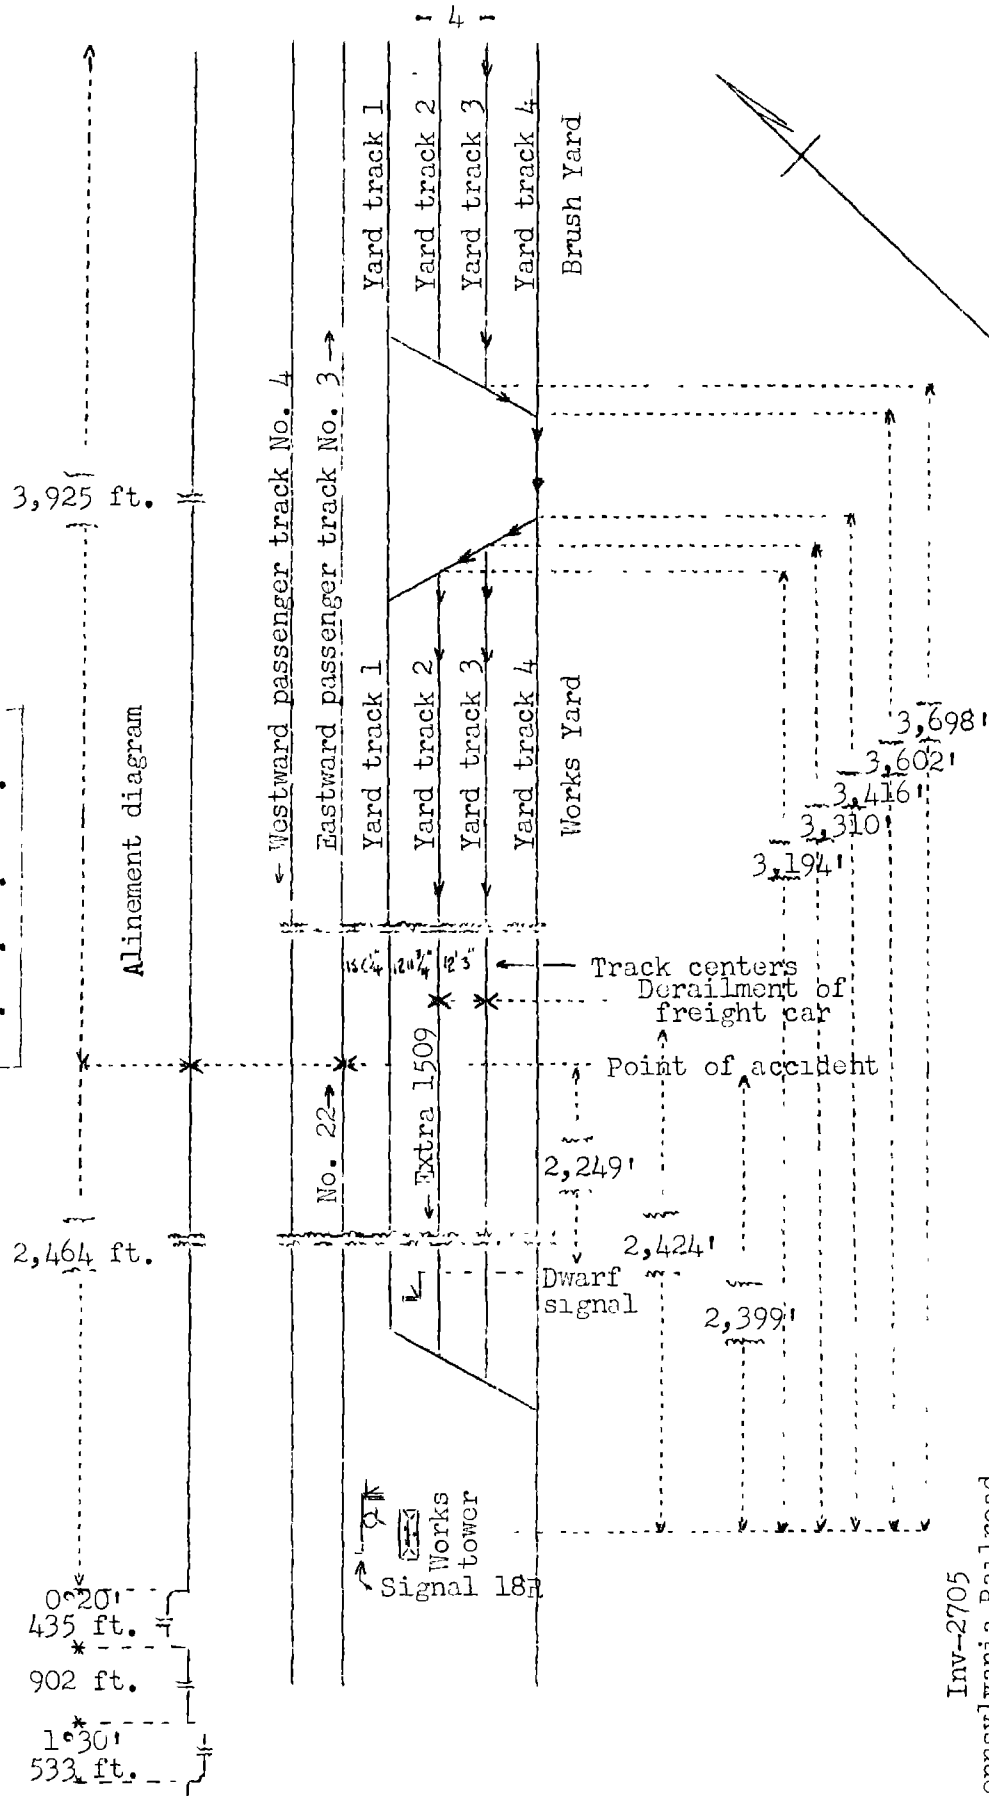
Inv-2705
 Pennsylvania Railroad
 Works, Pa.
 June 8, 1943

To Banks →

← To Slope

Location of Accident and Method of Operation

After the accident, engine 1509 and 54 cars were on track 2 of Works Yard, the fifty-fifth to the fifty-eighth cars, inclusive, were derailed and, beginning with the fifty-ninth car, the rear portion was headed into track 3. The switch to track 3 was lined for entry to that track, the throwing lever was latched, the switch lamp was extinguished, and the wick was turned down. A piece 1 inch long by 1/4 inch wide was broken off the top of the north switch point about 1 inch from the actual point of switch. The first mark on the track structure was a flange mark on the top surface of the south rail at a point 86 feet 6 inches west of the point of switch, and it extended diagonally across the head of the rail a distance of 6 inches. At a point 3 feet farther west a flange mark appeared on the south wing of the frog. Westward from these marks throughout a distance of 800 feet, flange marks appeared on the ties about 17 inches outside the south rail and 2 feet inside the north rail. The first mark on track 2 was a flange mark on the north wing of the frog at a point 104 feet west of the mark on the frog of track 3. Opposite the mark on the wing of the frog of track 2, a flange mark appeared on the guard rail and it extended diagonally across the head of the rail a distance of 6 inches. From this point westward throughout a distance of 696 feet, flange marks appeared on the ties about 1 foot 6 inches outside the north rail and 2 feet 2 inches inside the south rail. Examination of the switch to track 3 disclosed that the points fitted properly against the stock rails in either position. The switch operated easily when lined for entry to track 3, but operated very hard when it was thrown to the reverse position. A yard employee who was in charge of the switches at the east end of Works Yard said that when he lined the east switch of track 4 a few minutes before the cars were moved eastward from track 2 to the lead track he observed that the switch lamp on the east switch of track 3 displayed a green aspect, which indicated that this switch was lined for movement on the lead track. The accident occurred about 35 minutes later and soon afterward he examined the switch lamp and found that the wick had been turned down and the light extinguished. He was of the opinion that the throwing lever of the switch was not properly latched and was thrown for movement to track 3 by the movement of the cars over the switch points, or that
