INTERSTATE COMMERCE COMMISSION

REPORT NO. 3671

THE PENNSYLVANIA RAILROAD COMPANY

IN RE ACCIDENT

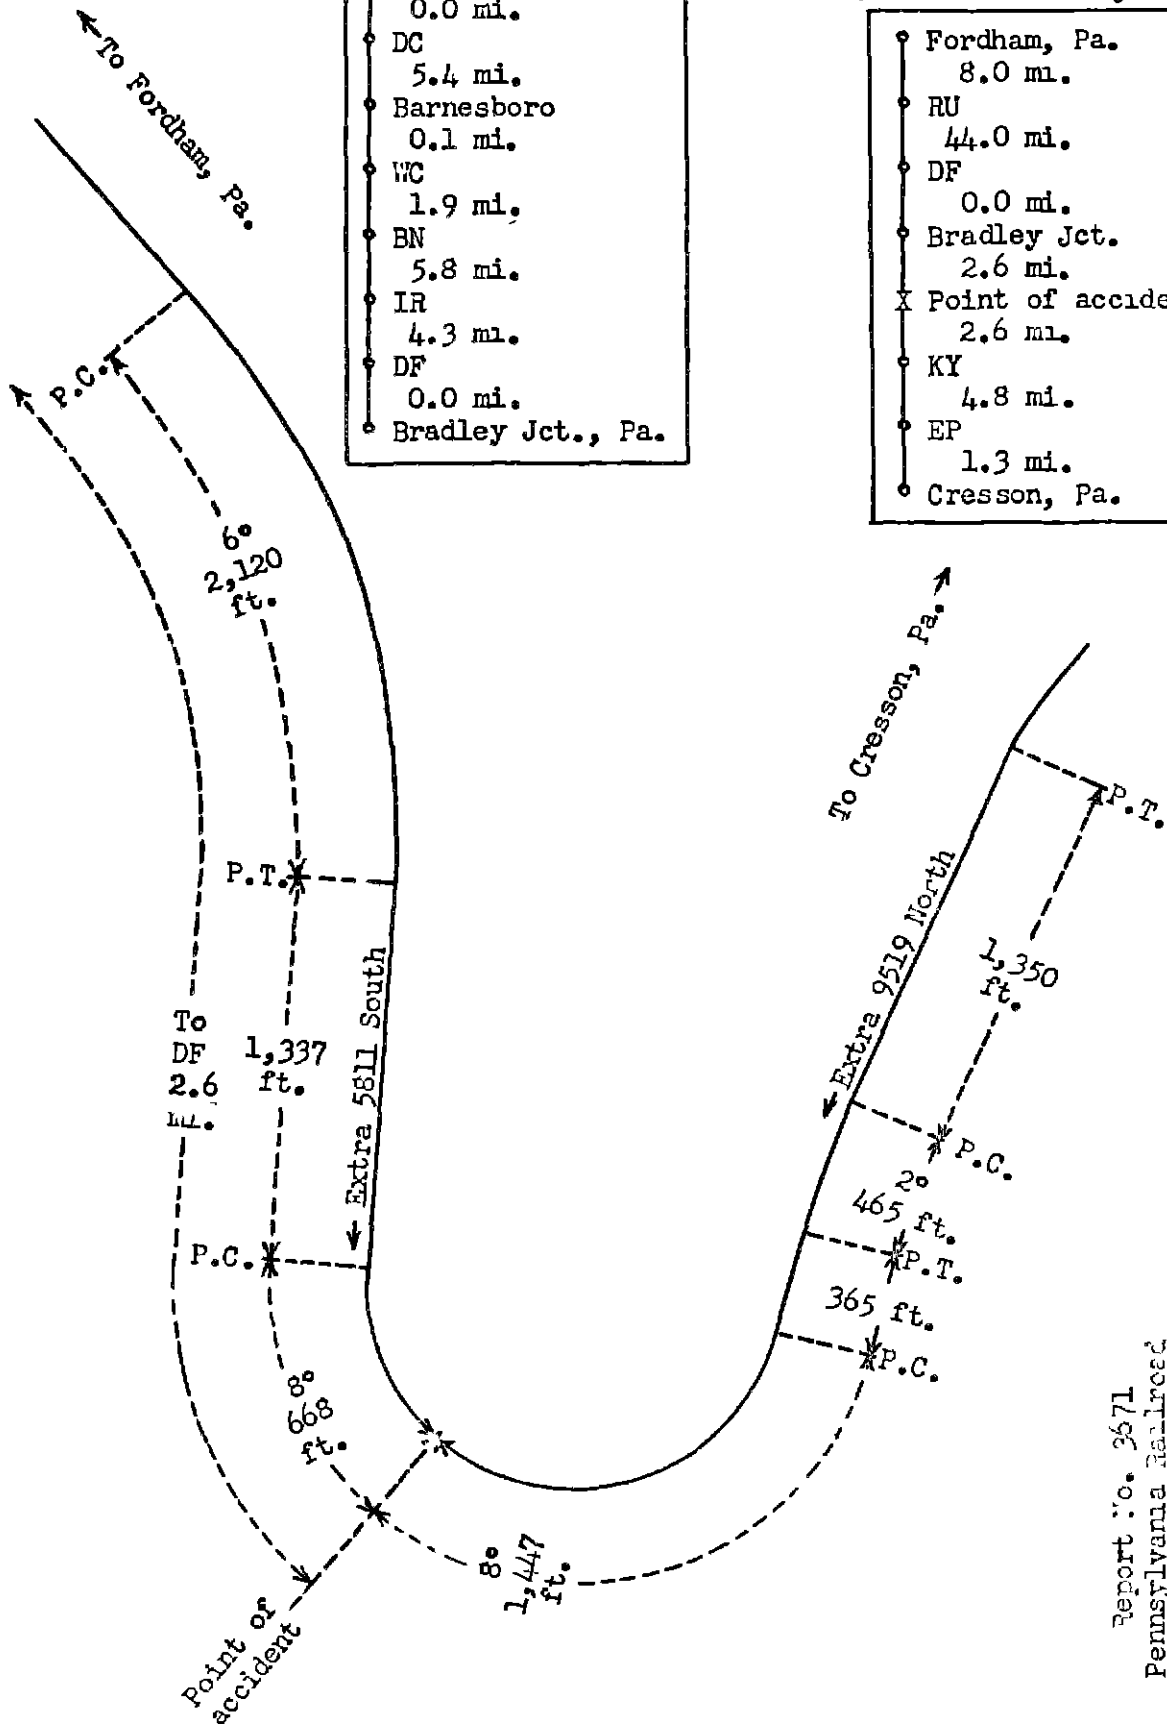
Susquehanna Secondary Track

Cresson Secondary Track

- Fordham, Pa.
8.0 mi.
- RU
44.0 mi.
- DF
0.0 mi.
- Bradley Jct.
2.6 mi.
- X Point of accident
2.6 mi.
- KY
4.8 mi.
- EP
1.3 mi.
- Cresson, Pa.

Report No. 3671
 Pennsylvania Railroad
 Near Bradley Jct., Pa.
 December 3, 1955

Location of Accident and Method of Operation
