REPORT NO. 3641
THE PENNSYLVANIA RAILROAD COMPANY
IN RE ACCIDENT
NEAR BUCYRUS, OHIO, ON
JULY 11, 1955

Accident near Bucyrus, Ohio, on July 11, 1955, caused
by failure to operate the following train in
accordance with signal indications.

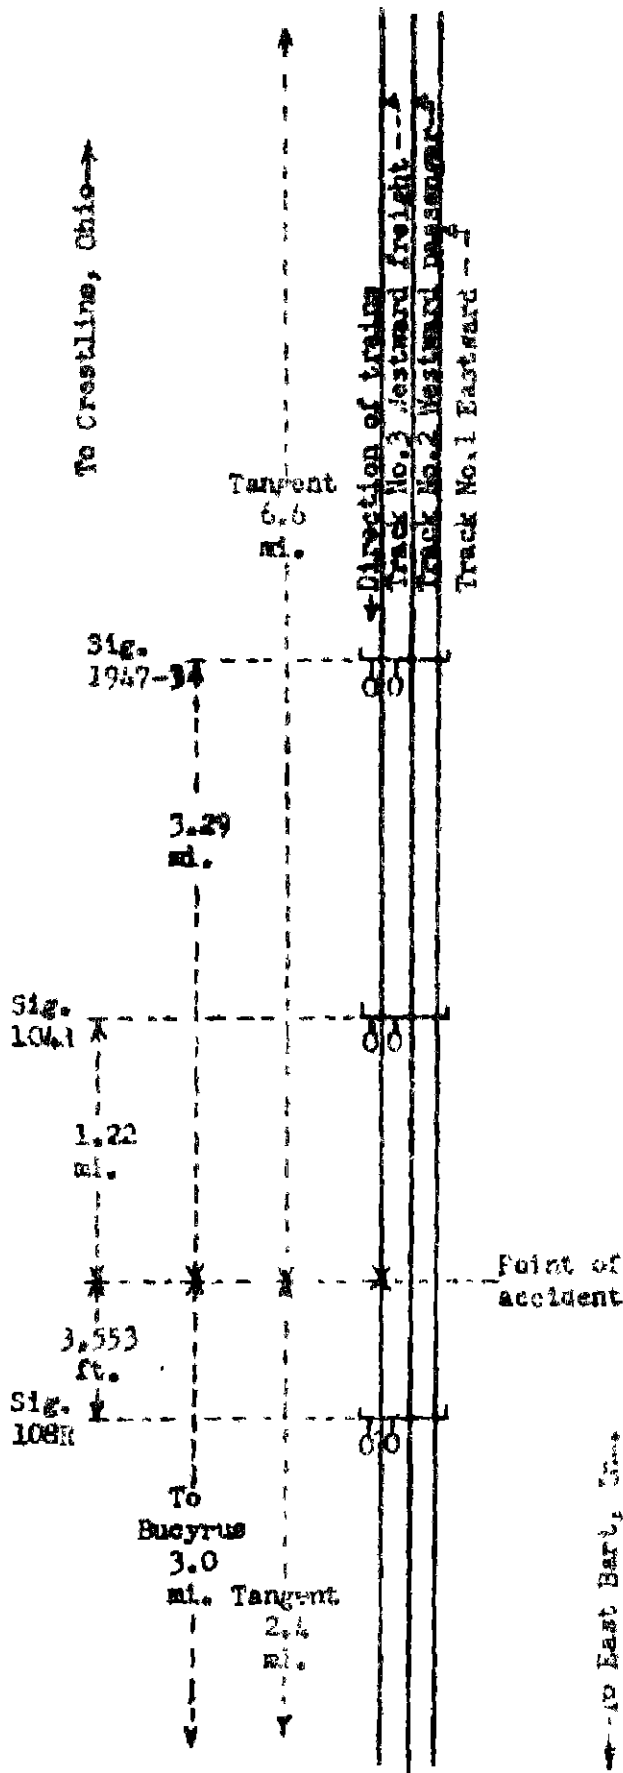
Report No. 3047
 Pennsylvania Railroad
 Near Bucyrus, Ohio
 July 11, 1955

- Division Post 1.7 mi.
- Crestline, Ohio 2.5 mi.
- West Yard 7.0 mi.
- Point of accident 3.0 mi.
- Bucyrus, Ohio 32.5 mi.
- Division Post 0.1 mi.
- East Bart, Ind. 0.1 mi.

These signals form part of a traffic-control system. The control machine is located at Crestline. The controlling circuits are so arranged that when a west-bound train passes signal 104R while the indication of the signal is less restrictive than Stop, the indication will change to Stop. If the code is then transmitted to cause the signal to display an aspect to proceed before the train clears the block of the signal, the indication will change from Stop to Stop-then-proceed-at-restricted-speed. When the block of signal 1947-3 is unoccupied and signal 104R indicates either Stop or Stop-then-proceed-at-restricted-speed, signal 1947-3 indicates Proceed-prepared-to-stop-at-next-signal.
