INTERSTATE COMMERCE COMMISSION
WASHINGTON

REPORT NO. 3677
THE PENNSYLVANIA RAILROAD COMPANY
IN RE ACCIDENT
AT VERN, MD., ON
FEBRUARY 23, 1956

Accident at Vern, Md., on February 23, 1956, caused by a
broken journal.

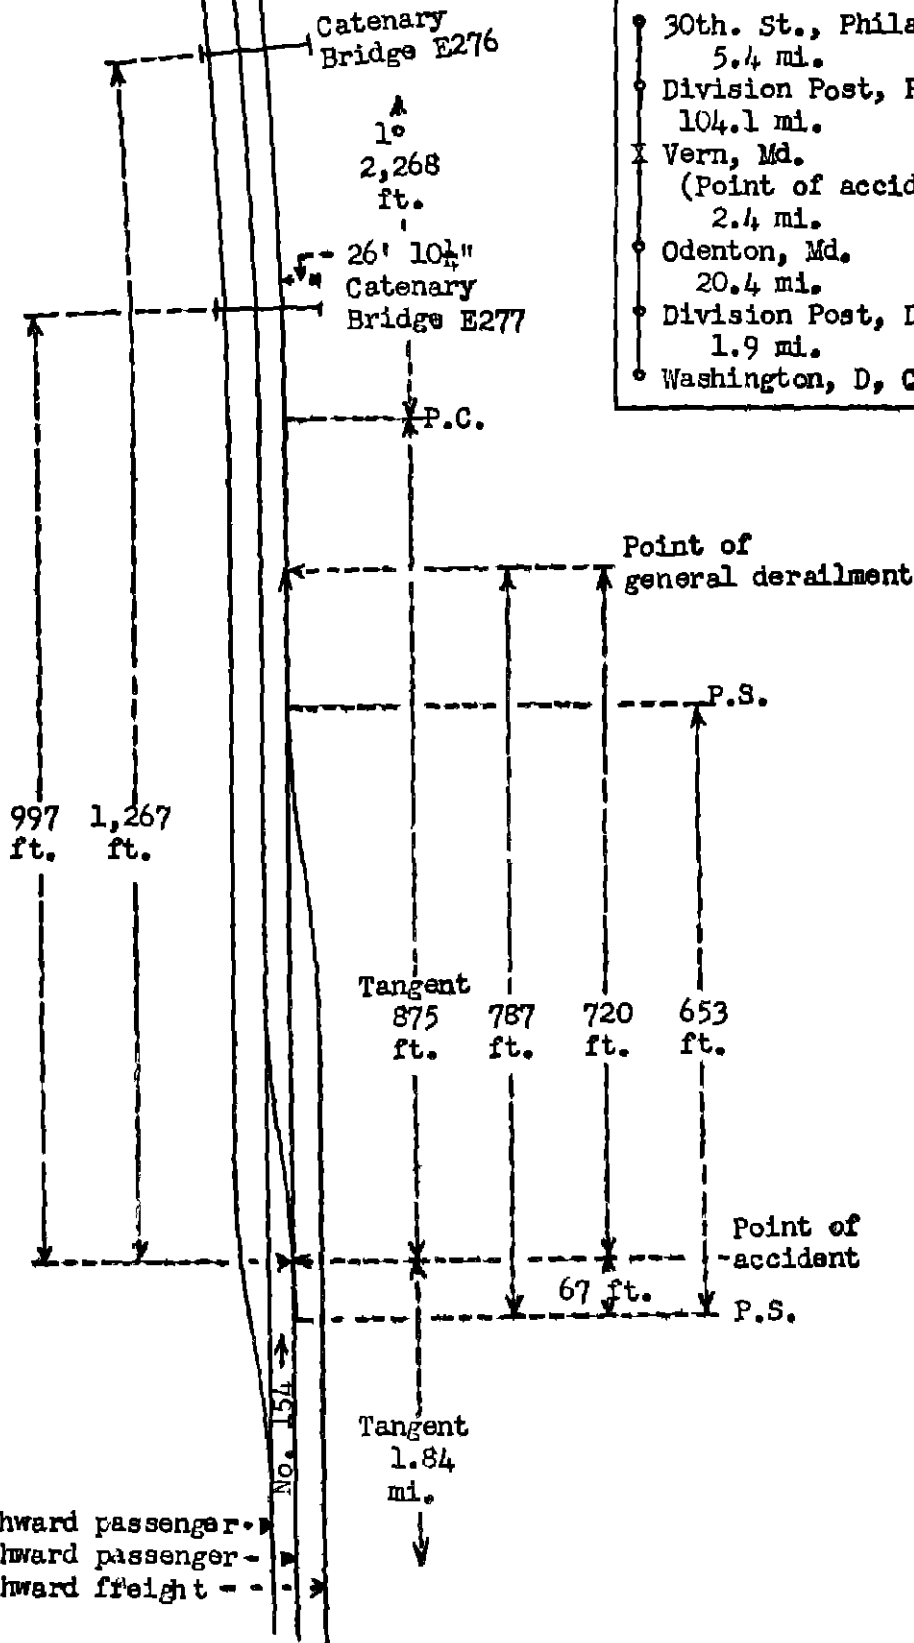
Report No. 3677
 Pennsylvania Railroad
 Vern, Md.
 February 23, 1956

To Philadelphia, Pa. →

← To Washington, D. C.

- ← No. 4 Southward freight
- ← No. 3 Southward passenger
- ← No. 2 Northward passenger

- 30th. St., Philadelphia, Pa. 5.4 mi.
- Division Post, Pa. 104.1 mi.
- Vern, Md. (Point of accident) 2.4 mi.
- Odenton, Md. 20.4 mi.
- Division Post, D. C. 1.9 mi.
- Washington, D. C.

- No. 3 Southward passenger →
- No. 2 Northward passenger →
- No. 1 Northward freight →
