INVESTIGATION NO. 2953
THE PEORIA AND EASTERN RAILWAY COMPANY
AND
THE WABASH RAILROAD COMPANY
REPORT IN RE ACCIDENT
AT DANVILLE JCT., ILL., ON
DECEMBER 6, 1945

Accident at Danville Jct., Ill., on December 6, 1945, caused
by failure to provide adequate protection for movements
over the crossing involved.

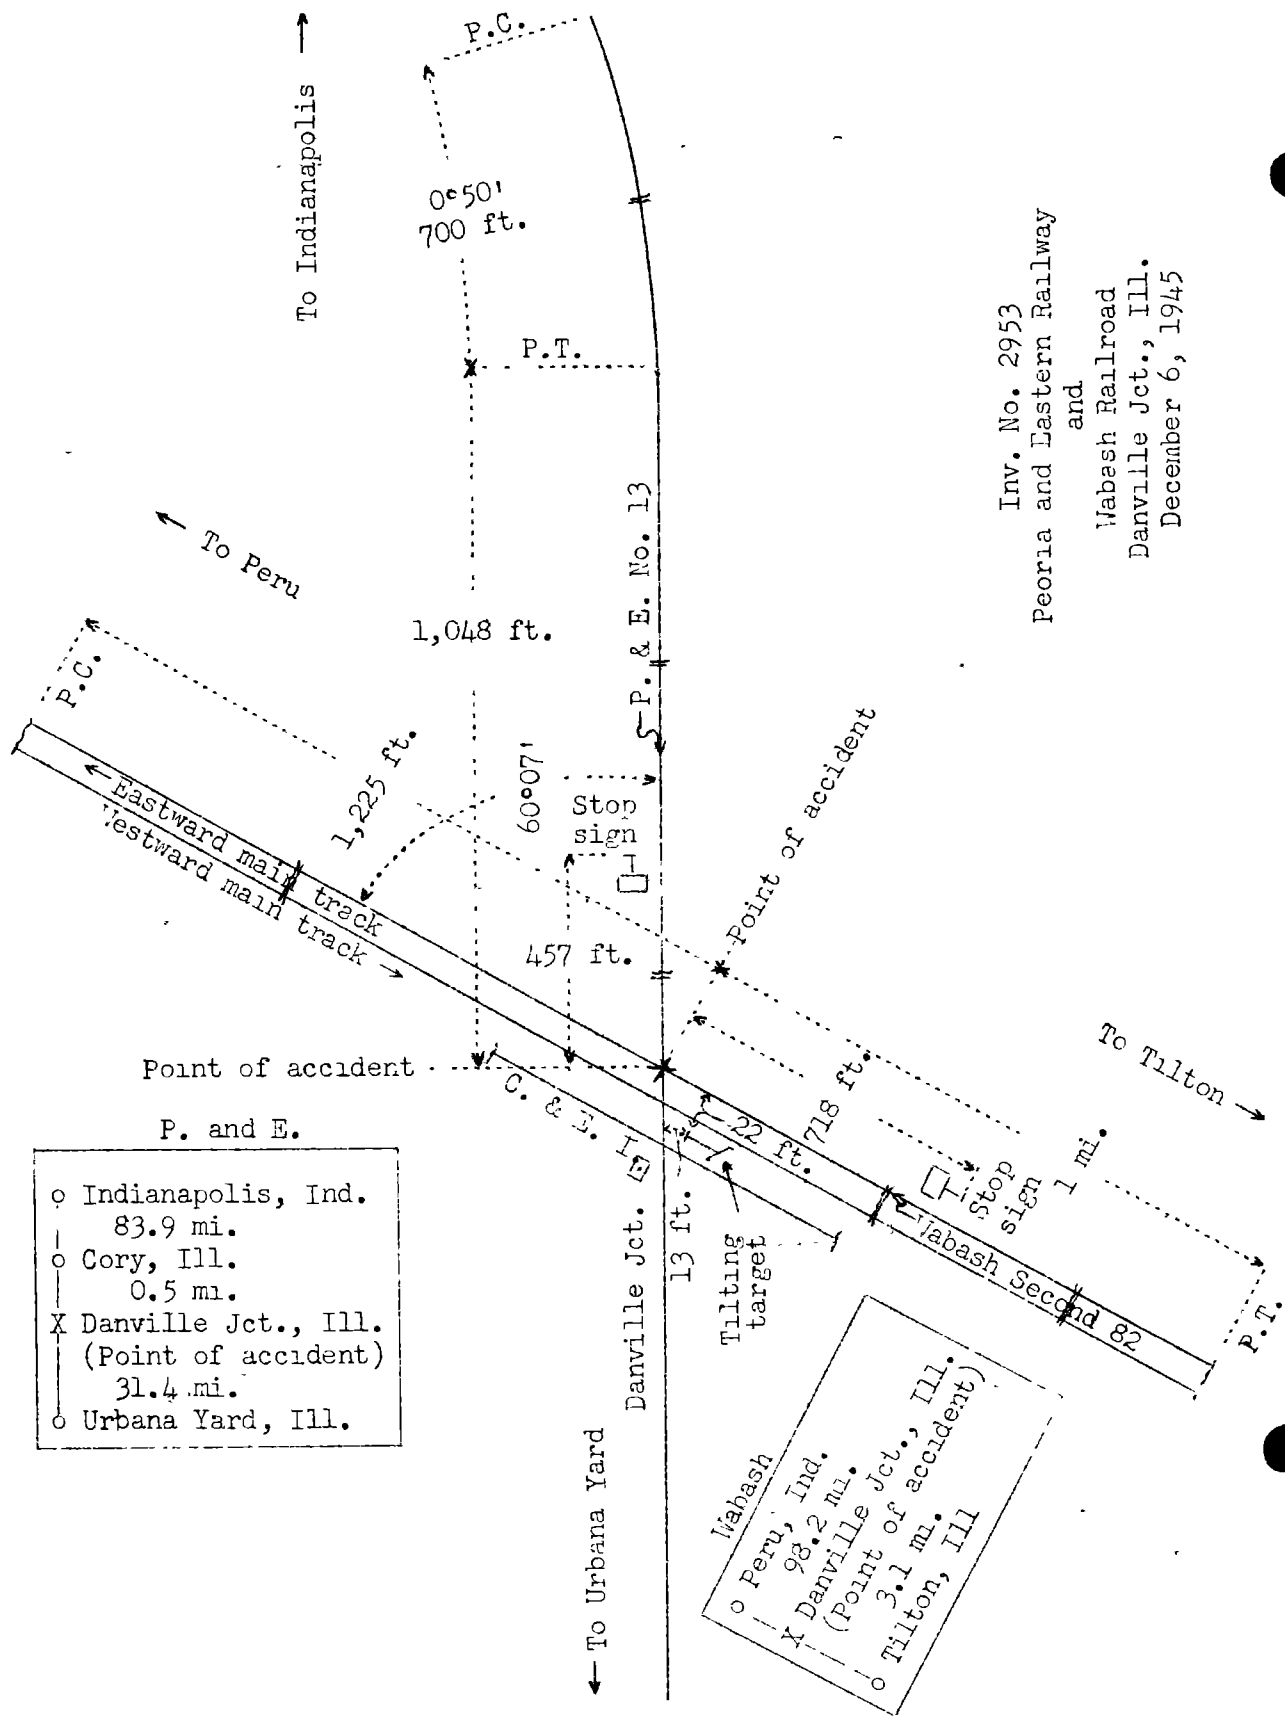
Inv. No. 2953
 Peoria and Eastern Railway
 and
 Mabash Railroad
 Danville Jct., Ill.
 December 6, 1945

- P. and E.
- o Indianapolis, Ind.
83.9 mi.
 - o Cory, Ill.
0.5 mi.
 - X Danville Jct., Ill.
(Point of accident)
31.4 mi.
 - o Urbana Yard, Ill.
