## INTERSTATE COMMERCE COMMISSION

REPORT OF THE DIRECTOR OF THE BUREAU OF SAFETY IN RE  
INVESTIGATION OF AN ACCIDENT WHICH OCCURRED ON THE  
PERE MARQUETTE RAILWAY AT EDMORE, MICH., ON  
SEPTEMBER 25, 1931.

December 1, 1931.

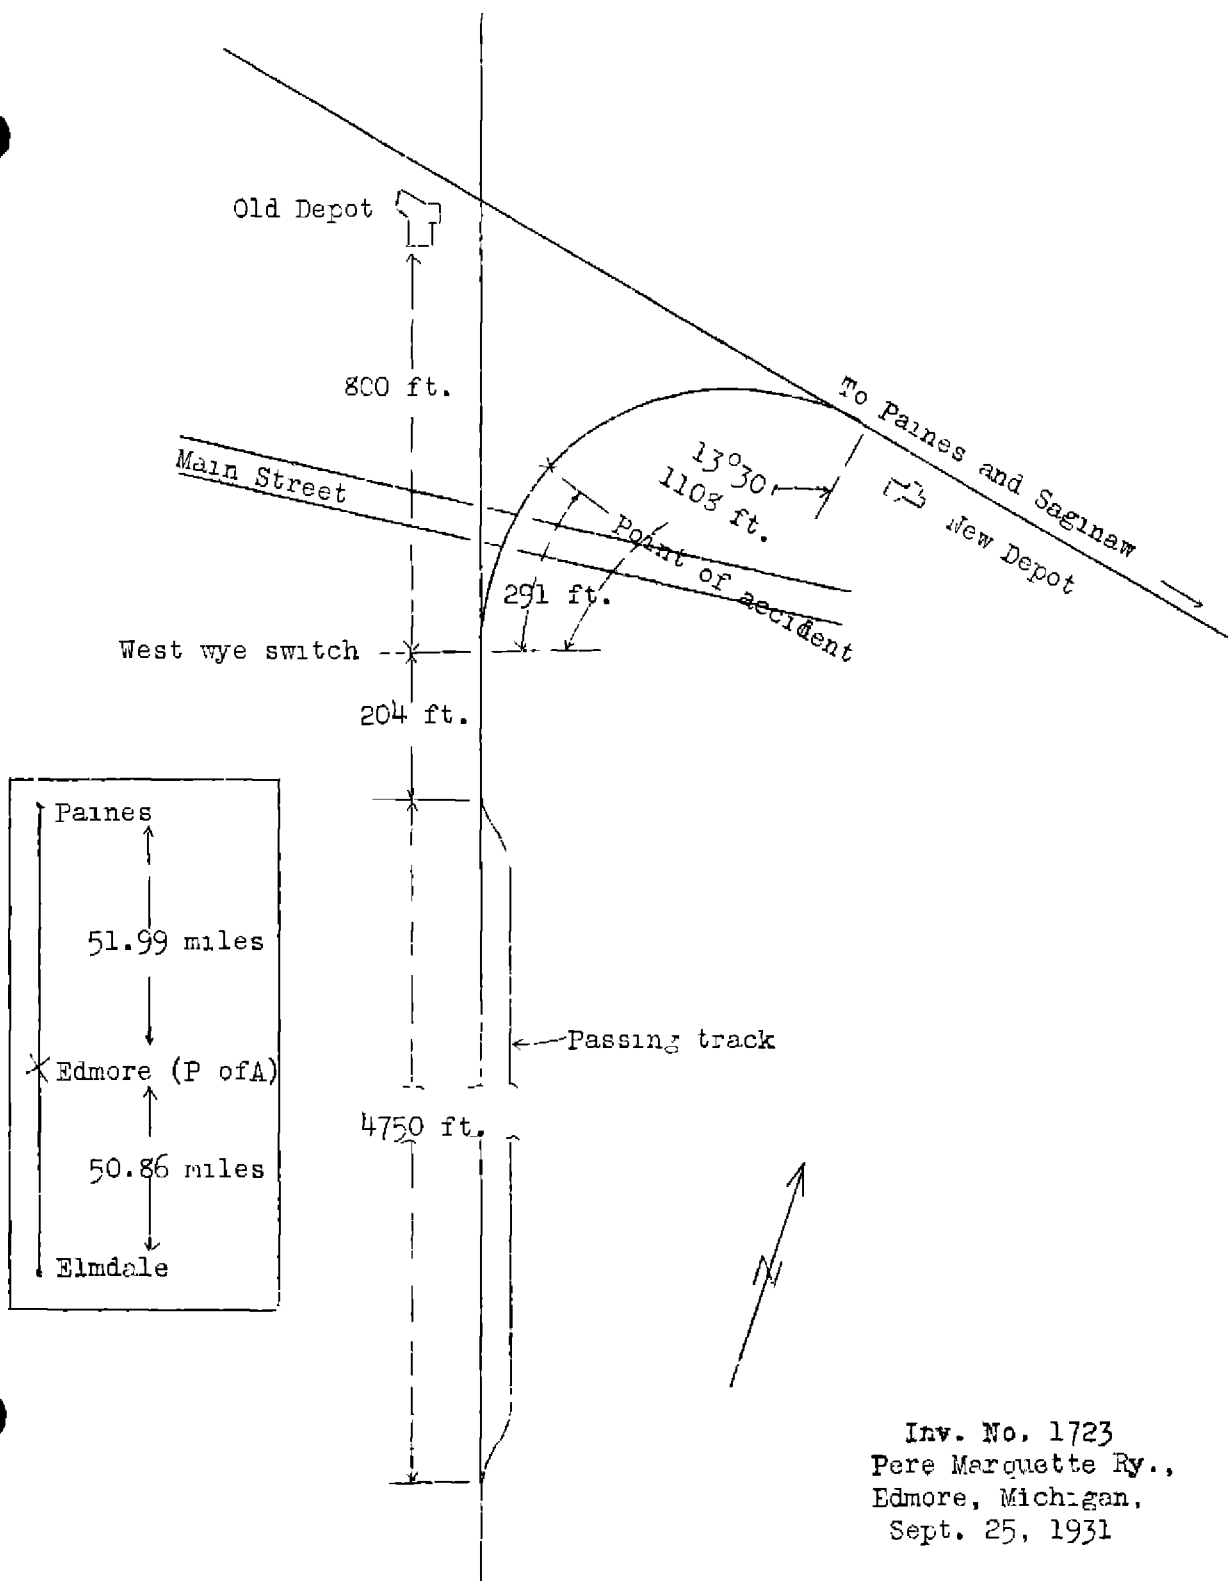
The accident occurred within yard limits, on the southeast leg of the wye, at a point 291 feet east of the west wye switch; approaching this point from the west, the track is tangent for a distance of 3,229 feet, followed by the wye track, which is on a  $13^{\circ} 30'$  curve to the right, 1,108 feet in length. Within these limits the grade is descending, varying from 0.24 to 0.71 per cent, being 0.42 per cent at the point of derailment. This leg of the wye has a No. 10 turn-out and is laid with 90-pound rails, averaging 38 feet 6 inches in length, double-spiked, fully tie-plated, with tie-rods spaced about 5 feet apart, and is ballasted with washed gravel to a depth of about 10 inches; it is well maintained. The wye is used as a portion of the main line, and special instructions in the time-table provide that the normal position of the switches is for movements over the wye and restrict the speed of all trains to 8 miles per hour while making this movement.

Engine 708, with tender coupled, came to rest on its left side parallel with the track, with the rear of the tender 363 feet east of the west wye switch, the combination mail and baggage car, the first two box cars, and about half of the third box car passed on by the derailed engine and came to rest in an upright position with the head end of the first car 165 feet east of the front end of the engine. The front truck of the mail car was demolished and the left side of the car was torn off almost entirely by contact with the derailed engine; the box car behind the mail car was slightly damaged and had the front pair of wheels of its rear truck derailed, but none of the remaining equipment was derailed or damaged. The employees killed were the engineman and the fireman and the employee injured was the brakeman-baggage man.
