REPORT OF THE DIRECTOR

ACCIDENT ON THE  
PERE MARQUETTE RAILWAY

MICHIGAN CITY, IND.

INVESTIGATION NO. 2157

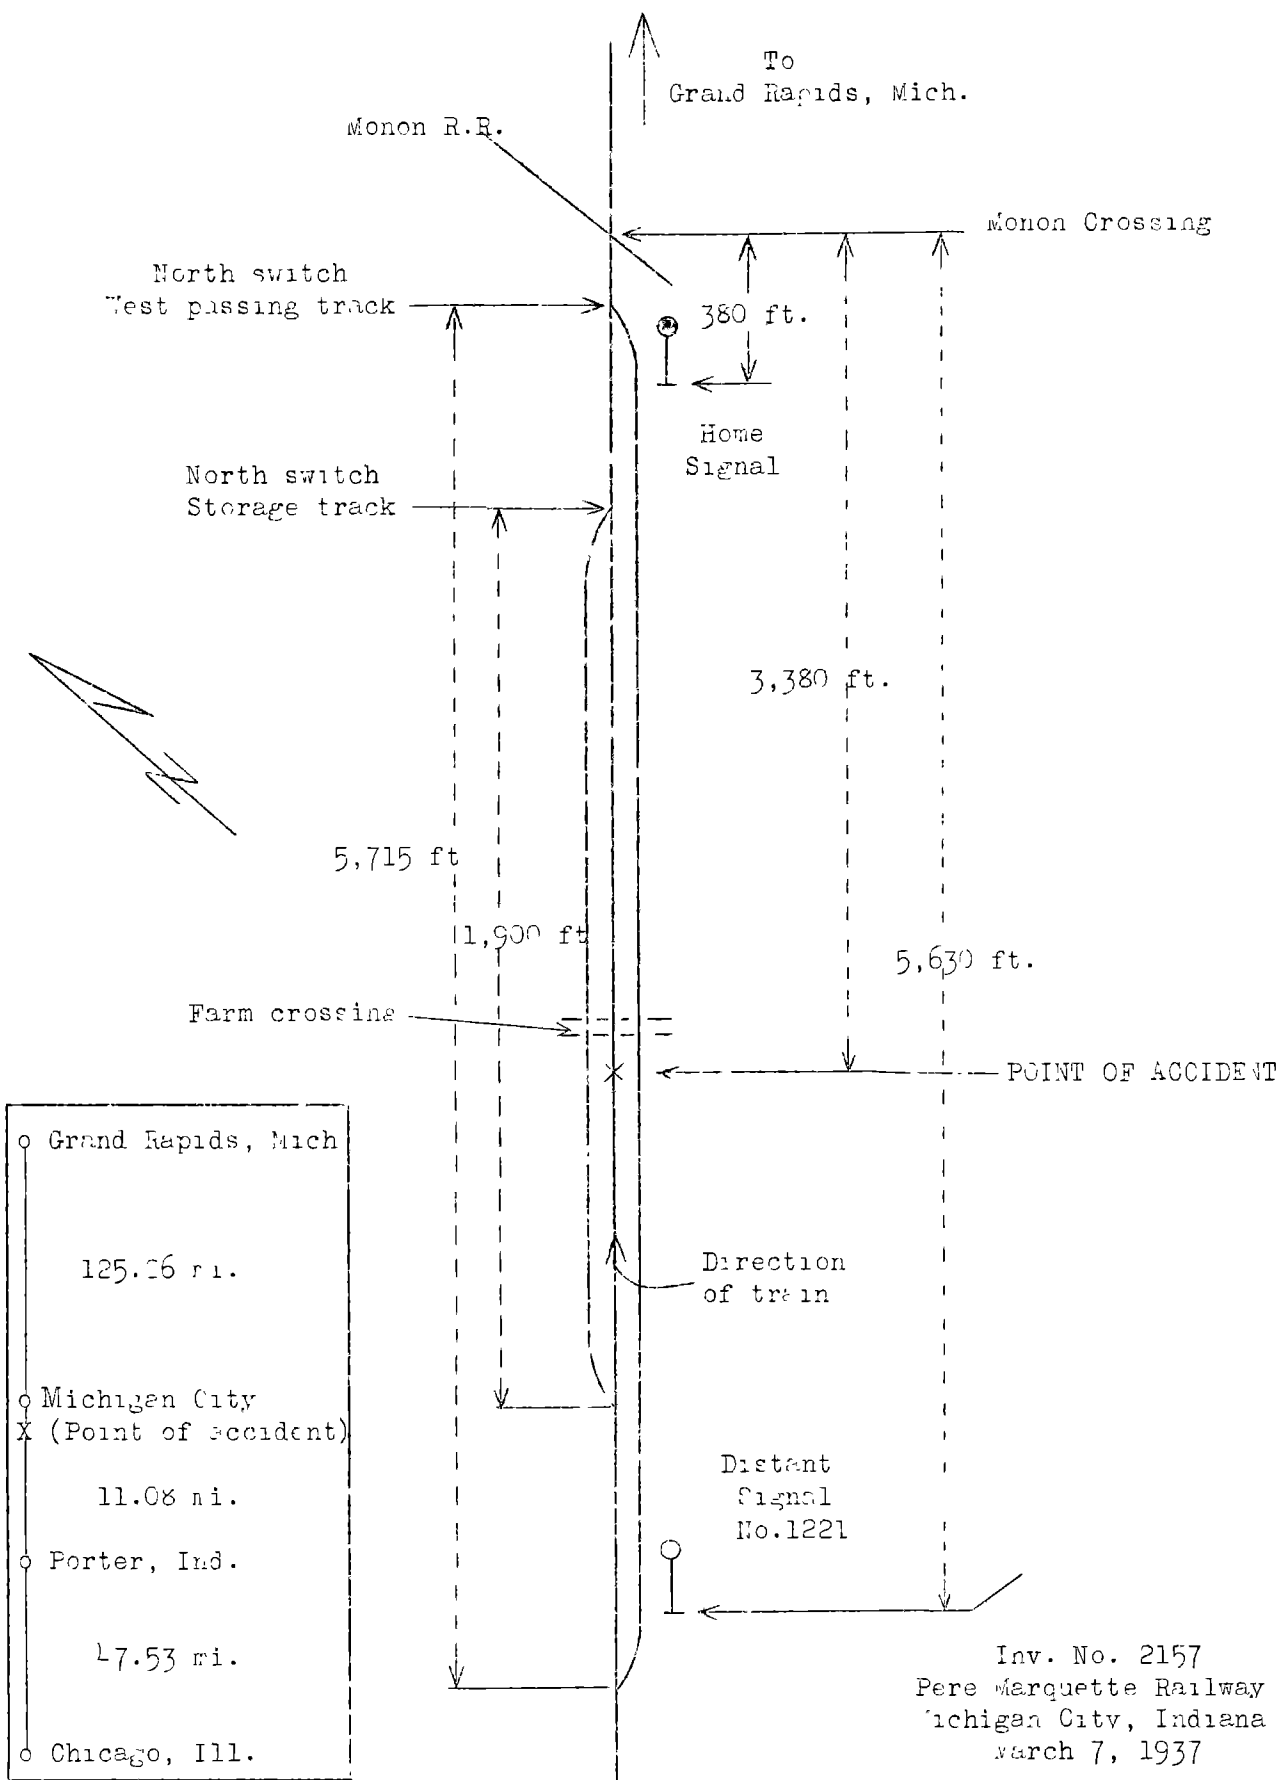
Inv. No. 2157  
 Pere Marquette Railway  
 Michigan City, Indiana  
 March 7, 1937

o Grand Rapids, Mich
125.26 mi.
o Michigan City X (Point of accident)
11.08 mi.
o Porter, Ind.
47.53 mi.
o Chicago, Ill.

This accident occurred on Sub-Division No. 1 of the Chicago-Petoskey Division, extending between Porter, Ind., and Grand Rapids, Mich., a distance of 136.34 miles. In the vicinity of the point of accident, this is a single track line over which trains are operated by time table, train orders and an automatic block signal system. The track is laid with 110 pound rails, 39 feet in length, with 24 treated hardwood ties to the rail length, fully tie plated, single spiked, with four rail anchors per rail and ballasted with from 10 to 12 inches of washed gravel, and is well maintained. The accident occurred at a point about 1 1/2 miles west of the station at Michigan City. Approaching this point from the west the track is tangent for more than 2 miles to the point of accident and for some distance beyond; the grade for east-bound trains is slightly descending, being 0.1 percent at the point of accident.
