INVESTIGATION NO. 2758
THE PIEDMONT & NORTHERN RAILWAY COMPANY
REPORT IN RE ACCIDENT
AT BELTON, S. C., ON
JANUARY 7, 1944

Railroad: Piedmont & Northern
Date: January 7, 1944
Location: Belton, S. C.
Kind of accident: Rear-end collision
Trains involved: Freight : Freight
Train numbers: 48 : 60
Engine numbers: Electric motor 5610 : Electric motor
5602
Consist: 35 cars, caboose : 11 cars, caboose
Speed: Standing : 15 m. p. n.
Operation: Timetable and train orders;
yard limits
Track: Single; 4^o curve; 0.20 percent
descending grade northward
Weather: Clear
Time: 10:35 a. m.
Casualties: 1 killed; 2 injured
Cause: Failure properly to control
speed of following train
moving within yard limits

Accident at Belton, S. C., on January 7, 1944, caused
by failure properly to control the speed of the
following train moving within yard limits.

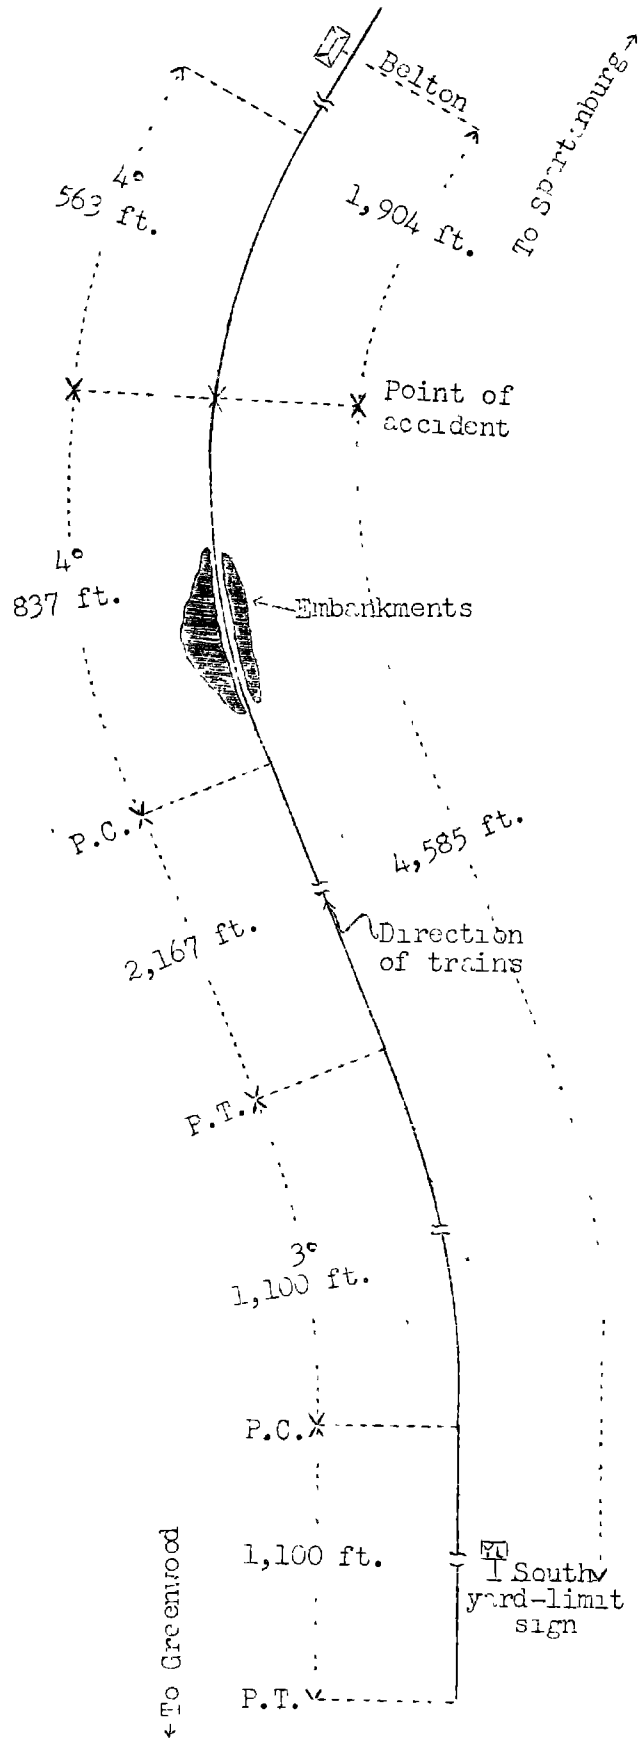
Inv. No. 2758
 Piedmont & Northern Railway
 Belton, S. C.
 January 7, 1944

- o Spartanburg, S. C.
58.0 mi.
- x Belton (P. of A.)
30.9 mi.
- o Greenwood, S. C.

This accident occurred on that part of the South Carolina Division extending between Greenwood and Spartanburg, S. C., 88.9 miles. This was a single-track line, equipped with an overhead catenary system for the electric propulsion of trains, over which trains were operated by timetable and train orders. There was no block system in use. The accident occurred on the main track 1,904 feet south of the station at Belton and 4,585 feet north of the south yard-limit sign. From the south there were, in succession, a tangent 1,100 feet, a 3° curve to the left 1,100 feet, a tangent 2,167 feet, and a 4° curve to the right 837 feet to the point of accident and 563 feet beyond. The grade for north-bound trains was, successively, 0.60 percent descending 2,150 feet, 0.65 percent ascending 750 feet and 0.20 percent descending 800 feet to the point of accident.
