REPORT NO. 3316

THE PITTSBURGH AND LAKE ERIE
RAILROAD COMPANY

IN RE ACCIDENT

MARCH 21, 1950

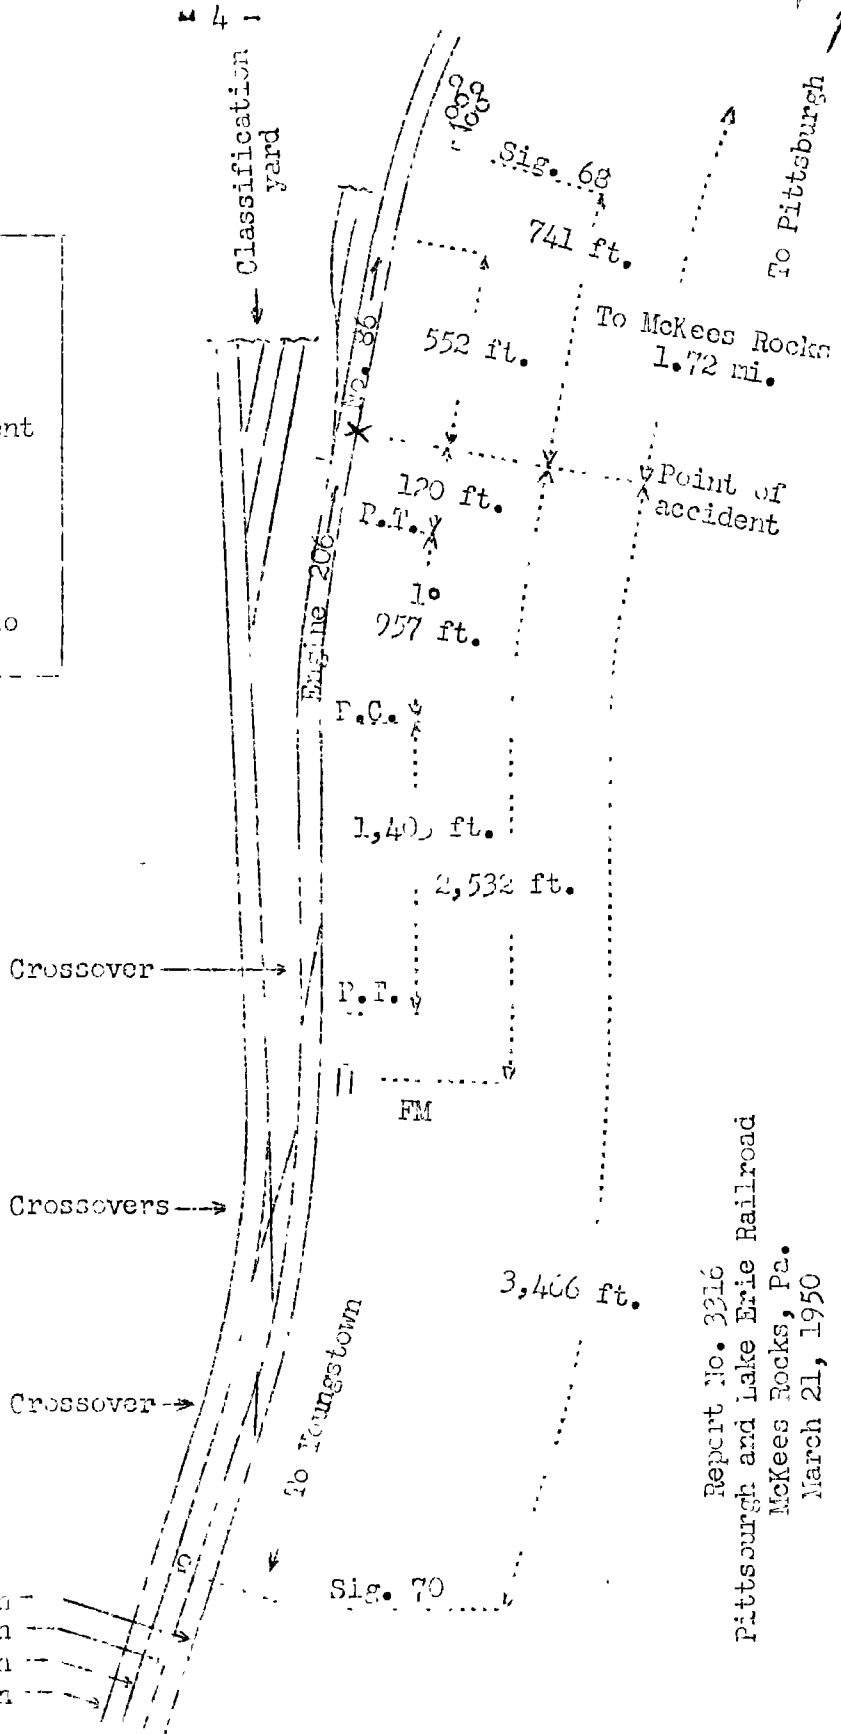
Report No. 3216
 Pittsburgh and Lake Erie Railroad
 McKees Rocks, Pa.
 March 21, 1950

- o Pittsburgh, Pa. | 3.50 mi.
- o McKees Rocks | 1.72 mi.
- X Point of accident | 0.48 mi.
- o FM | 41.60 mi.
- o New Castle, Pa. | 17.60 mi.
- o Youngstown, Ohio

- Track No. 1, eastward main
- Track No. 2, eastward main
- Track No. 3, westward main
- Track No. 4, westward main
