INVESTIGATION NO. 2685
THE PITTSBURGH & WEST VIRGINIA RAILWAY COMPANY
REPORT IN RE ACCIDENT
NEAR BANNING, PA., ON
MARCH 11, 1943

Railroad: Pittsburgh & West Virginia
Date: March 11, 1943
Location: Banning, Pa.
Kind of accident: Head-end collision
Trains involved: Freight : Freight
Train numbers: Fourth 92 : Extra 6050 West
Engine numbers: 1105 : 6055
Consist: 41 cars, caboose : 38 cars, caboose
Estimated speed: 10-30 m. p. h. : 20-25 m. p. h.
Operation: Timetable and train orders
Track: Single; tangent; 0.6 percent
descending grade eastward
Weather: Raining
Time: About 7:57 p. m.
Casualties: 1 killed; 2 injured
Cause: Accident caused by failure to
obey a meet order
Recommendation: That the Pittsburgh & West Virginia
Railway Company install an adequate
block system on the line on which
this accident occurred

Accident near Banning, Pa., on March 11, 1943, caused by
failure to obey a meet order.

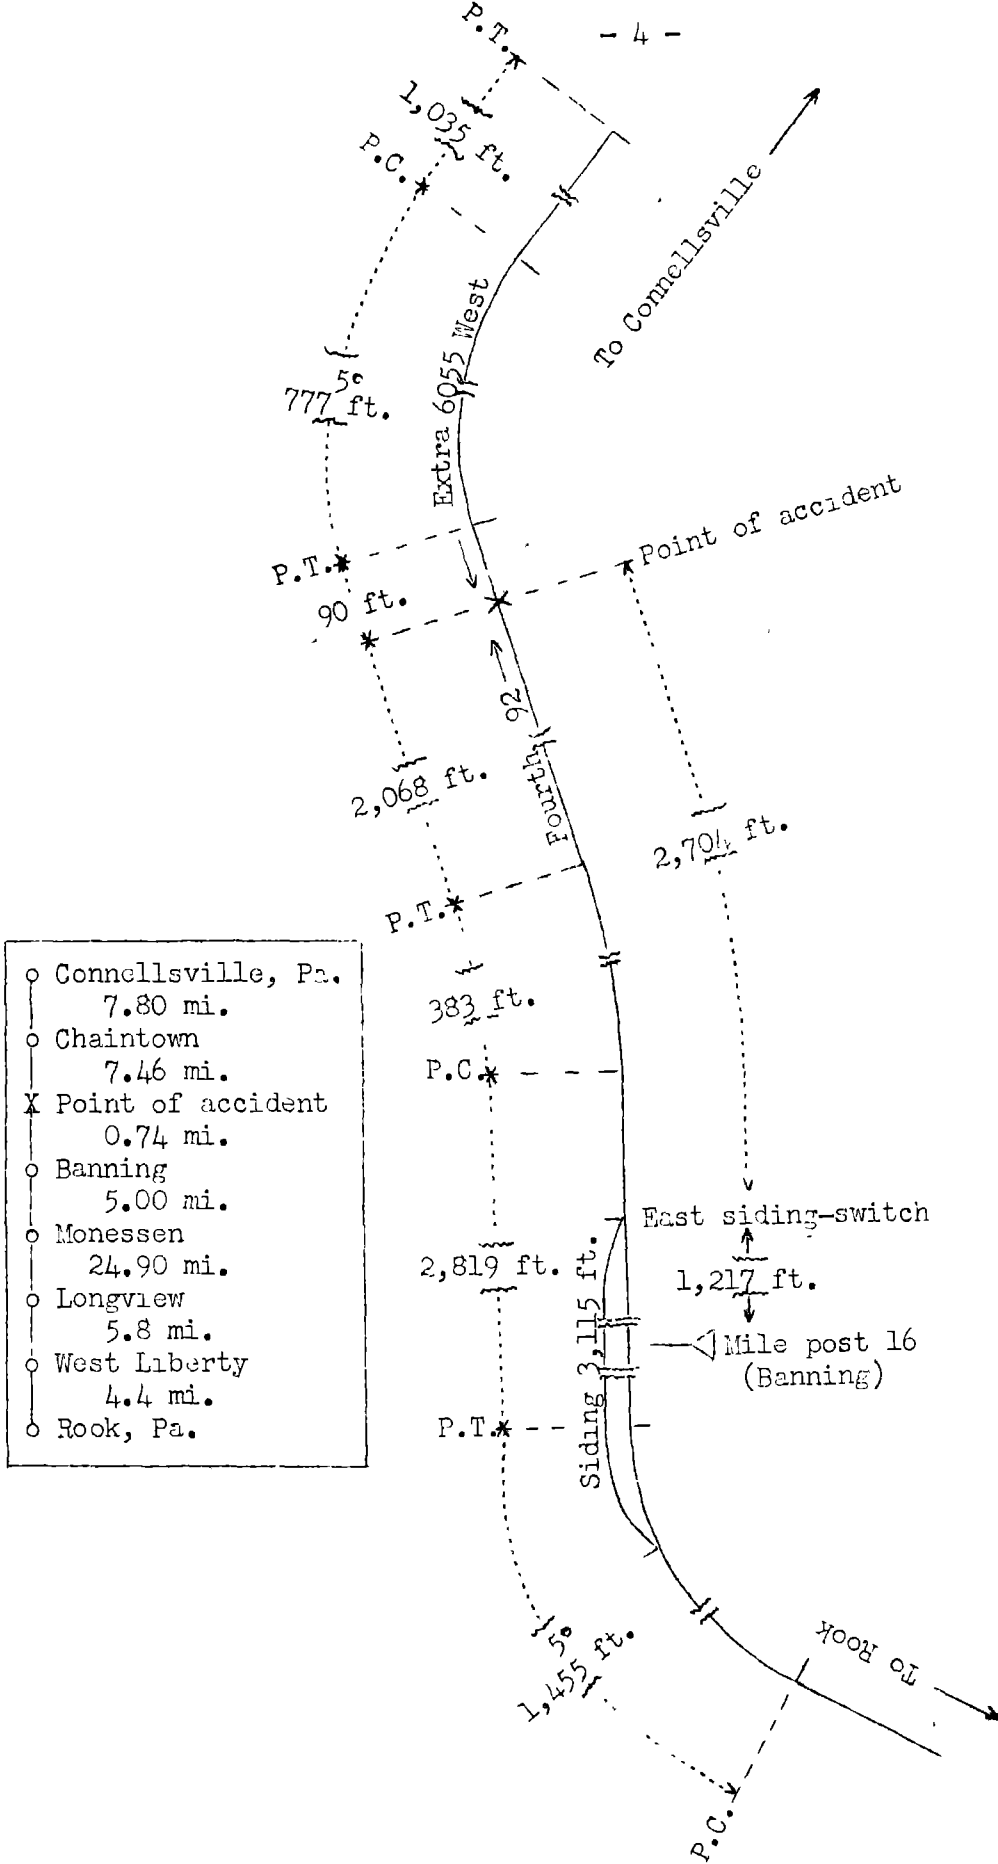
Inv-2685
 Pittsburgh & West Virginia Railway
 Banning, Pa.
 March 11, 1943

| ○ | Connellsville, Pa. | 7.80 mi. |
| ○ | Chaintown | 7.46 mi. |
| X | Point of accident | 0.74 mi. |
| ○ | Banning | 5.00 mi. |
| ○ | Monessen | 24.90 mi. |
| ○ | Longview | 5.8 mi. |
| ○ | West Liberty | 4.4 mi. |
| ○ | Rook, Pa. | |

Location of Accident and Method of Operation
