INVESTIGATION NO. 3108
THE PITTSBURGH & WEST VIRGINIA RAILWAY COMPANY
REPORT IN RE ACCIDENT
NEAR ROCKDALE, W. VA., ON
JUNE 10, 1947

Accident near Rockdale, W. Va., on June 10, 1947, caused
by failure to obey a meet order.

Inv. No. 3108
 Pittsburgh & West Virginia Railway
 Rockdale, W. Va.
 June 10, 1947

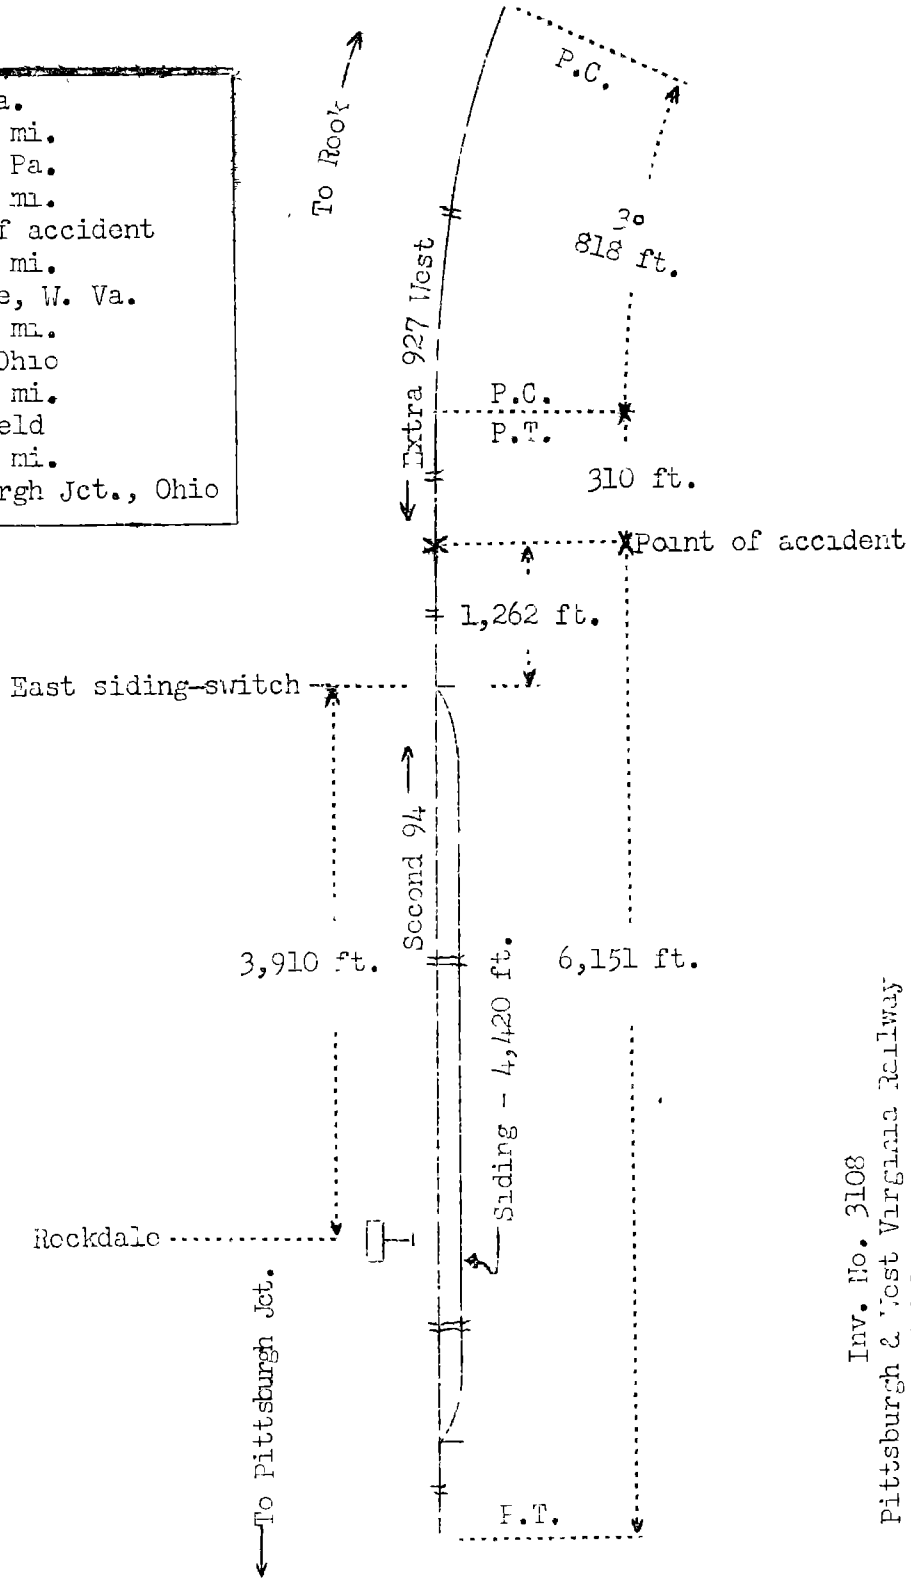
○ Rook, Pa.	26.20 mi.
○ Aveilla, Pa.	6.42 mi.
X Point of accident	0.98 mi.
○ Rockdale, W. Va.	2.00 mi.
○ Mingo, Ohio	8.10 mi.
○ Smithfield	11.40 mi.
○ Pittsburgh Jct., Ohio
