INTERSTATE COMMERCE COMMISSION
WASHINGTON

INVESTIGATION NO. 2849

POTOMAC YARD
AND
THE RICHMOND, FREDERICKSBURG AND POTOMAC
RAILROAD COMPANY

REPORT IN RE ACCIDENT
AT POTOMAC YARD, VA., ON
DECEMBER 12, 1944

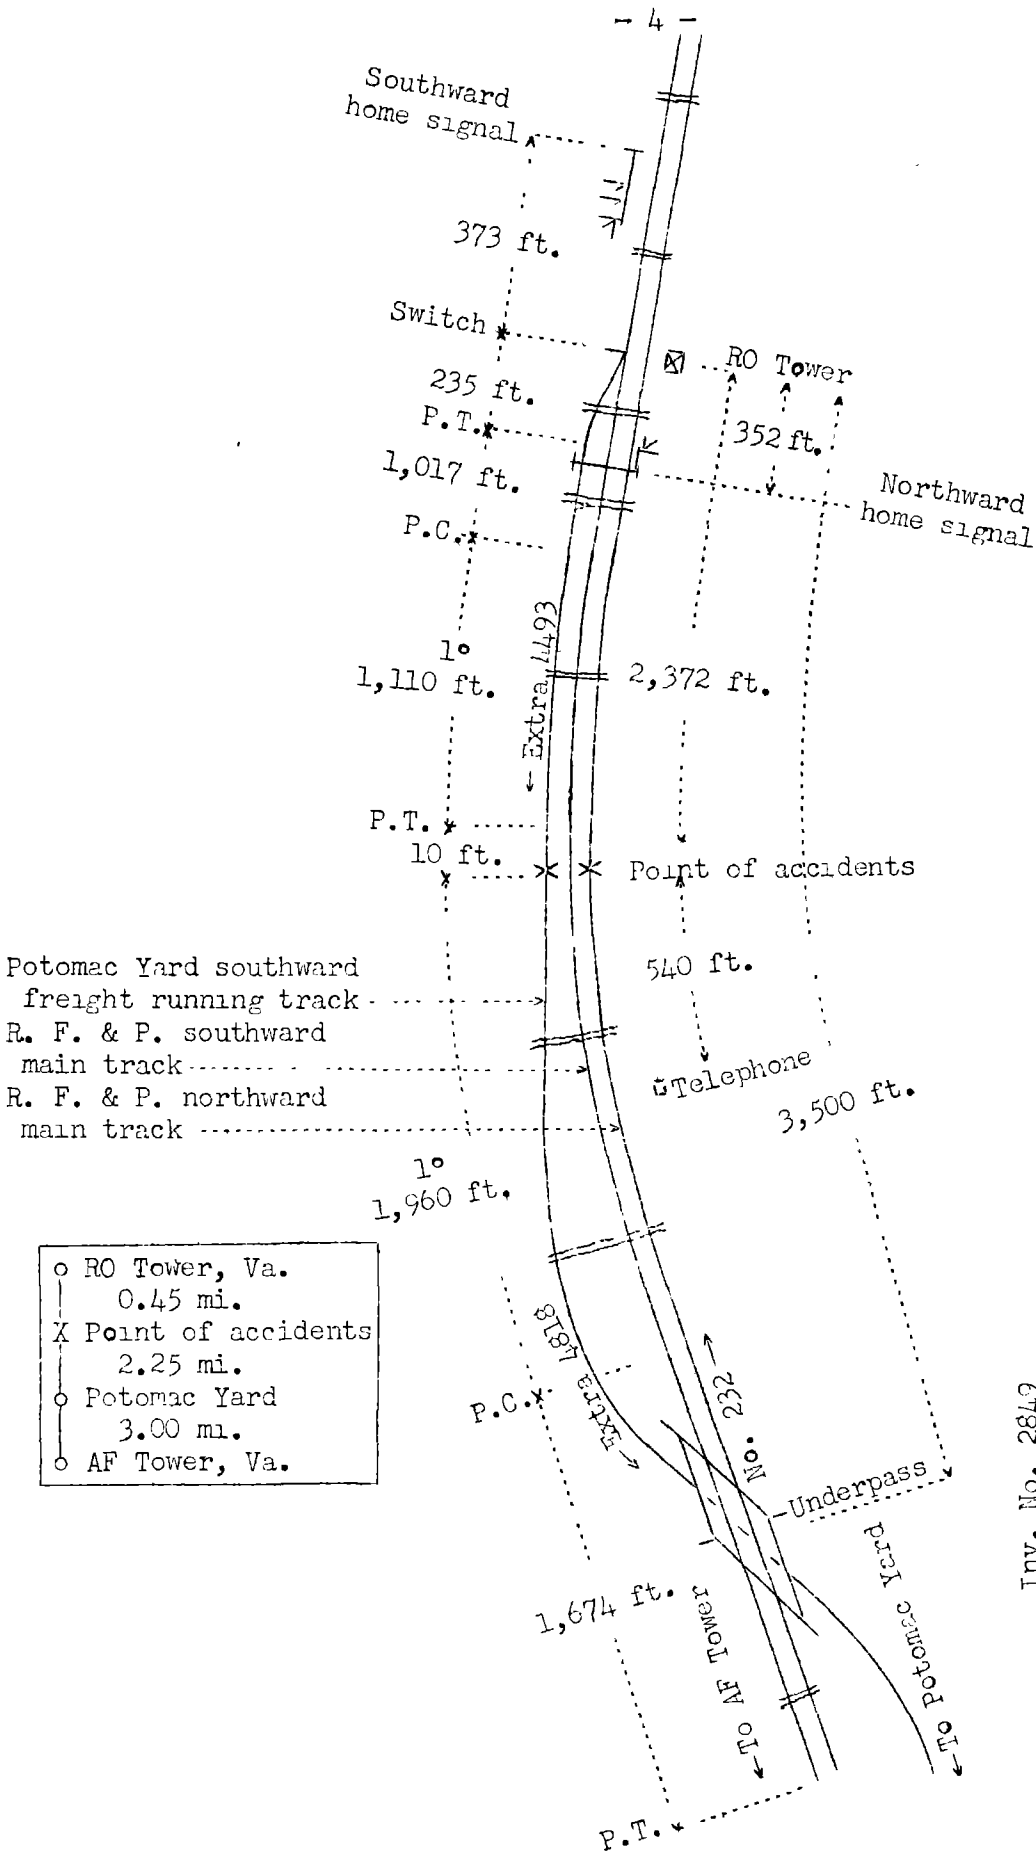
| o | RO Tower, Va. |

On December 12, 1944, there was a rear-end collision between a Pennsylvania Railroad freight train and a Baltimore & Ohio Railroad freight train on a freight running track at Potomac Yard, Va., and the wreckage was struck by a Southern Railway passenger train on the line of the Richmond, Fredericksburg and Potomac Railroad. These accidents resulted in the death of one train-service employee, and the injury of six passengers, three railway-mail clerks and three train-service employees.
