INVESTIGATION NO. 2458
THE READING COMPANY
REPORT IN RE ACCIDENT
AT LOGAN, PA., ON
OCTOBER 31, 1940

Accident at Logan, Pa., on October 31, 1940, caused by
failure to furnish proper flag protection for pre-
ceding train and failure to operate following
train in accordance with signal indication.

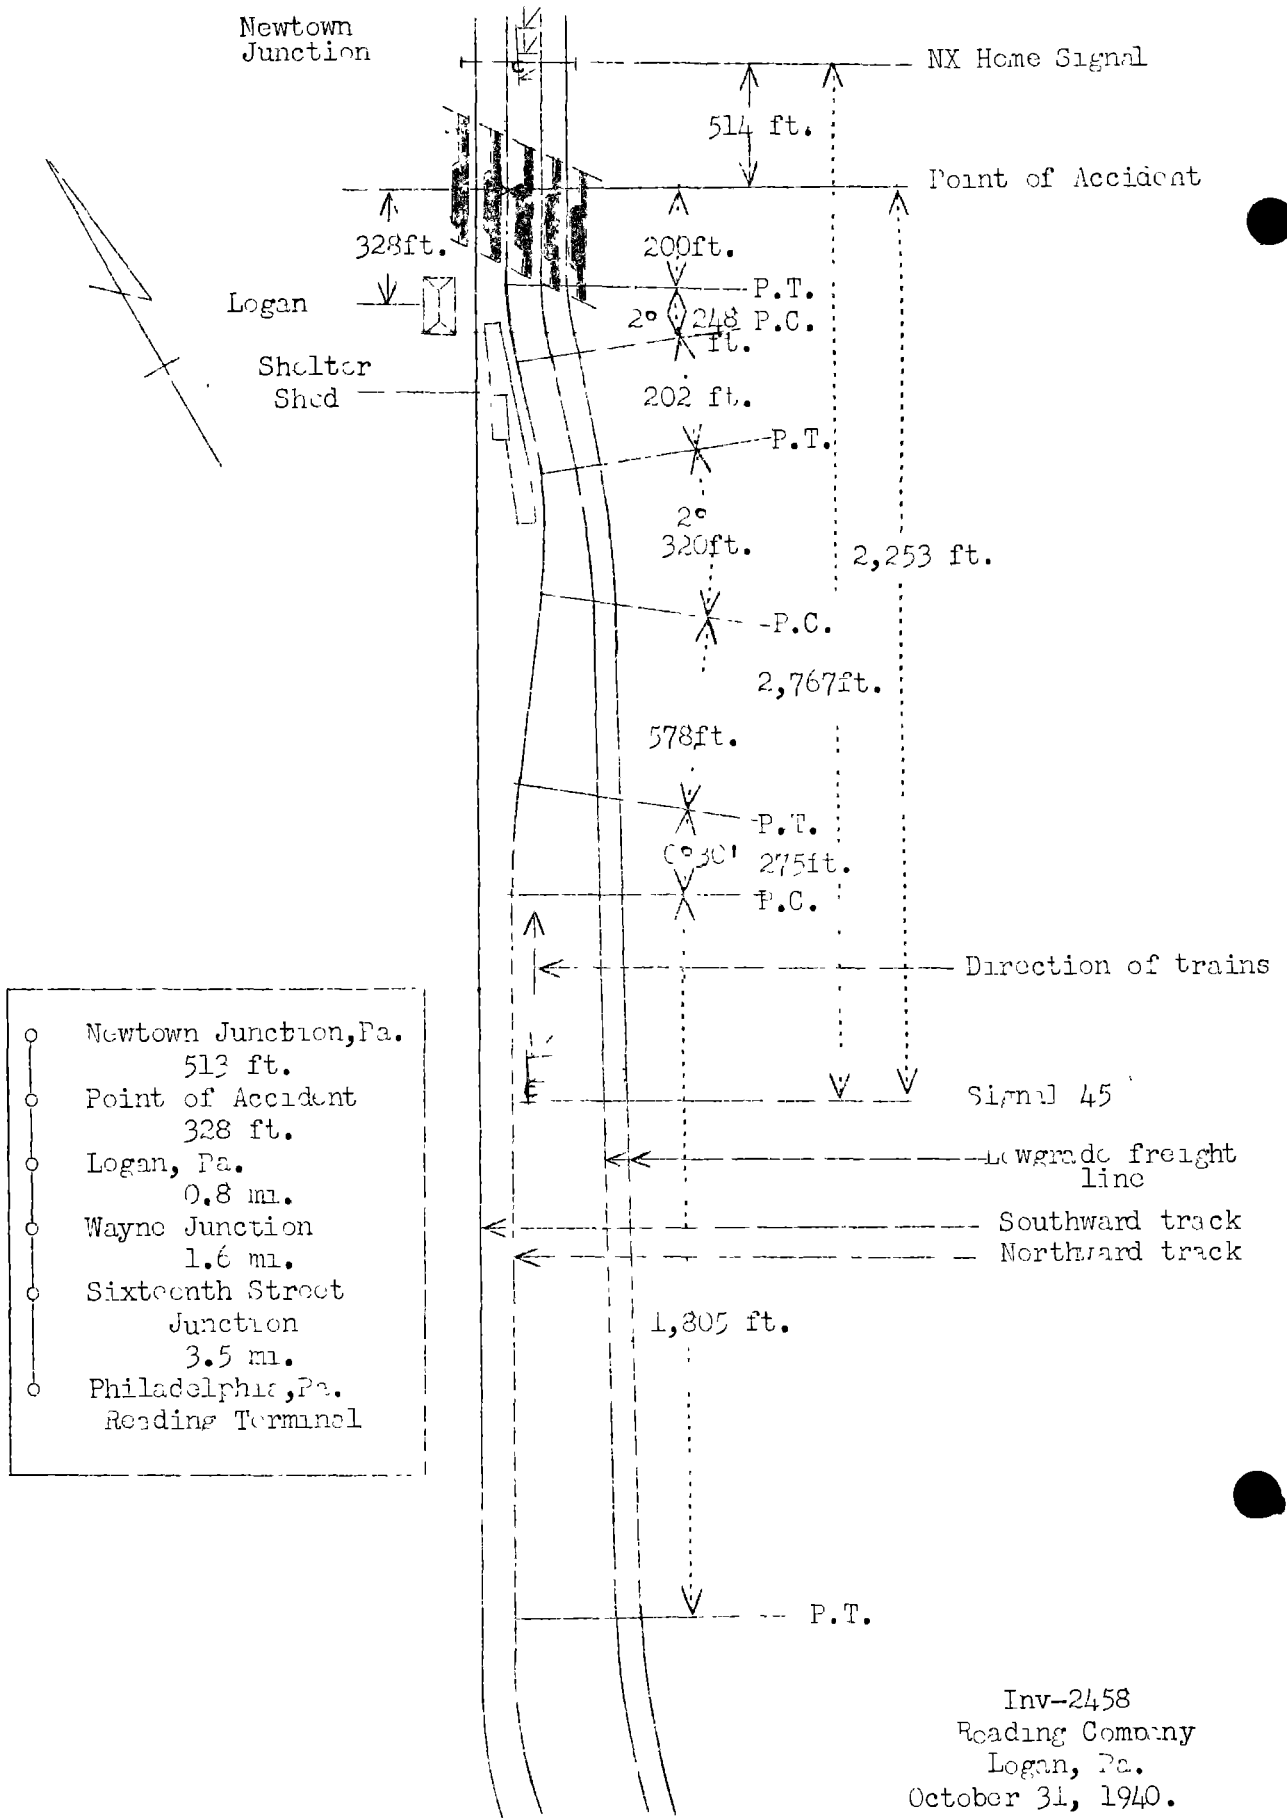
Inv-2458
 Reading Company
 Logan, Pa.
 October 31, 1940.

- Newtown Junction, Pa. 513 ft.
- Point of Accident 328 ft.
- Logan, Pa. 0.8 mi.
- Wayne Junction 1.6 mi.
- Sixteenth Street Junction 3.5 mi.
- Philadelphia, Pa. Reading Terminal

This accident occurred on that part of the Philadelphia Division which extends between Reading Terminal Station, Philadelphia, Pa., and Newtown Junction, Philadelphia, a distance of 6.3 miles. In the vicinity of the point of accident this is a double-track line over which trains are operated by an automatic block-signal system, the indications of which supersede time-table superiority. This line is equipped with an overhead catenary system for electric propulsion of trains; however, both electric and steam trains are operated. The accident occurred on the northward track at a point 328 feet north of Logan and 513 feet south of the northward home interlocking signal at Newtown Junction. As the point of accident is approached from the south there are, in succession, a tangent 1,805 feet in length, a $0^{\circ}30'$ curve to the right 275 feet, a tangent 578 feet, a 2° curve to the left 320 feet, a tangent 202 feet, a 2° curve to the right 248 feet, then a tangent 200 feet to the point of accident and 425 feet beyond. The grade on the northward track is level at the point of accident.
