INVESTIGATION NO. 3181
READING COMPANY
REPORT IN RE ACCIDENT
NEAR VALLEY FORGE, PA., ON
MAY 9, 1948

Accident near Valley Forge, Pa., on May 9, 1948, caused
by malicious tampering with the track.

Inv. No. 3181
Reading Company
Valley Forge, Pa.
May 9, 1948

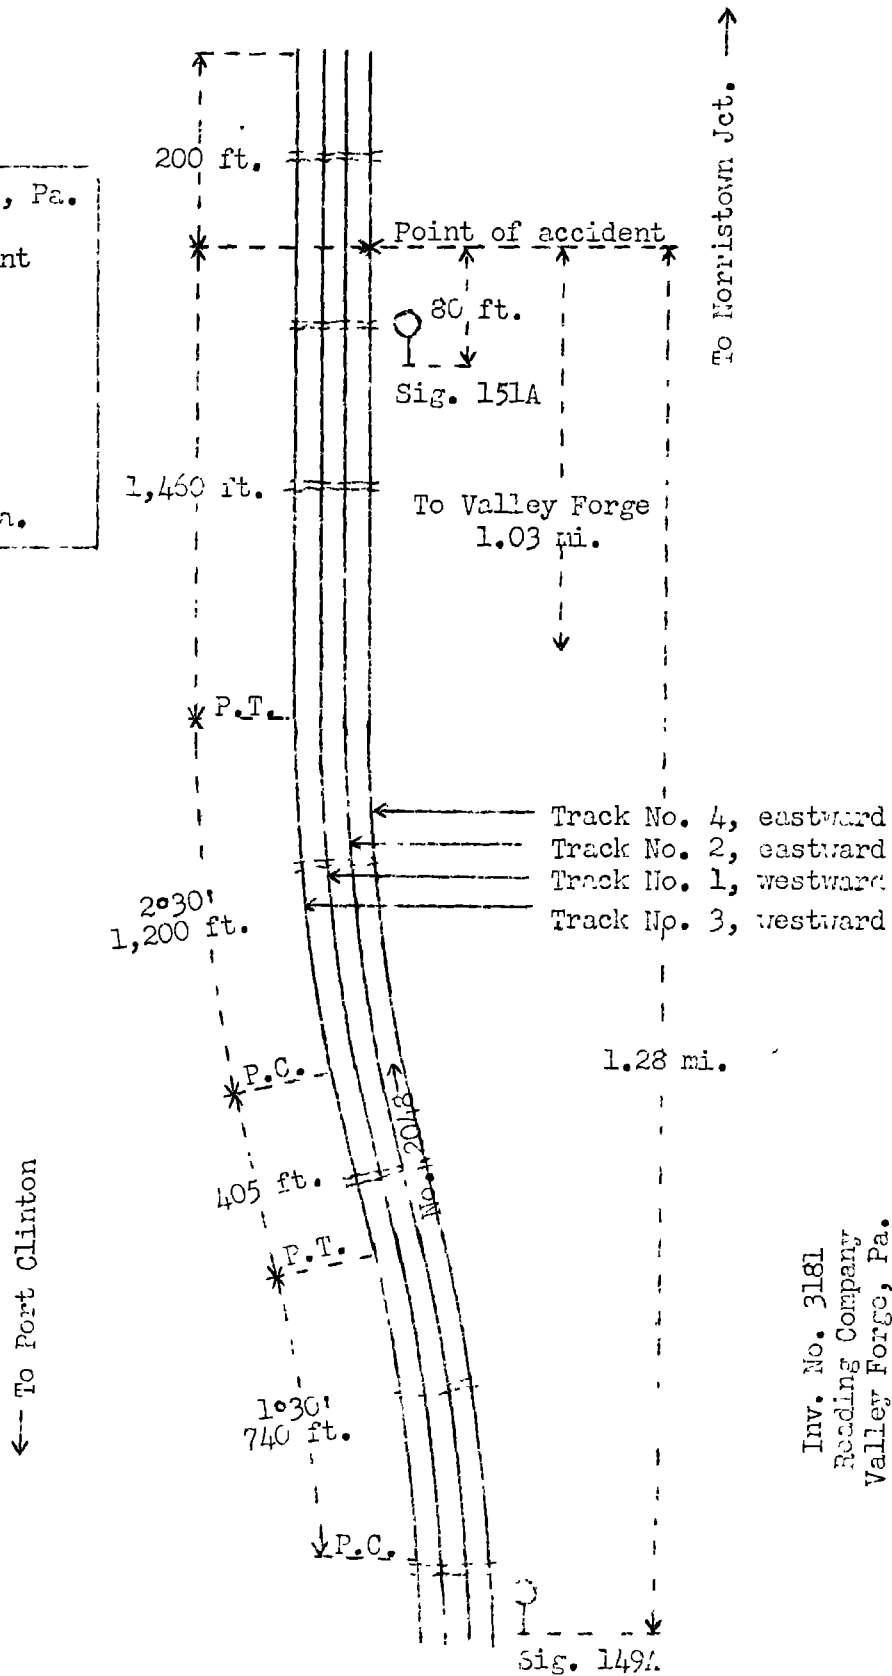
- o Norristown Jct., Pa. 4.62 mi.
- X Point of accident 1.03 mi.
- o Valley Forge 1.23 mi.
- o Perkiomem Jct. 52.15 mi.
- o Division Post 1.25 mi.
- o Port Clinton, Pa.

This accident occurred on that part of the Reading Division extending between Division Post, near Port Clinton, and Norristown Jct., Pa., 59.03 miles. In the vicinity of the point of accident this is a four-track line over which trains moving with the current of traffic are operated by signal indications. The main tracks from south to north are designated as No. 4 and No. 2, eastward, and No. 1 and No. 3, westward. The accident occurred on track No. 4 at a point 55.66 miles east of Port Clinton and 1.03 miles east of the station at Valley Forge. From the west on track No. 4 there are, in succession, a 1°30' curve to the left 740 feet in length, a tangent 405 feet, a 2°30' curve to the right 1,200 feet and a tangent 1,460 feet to the point of accident and 200 feet eastward. The grade is 0.19 percent descending eastward.
