RAILROAD ACCIDENT INVESTIGATION

Report No 3766

READING COMPANY

COATESVILLE, PA

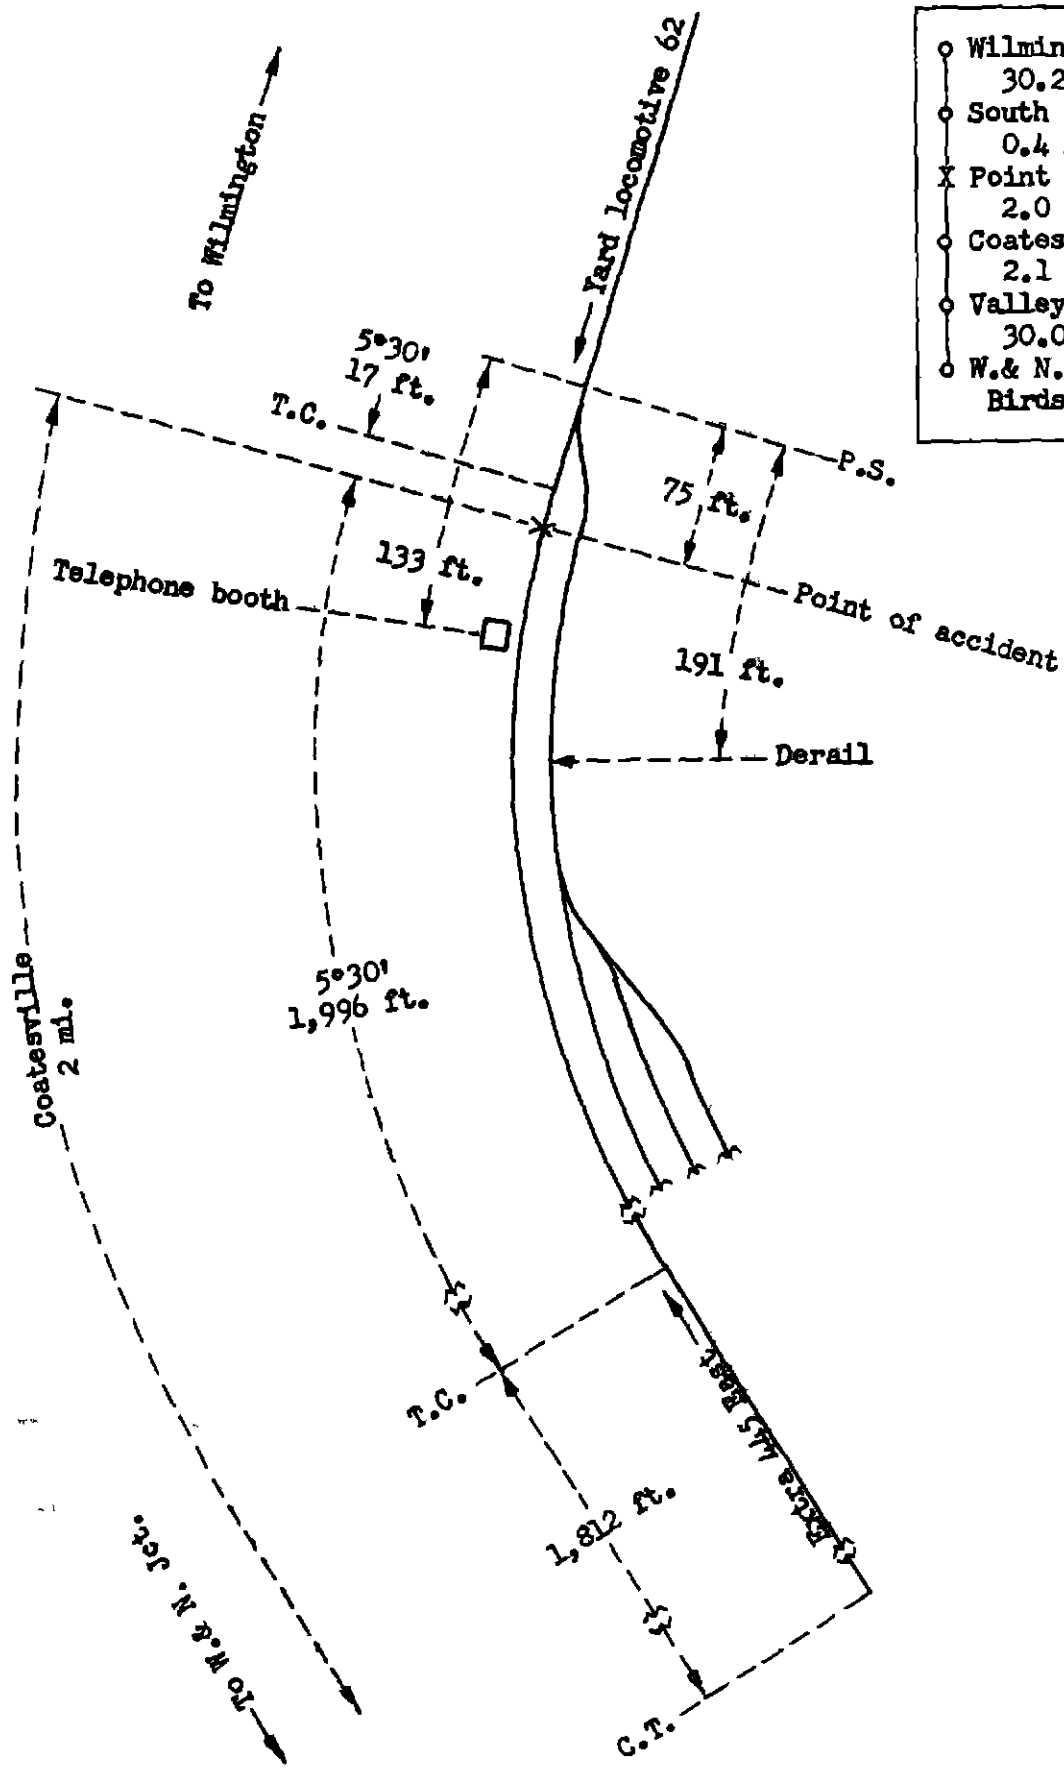
Reading Company
 Coatesville, Pa.
 July 8, 1957

- Wilmington, Del. 30.2 mi.
- South Modena, Pa. 0.4 mi.
- X Point of accident 2.0 mi.
- Coatesville 2.1 mi.
- Valley 30.0 mi.
- W. & N. Jct., Birdsboro, Pa.

Location of Accident and Method of Operation
