INVESTIGATION NO. 3221  
RUTLAND RAILROAD COMPANY  
REPORT IN RE ACCIDENT  
NEAR ALBURGH, VT., ON  
DECEMBER 22, 1948

Accident near Alburgh, Vt., on December 22, 1948, caused  
by failure to provide adequate protection for the  
movement of each train.

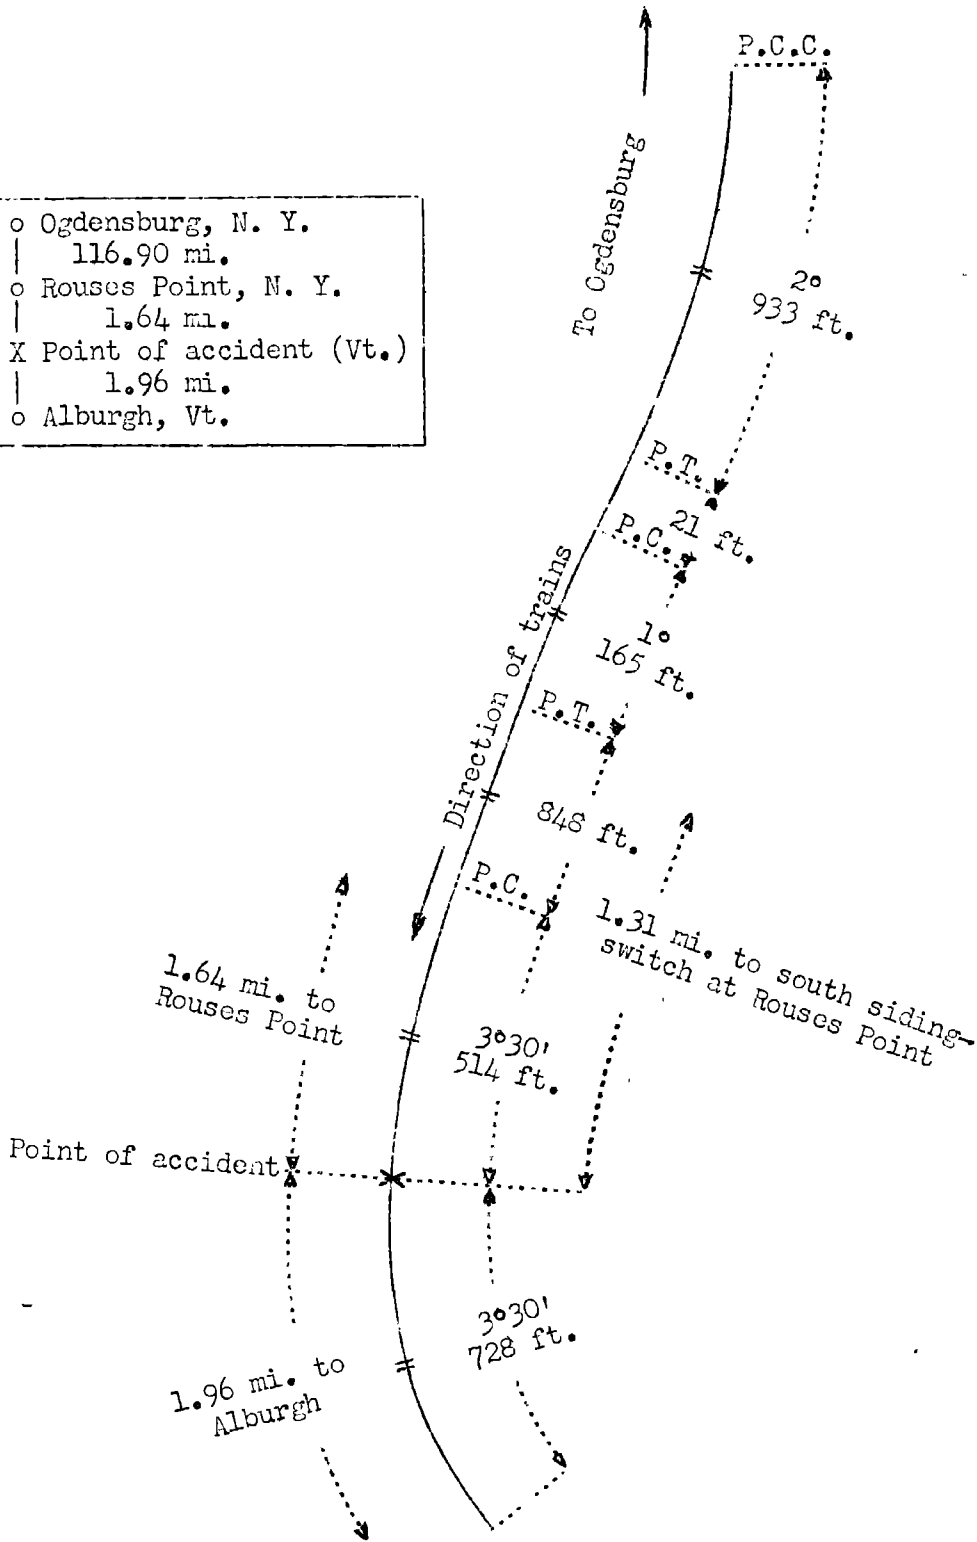
Inv. No. 3221  
Rutland Railroad  
Alburgh, Vt.  
December 22, 1948

Location of Accident and Method of Operation
