INVESTIGATION NO. 2976
RUTLAND RAILROAD COMPANY
REPORT IN RE ACCIDENT
AT MOOERS, N. Y., ON
FEBRUARY 22, 1946

Railroad: Rutland
Date: February 22, 1946
Location: Mooers, N. Y.
Kind of accident: Head-end collision
Trains involved: Passenger : Freight
Train numbers: 6 : Extra 24 North
Engine numbers: 53 : 24
Consist: 5 cars : Snow plow, caboose
Estimated speed: Standing : 12 m. p. h.
Operation: Timetable, train orders and
manual-block system
Track: Single; tangent; 0.70 percent
ascending grade northward
Weather: Clear
Time: 12:30 a. m.
Casualties: 1 killed; 4 injured
Cause: Failure to obey meet order

Accident at Mooers, N. Y., on February 22, 1946, caused
by failure to obey a meet order.

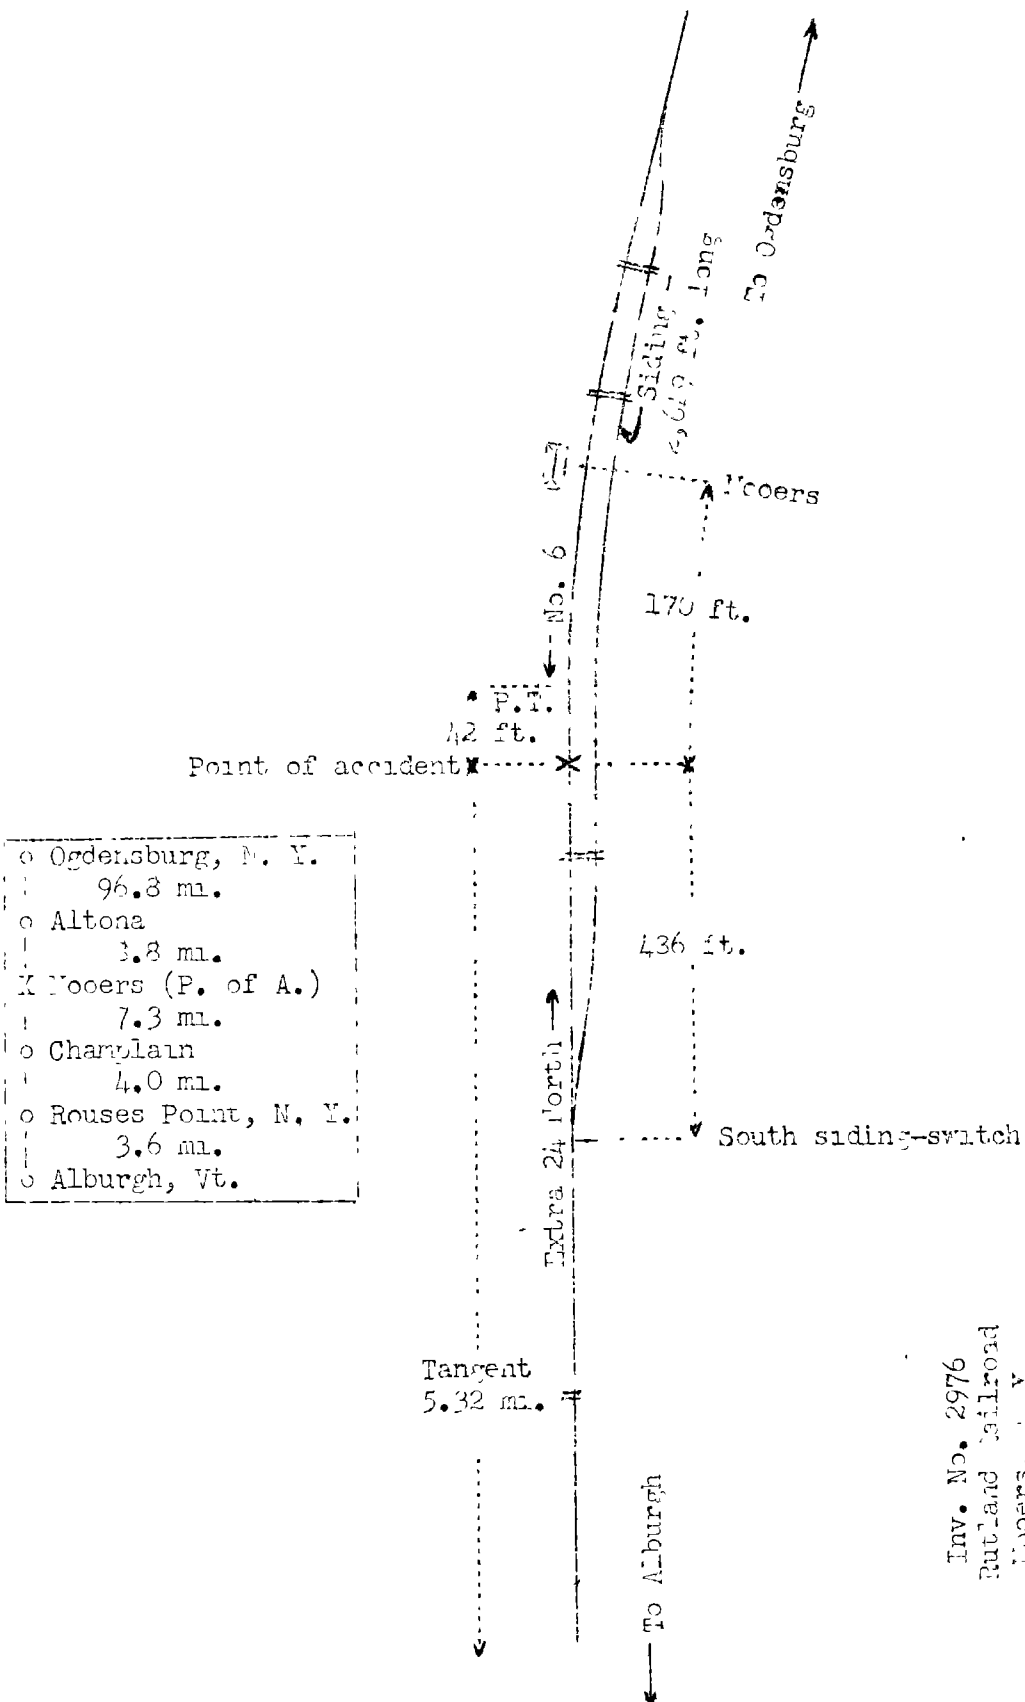
Inv. No. 2976
 Rutland Railroad
 Mooers, N. Y.
 February 22, 1946

| o | Ogdensburg, N. Y. |
| o | Altona |
| o | K Mooers (P. of A.) |
| o | Champlain |
| o | Rouses Point, N. Y. |
| o | Alburgh, Vt. |
