**RAILROAD ACCIDENT INVESTIGATION**

SEABOARD AIR LINE RAILROAD COMPANY

MELDRIM, GA

JUNE 28, 1959

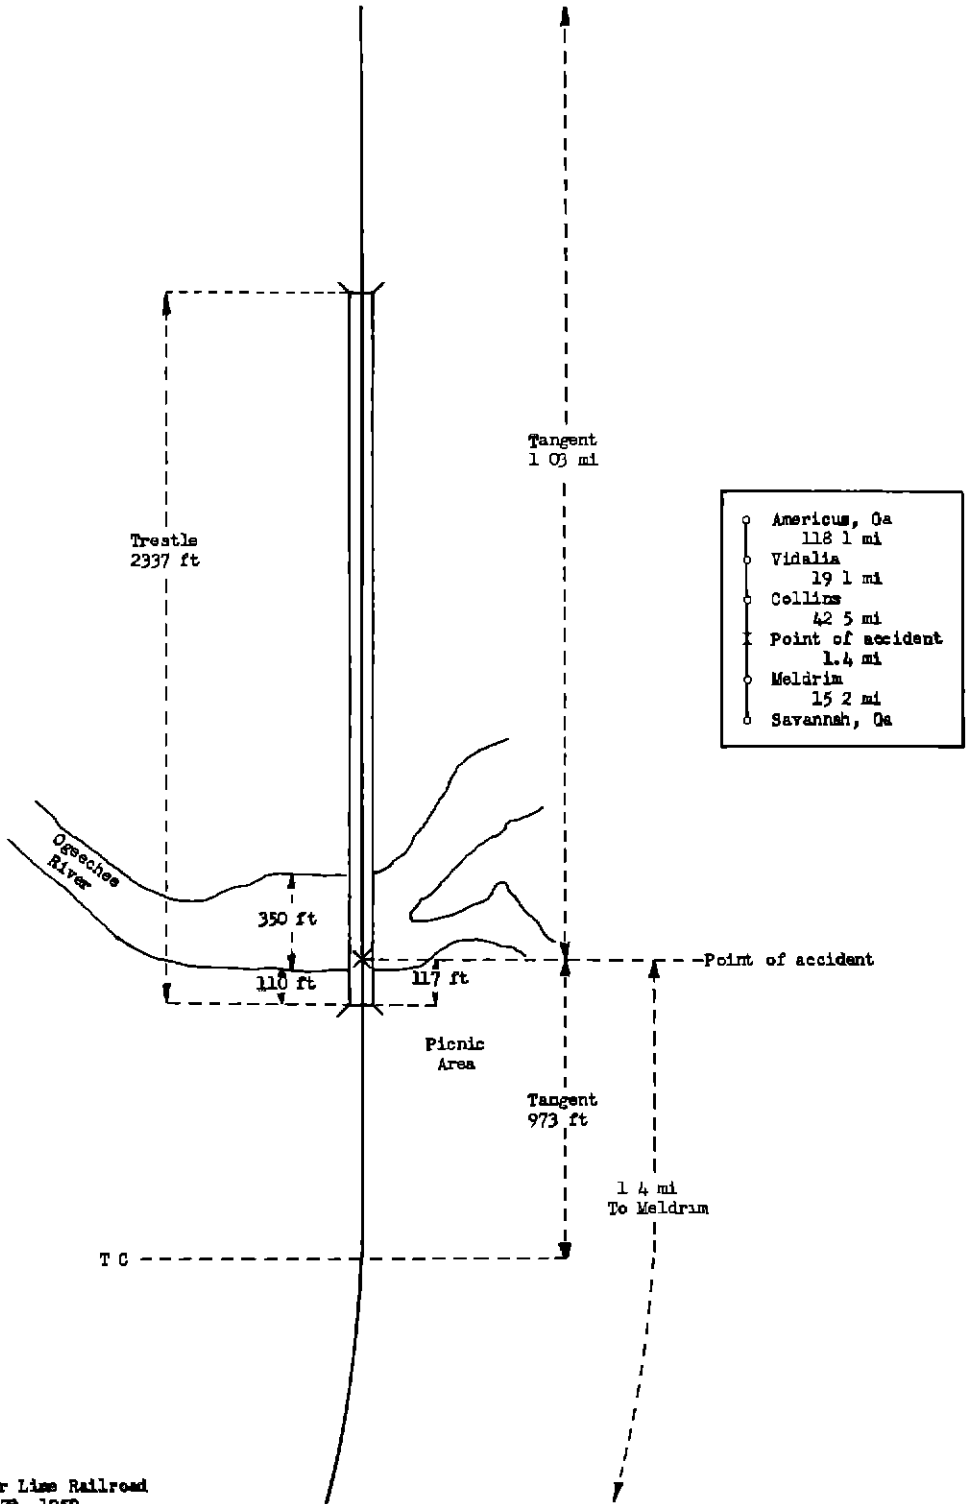
Seaboard Air Line Railroad  
 June 28, 1959  
 Meldrim, Ga.

○	Americus, Ga	118.1 mi
○	Vidalia	19.1 mi
○	Collins	42.5 mi
	Point of accident	1.4 mi
○	Meldrim	15.2 mi
○	Savannah, Ga

This accident occurred on that part of the Carolina Division extending between Americus and Savannah, Ga., 196.3 miles, a single-track line over which trains are operated by timetable and train orders. There is no block system in use. Near Meldrum, 181.1 miles east of Americus, a bridge 2,337 feet in length spans a slough and the Ogeechee River. The accident occurred on the main track at a point 117 feet west of the east end of this bridge and 1.4 miles west of the station at Meldrum. The track is tangent throughout a distance of 1.03 miles immediately west of the point of accident and 973 feet eastward. The grade is successively, 0.17 percent ascending eastward 1900 feet, 0.07 percent descending 300 feet to the point of accident and 700 feet eastward.
