INVESTIGATION NO. 2638
THE SEABOARD AIR LINE RAILWAY COMPANY
REPORT IN RE ACCIDENT
AT DEERFIELD, FLA., ON
OCTOBER 22, 1942

Railroad: Seaboard Air Line
Date: October 22, 1942
Location: Deerfield, Fla.
Kind of accident: Rear-end collision
Trains involved: Passenger : Freight
Train numbers: 191 : 77
Engine numbers: 246 : 221
Consist: 11 cars : 23 cars, caboose
Speed: 2-3 m. p. h. : 25 m. p. h.
Operation: Timetable and train orders, and
manual-block system for follow-
ing passenger trains only
Track: Single; tangent; level
Weather: Slightly cloudy
Time: About 8:05 a. m.
Casualties: 1 killed; 46 injured
Cause: Accident caused by failure to
provide adequate protection
for preceding train
Recommendation: That the Seaboard Air Line Rail-
way Company establish an adequate
block system on the line involved
in this accident

Accident at Deerfield, Fla., on October 22, 1942, caused
by failure to provide adequate protection for pre-
ceding train.

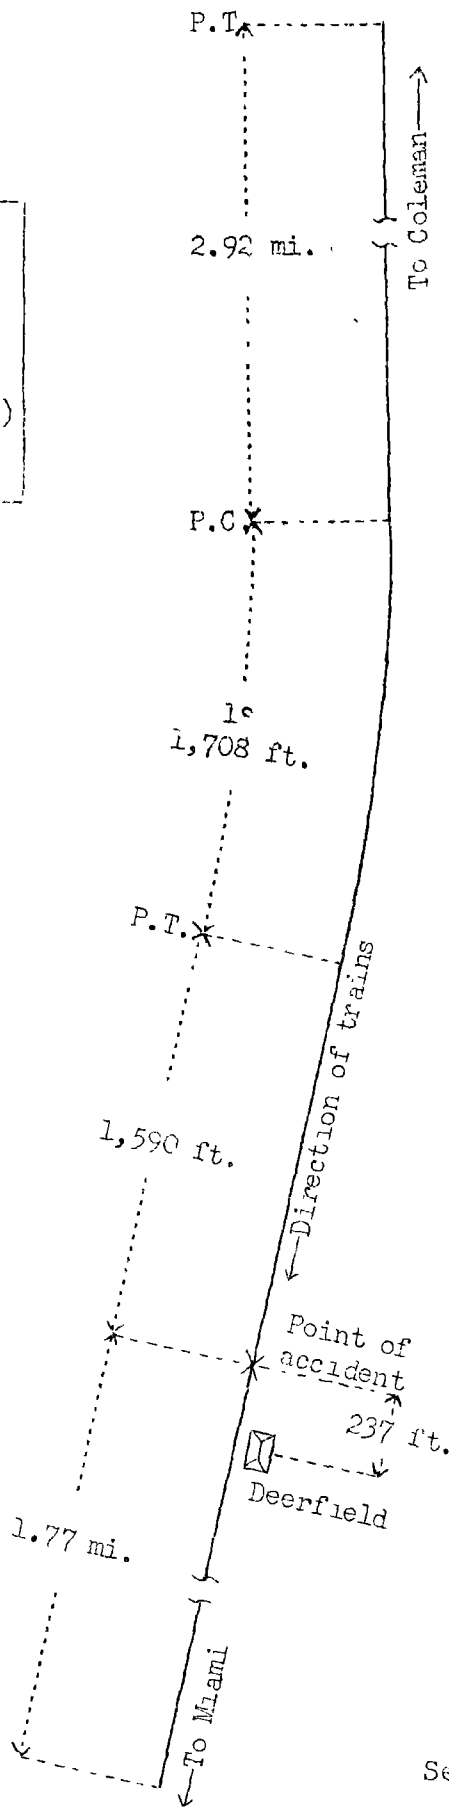
Inv. No. 2638
 Seaboard Air Line Railway
 Deerfield, Fla.
 October 27, 1942

o	Coleman, Fla.	69.7 mi.
o	West Lake Wales	134.1 mi.
o	West Palm Beach	208.4 mi.
X	Deerfield (P. of A.)	41.7 mi.
o	Miami, Fla.

Location of Accident and Method of Operation
