INVESTIGATION NO. 2703
THE SEABOARD AIR LINE RAILWAY COMPANY
REPORT IN RE ACCIDENT
NEAR GARLINGTON, S. C., ON
JUNE 1, 1943

Railroad: Seaboard Air Line
Date: June 1, 1943
Location: Garlington, S. C.
Kind of accident: Head-end collision
Trains involved: Freight : Freight
Train numbers: First 90 : Second 95
Engine numbers: 361 : 2302-2464
Consist: 32 cars, caboose : 2 cabooses
Speed: 30-35 m. p. h. : 10-18 m. p. h.
Operation: Timetable and train orders, and
manual-block system for follow-
ing passenger trains only
Track: Single; 1° curve; 0.80 percent
ascending grade northward
Weather: Clear
Time: 1:57 a. m.
Casualties: 3 killed; 3 injured
Cause: Failure to deliver meet order to
superior train
Recommendation: That the Seaboard Air Line Railway
Company establish an adequate
block-signal system on the line
on which this accident occurred

Accident near Garlington, S. C., on June 1, 1943, caused
by failure to deliver a meet order to the superior
train.

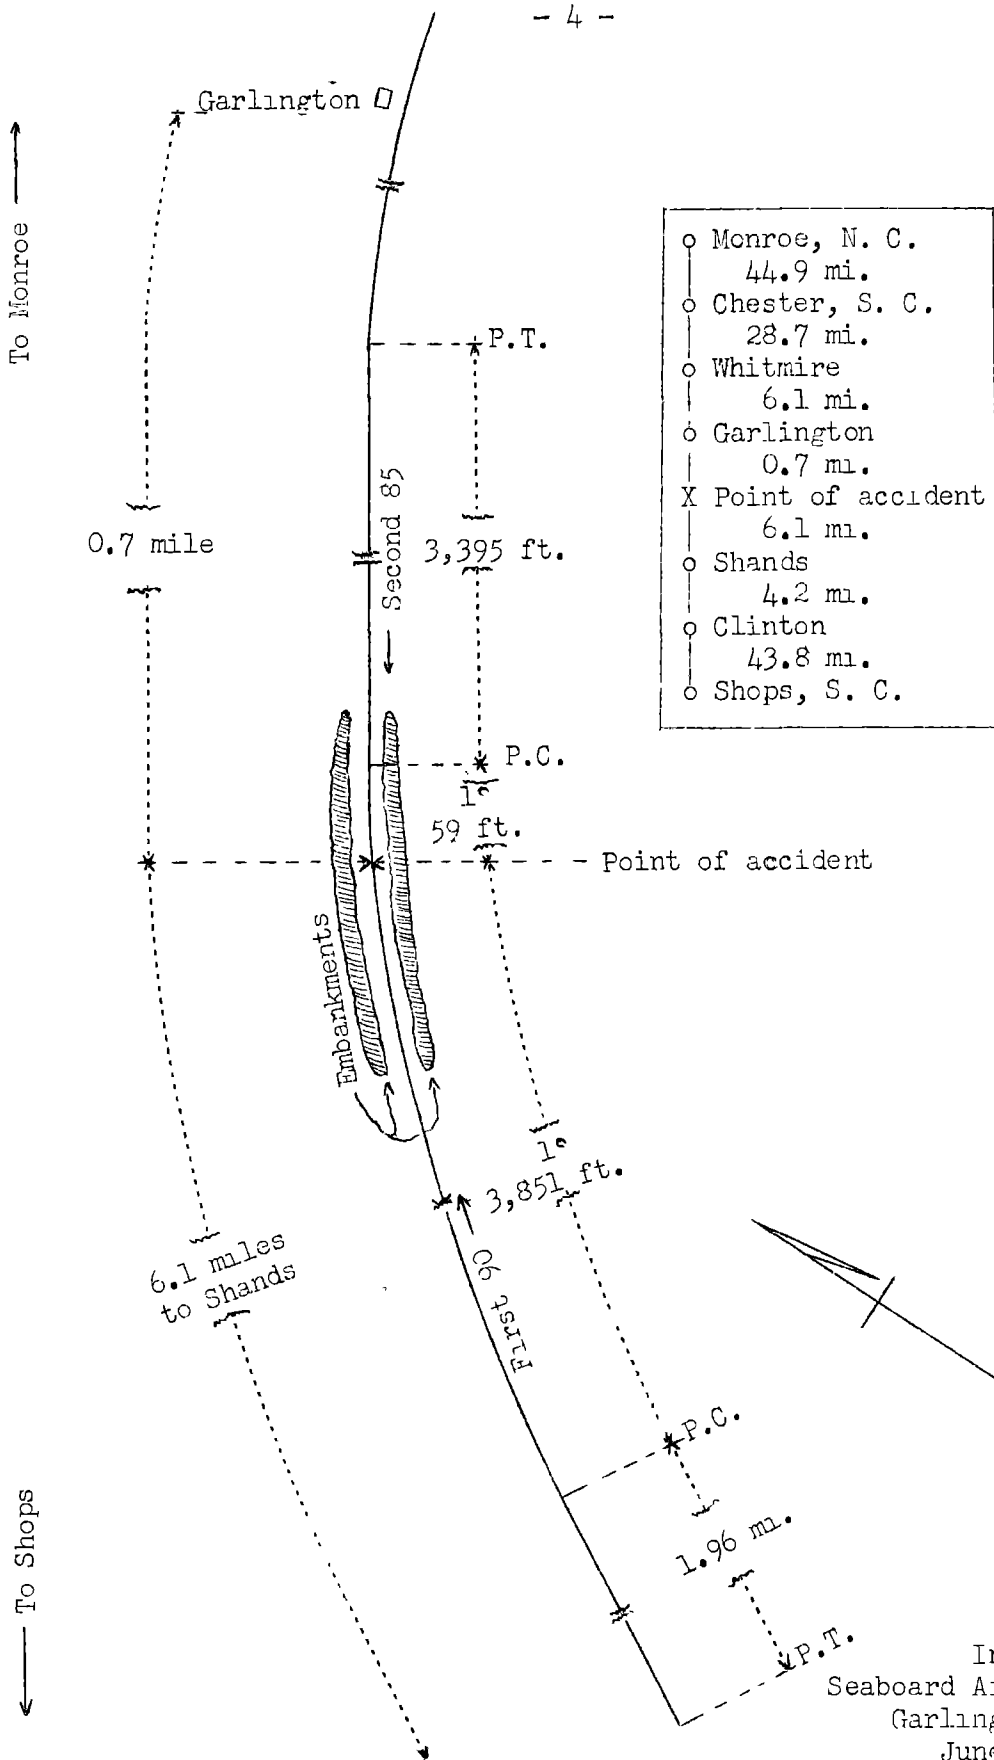
Inv-2703
 Seaboard Air Line Railway
 Garlington, S. C.
 June 1, 1943

This accident occurred on that part of the Georgia Division designated as the Abbeville Sub-division and extending between Monroe, N. C., and Shops, S. C., 134.5 miles. This was a single-track line over which trains were operated by timetable and train orders, and a manual-block system for following passenger trains only. The accident occurred 0.7 mile south of Garlington and 6.1 miles north of Shands. Approaching from the south there was a tangent 1.96 miles in length, which was followed by a 1° curve to the right 3,851 feet to the point of accident and 59 feet beyond. Approaching from the north there was a tangent 7,395 feet in length, which was followed by the curve on which the accident occurred. The grade for north-bound trains varied between 0.50 and 0.80 percent ascending 1,441 feet to the point of accident, and was 0.80 percent at that point. The grade for south-bound trains was, successively, 1.30 percent ascending 2,100 feet, level 200 feet and 0.80 percent descending 659 feet to the point of accident. The accident occurred in a cut, the walls of which rose to a maximum height of 12 feet.
