INVESTIGATION NO. 2595  
THE SEABOARD AIR LINE RAILWAY COMPANY  
REPORT IN RE ACCIDENT  
AT KITTRELL, N. C., ON  
JUNE 14, 1942

Location: Kittrell, N. C.

Kind of accident: Rear-end collision

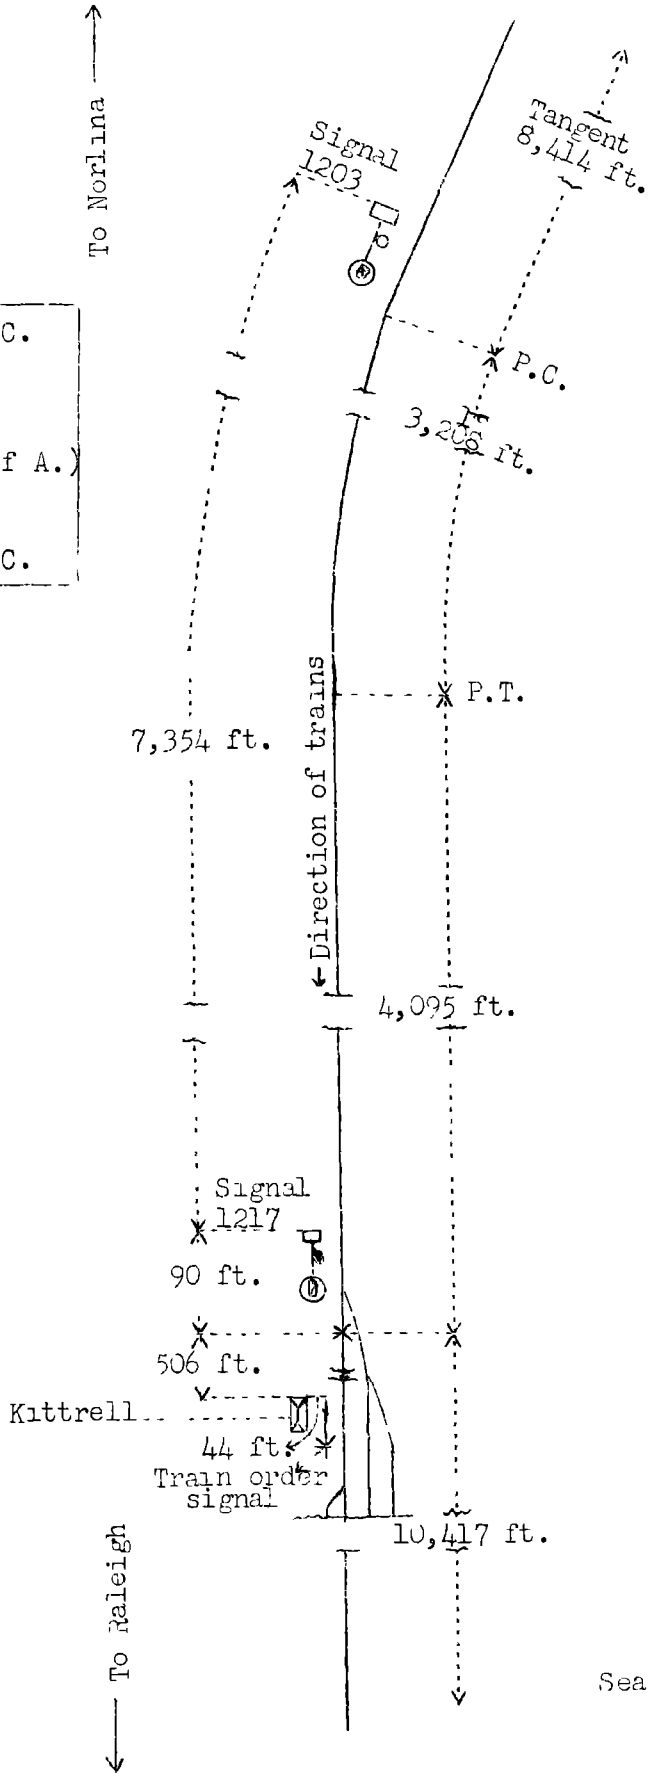
Inv. No. 2595  
 Seaboard Air Line Railway  
 Kittrell, N. C.  
 June 14, 1942

- Norlina, N. C. 15.4 mi.
- Henderson 8.0 mi.
- ✱ Kittrell (P. of A.) 34.3 mi.
- Johnson St., Raleigh, N. C.

Location of Accident and Method of Operation
