INVESTIGATION NO. 2958
SEABOARD AIR LINE RAILWAY COMPANY
REPORT IN RE ACCIDENT
AT KOLLOCKS, S. C., ON
DECEMBER 16, 1945

Accident at Kollocks, S. C., on December 16, 1945, caused
by failure to obey a meet order.

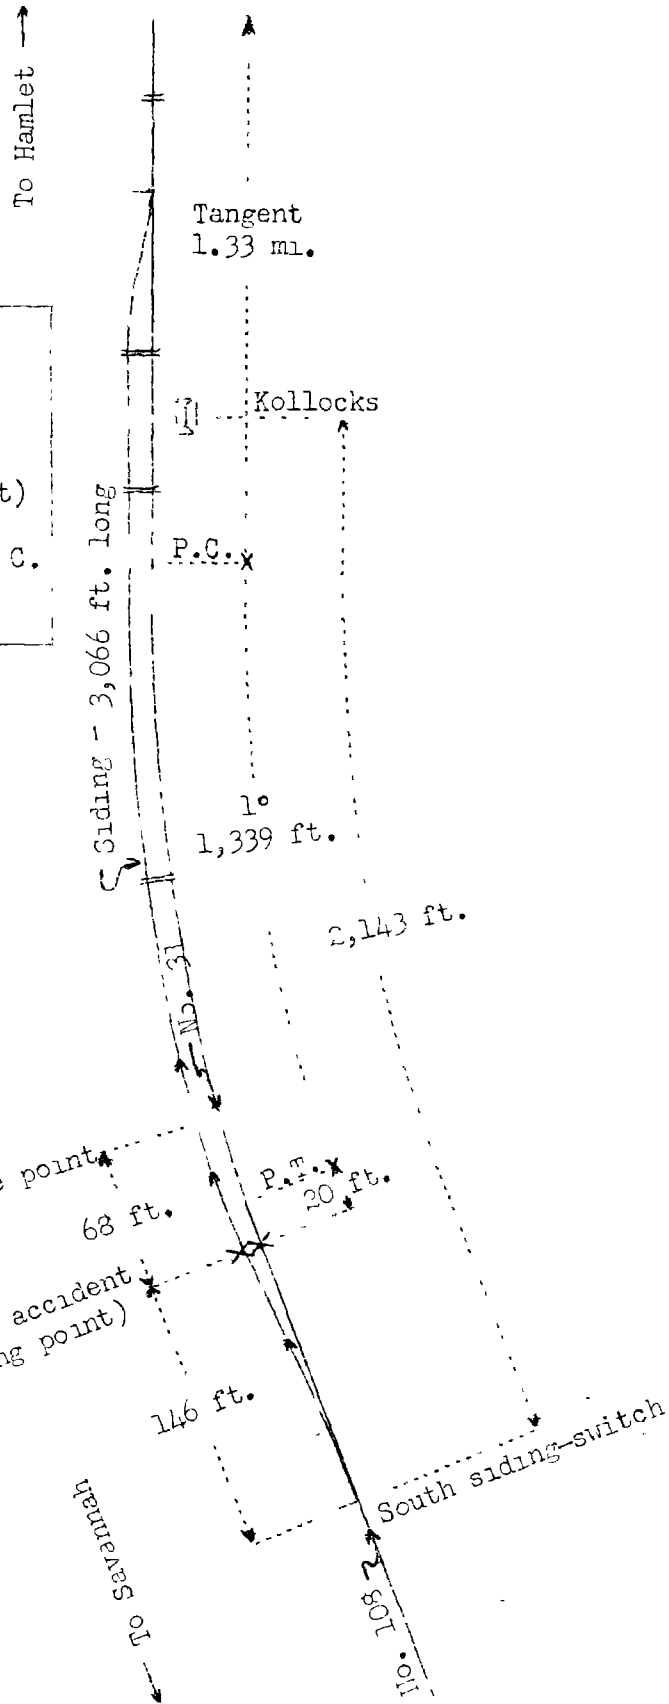
Inv. No. 2958
 Seaboard Air Line Railway
 Kollocks, S. C.
 December 16, 1945

Location of Accident and Method of Operation

The sixth to ninth cars, inclusive, of No. 108 were derailed to the west. The sixth car stopped at an angle of about 15 degrees to the track and leaned to the west at an angle of 45 degrees. The right side-sheets of this car were crushed inward about 1 foot. The seventh and eighth cars overturned and stopped on their left sides about 30 feet west of the turnout and parallel to it. The front end of the right side of the seventh car was demolished a distance of 18.5 feet and a considerable number of seats were torn loose. The front end of the right side of the eighth car was demolished a distance of 12 feet. The ninth car remained upright and stopped at an angle of about 15 degrees to the track, and was badly damaged. The Diesel-electric units and the first to fifth cars, inclusive, of No. 31 were derailed. The first unit stopped upright and in line with the track, with the front end 407 feet south of the point of accident and about 50 feet east of the main track. The second unit stopped at the rear of the first unit and at an angle of 30 degrees to the track. Both units were badly damaged. The first car stopped upright 407 feet south of the point of accident, with the front end 110 feet east of the track and the rear end 70 feet east of the track. The second to fifth cars, inclusive, remained coupled and stopped upright at the rear of the first car. The front end of the first car was demolished throughout a distance of 15 feet, the second car was badly damaged, and the third to fifth cars, inclusive, were more or less damaged.
