INVESTIGATION NO. 2918
SEABOARD AIR LINE RAILWAY COMPANY
REPORT IN RE ACCIDENT
NEAR RICHLAND, GA., ON
AUGUST 6, 1945

Accident near Richland, Ga., on August 6, 1945, caused by
failure to provide adequate protection for the
preceding train.

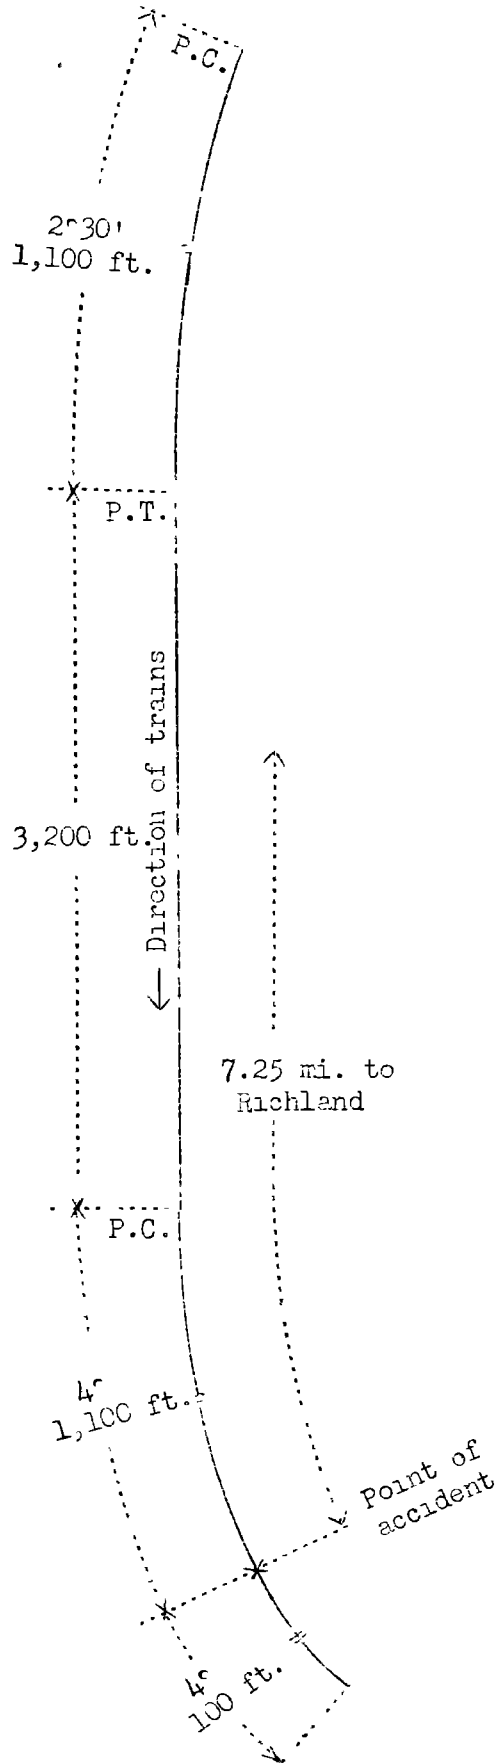
Inv. No. 2918
 Seaboard Air Line Railway
 Richland, Ga.
 August 6, 1945

- Shops, Ga.
1.00 mi.
- Americus
28.20 mi.
- Richland
7.25 mi.
- X Point of accident
1.35 mi.
- Lumpkin, Ga.
102.20 mi.
- Montgomery, Ala.
