INVESTIGATION NO. 2591

THE SEABOARD AIR LINE RAILWAY COMPANY

REPORT IN RE ACCIDENT

NEAR RYAN, VA., ON

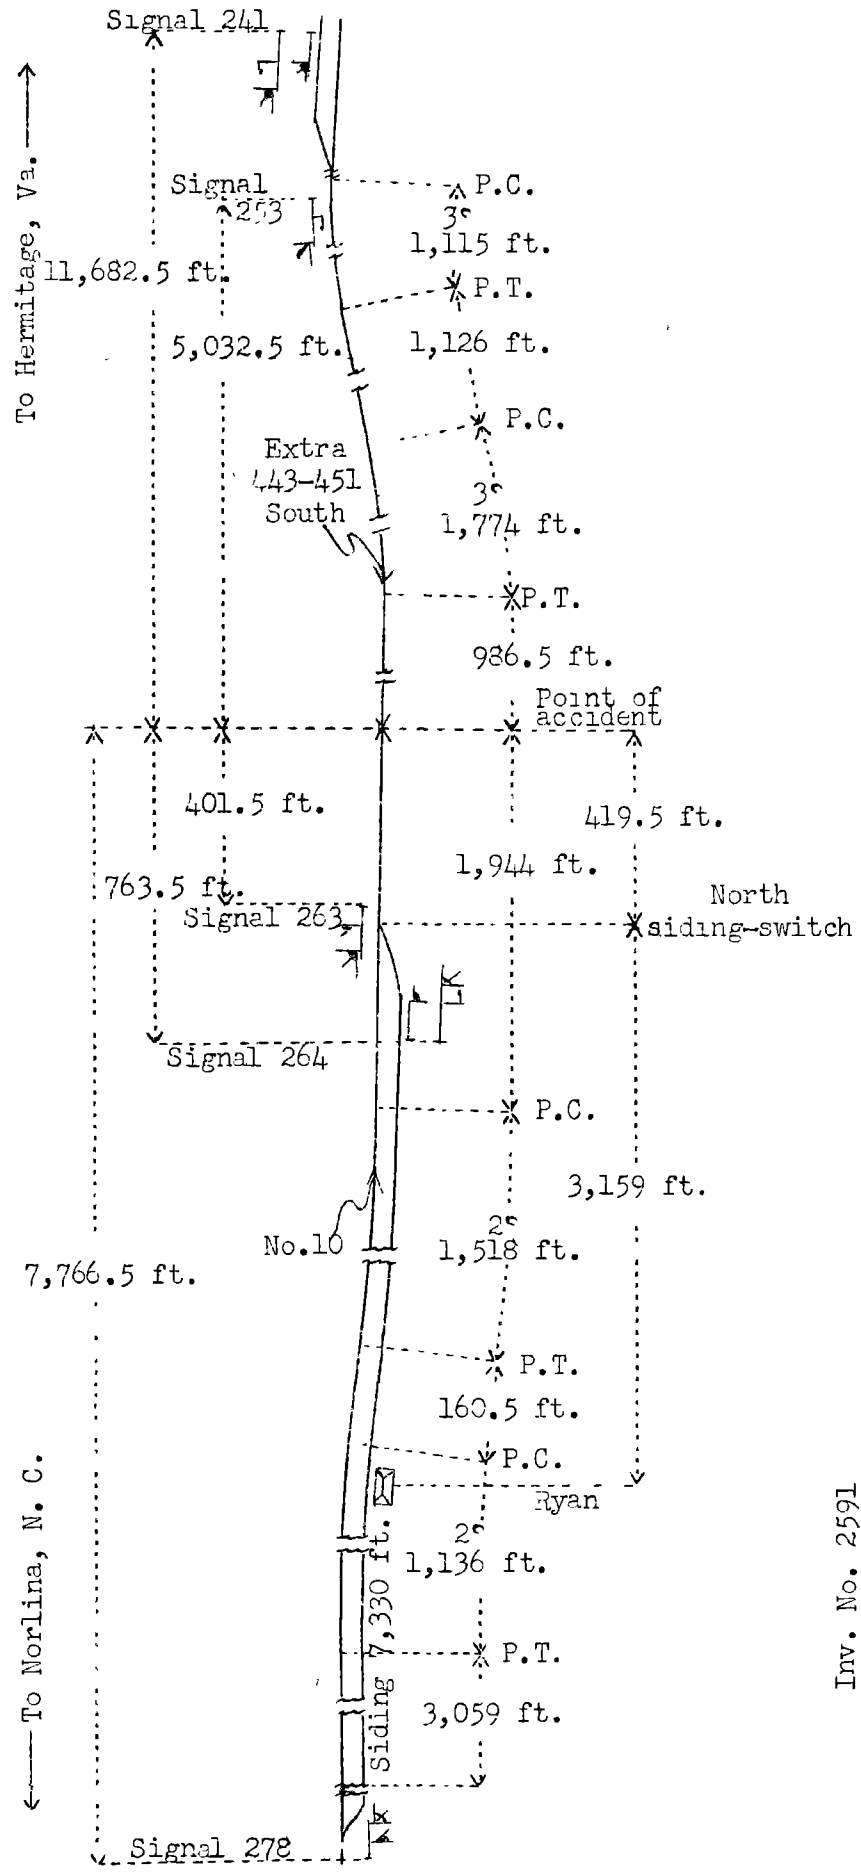
Inv. No. 2591
 Seaboard Air Line Railway
 Ryan, Va.
 May 28, 1942

- o Hermitage, Va. 3.3 mi.
- o Brown Street 0.6 mi.
- o Richmond 18.7 mi.
- o Lynch 4.2 mi.
- o Petersburg 4.6 mi.
- x Ryan (P. of A.) 3.6 mi.
- o Burgess 32.8 mi.
- o Cochran, Va. 34.5 mi.
- o Norlina, N. C. 57.7 mi.
- o Raleigh, N. C.

Location of Accident and Method of Operation
