INVESTIGATION NO. 2902
THE SOUTH GEORGIA RAILWAY COMPANY
REPORT IN RE ACCIDENT
NEAR QUITMAN, GA., ON
JUNE 19, 1945

Railroad: South Georgia
Date: June 19, 1945
Location: Quitman, Ga.
Kind of accident: Derailment
Train involved: Freight
Train number: Extra 103 North
Engine number: 103
Consist: 20 cars
Speed: 35 m. p. h.
Operation: Timetable and train orders
Track: Single; 1°54' curve; 2.25 percent descending grade northward
Weather: Clear
Time: 8:45 a. m.
Casualties: 2 killed; 1 injured
Cause: Insecure track which rendered it unsafe for the speed permitted
Recommendation: That the South Georgia Railway Company establish maximum authorized speed consistent with the condition of the track

Accident near Quitman, Ga., on June 19, 1945, caused by
insecure track which rendered it unsafe for the
speed permitted.

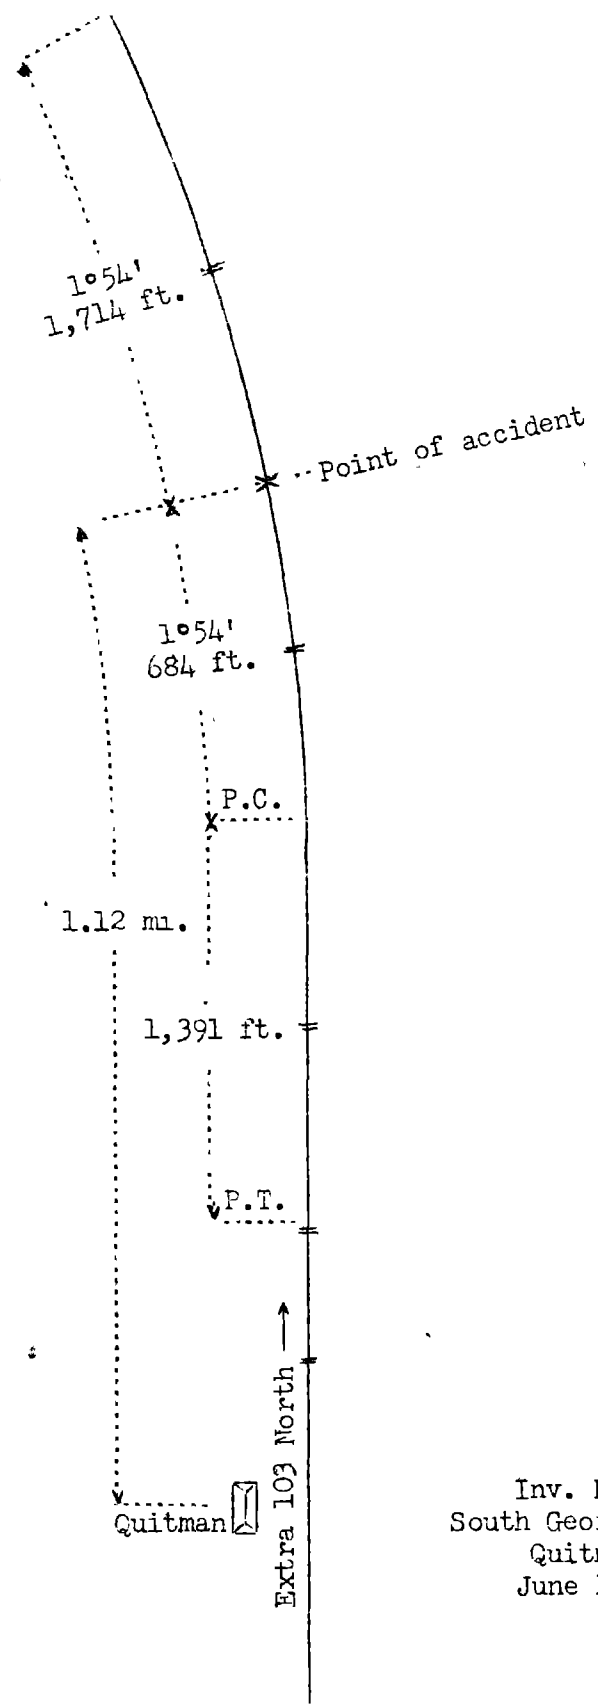
Inv. No. 2902
 South Georgia Railway
 Quitman, Ga.
 June 19, 1945

To Adel →

- Adel, Ga.
26.38 mi.
- X Point of accident
1.12 mi.
- Quitman, Ga.

There was no indication of any obstruction having been on the track. Examination of the track disclosed that many ties were so badly decayed that the spikes were not holding the rails securely. Beginning at a point 684 feet north of the south end of the curve on which the derailment occurred, a scraping mark appeared on the inside of the head of the low rail. At a point 3 feet 11 inches farther north a wheel mark appeared inside the high rail, and the low rail was canted outward. At this point wheel marks appeared in the web of the low rail, and the leading end was overturned. From this point the track was destroyed about 300 feet northward.
