REPORT OF THE DIRECTOR

ACCIDENT ON THE

SOUTHERN PACIFIC RAILROAD

ELIOT, CALIF.

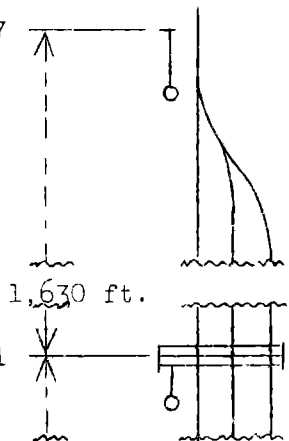
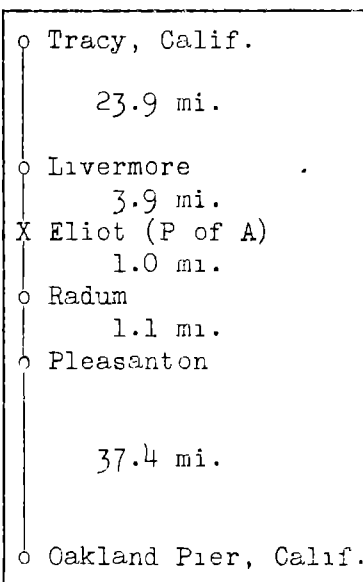
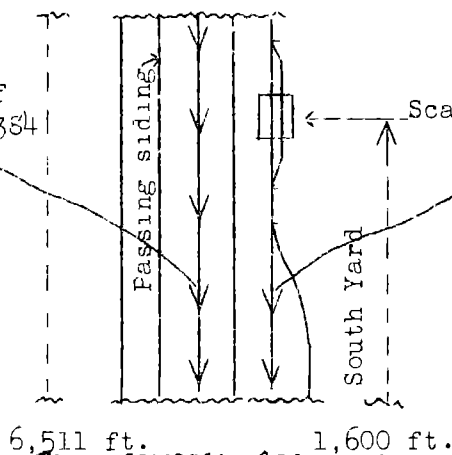
Signal 447

Signal 441

1,630 ft.

Route of Extra 2384

Scale house

Route of Engine 2525

The South Yard at Eliot parallels the main track on the south and consists of 3 tracks; the center track is known as the middle track and another track is the scale track. The North Yard consists of 2 tracks paralleling the main track on the north opposite the South Yard, and the track in the North Yard adjacent to the main track is used as a passing track. The west switch of the North Yard is located 311 feet east of the west switch of the South Yard; the stands of these switches have targets, but are not equipped with switch lights. The yards extend for about 8,000 feet. The North Yard tracks are on a level with the main track, but the South Yard tracks are slightly below the level of the main track and the lead to the west switch ascends westward on a 0.705 percent grade for a distance of 220 feet to the main track. There are no yard limit boards at this station. Several tracks lead southward from the South Yard to rock and gravel pits and loaded cars are brought from the pits to Eliot, where they are weighed and picked up by main line trains. Eliot is a non-
