ACCIDENT ON THE
SOUTHERN PACIFIC RAILROAD

JASPER, OREG.

SEPTEMBER 12, 1938

INVESTIGATION NO. 2291

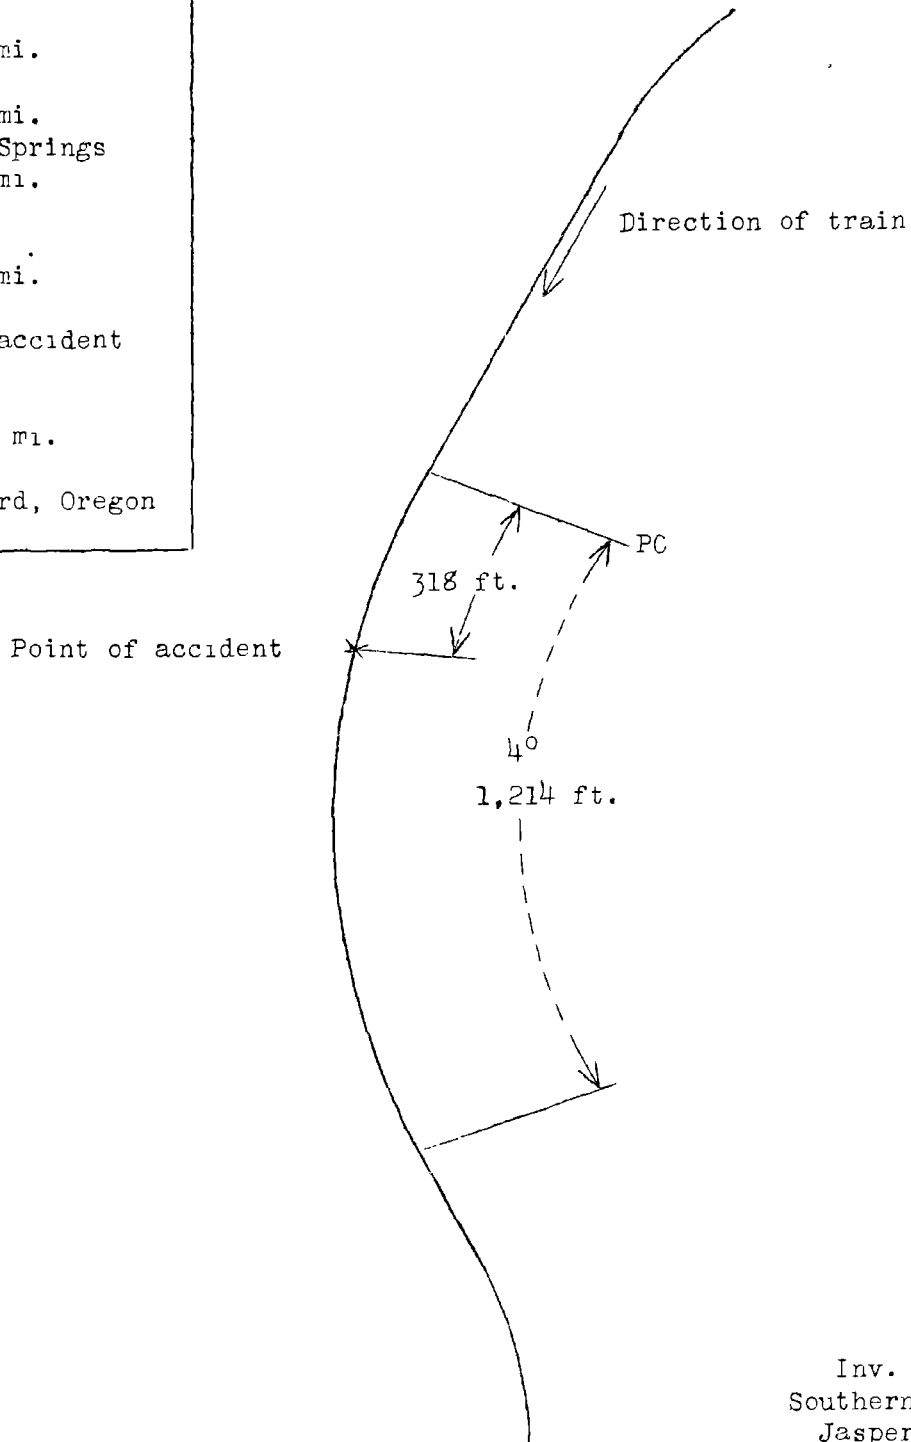
Inv. No. 2291
Southern Pacific R.R.
Jasper, Oregon
Sept. 12, 1938

o	Crescent Lake, Oregon	
		8.1 mi.
o	Cascade Summit	
		9.3 mi.
o	Cruzatte	
		14.4 mi.
o	Wicopee	
		8.9 mi.
o	McCredie Springs	
		11.2 mi.
o	Oakridge	
		31.4 mi.
X	Point of accident	
o	Jasper	
		13.6 mi.
o	Eugene Yard, Oregon

This accident occurred on the Portland Division, on that part of the Brooklyn Subdivision which extends between Crescent Lake and Eugene Yard, Oreg., a distance of 96.9 miles. In the vicinity of the point of accident this is a single-track line over which trains are operated by timetable, train orders and an automatic block-signal system. This line extends nearly north and south but the timetable directions are east and west; the latter directions are used in this report. The accident occurred at a point 3,092 feet west of the station at Jasper. Approaching this point from the west there is a series of short curves and tangents followed by a 4° curve to the left 1,214 feet in length, the superelevation on which is 5 inches; the derailment occurred on this curve at a point 318 feet from its western end; at this point the track is on a 14-foot fill and the grade is 0.429 percent descending for east-bound trains.
