INVESTIGATION NO. 2732
THE SOUTHERN PACIFIC COMPANY
REPORT IN RE ACCIDENT
NEAR JUNCTION CITY, ORIG., ON
OCTOBER 8, 1943

Accident near Junction City, Oreg., on October 8, 1943,
caused by failure to operate the following train in
accordance with signal indications.

Inv. No. 2732
 Southern Pacific Company
 Junction City, Oreg.
 October 8, 1943

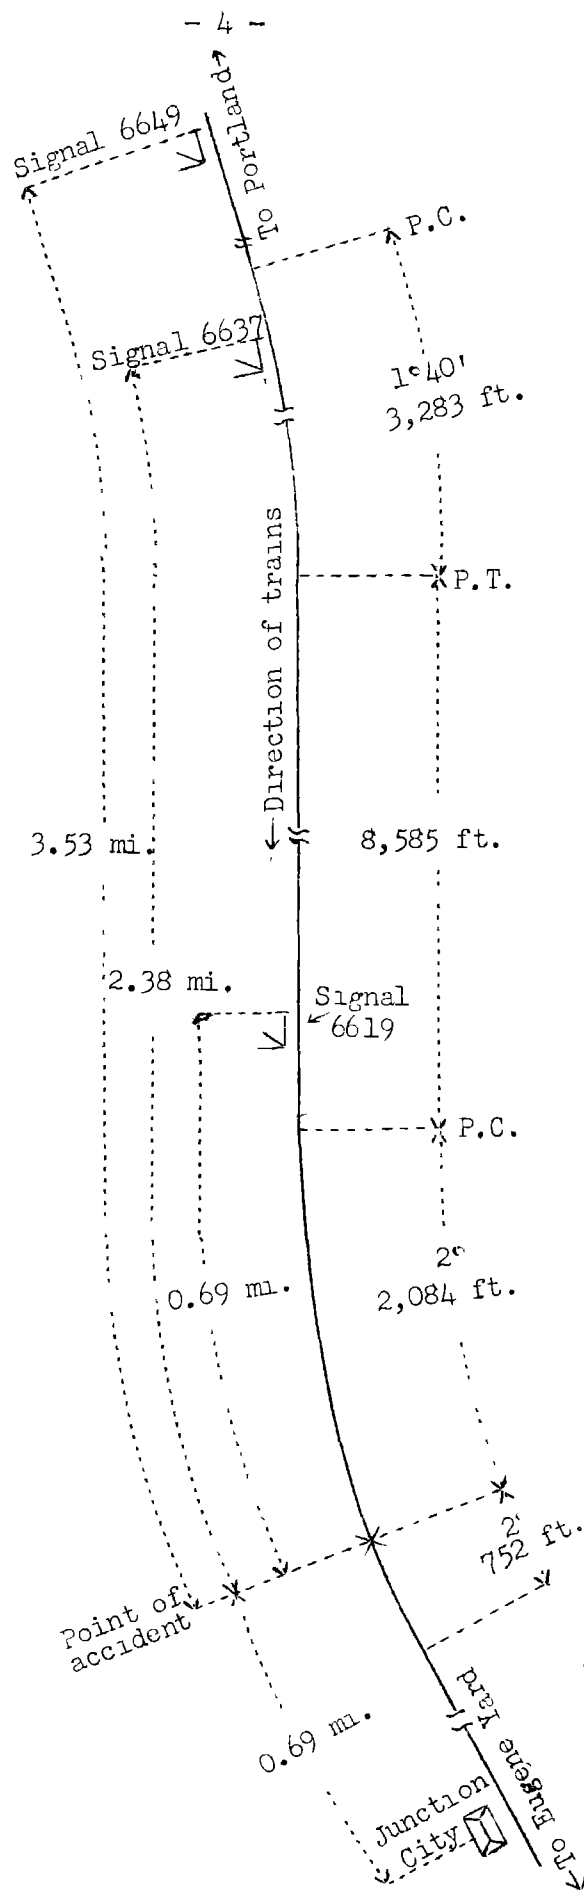
o	Portland, Oreg.
	86.40 mi.
o	Tangent
	10.80 mi.
o	Halsey
	8.70 mi.
o	Harrisburg
	3.81 mi.
X	Point of accident
	0.69 mi.
o	Junction City
	11.40 mi.
o	Eugene Yard, Oreg.

<u>Aspect</u>	<u>Indication</u>
Signal 6649	Red	Stop
	Green	Proceed
Signal 6637	Red	Stop
Signal 6619	Yellow	Proceed with caution
