INVESTIGATION NO. 2545
THE SOUTHERN PACIFIC COMPANY
REPORT IN RE ACCIDENT
AT SELMA, CALIF., ON
NOVEMBER 20, 1941

Accident at Selma, Calif., on November 20, 1941, caused by
train fouling main track immediately in front of an
overdue superior train, as result of failure properly
to observe location of clearance point.

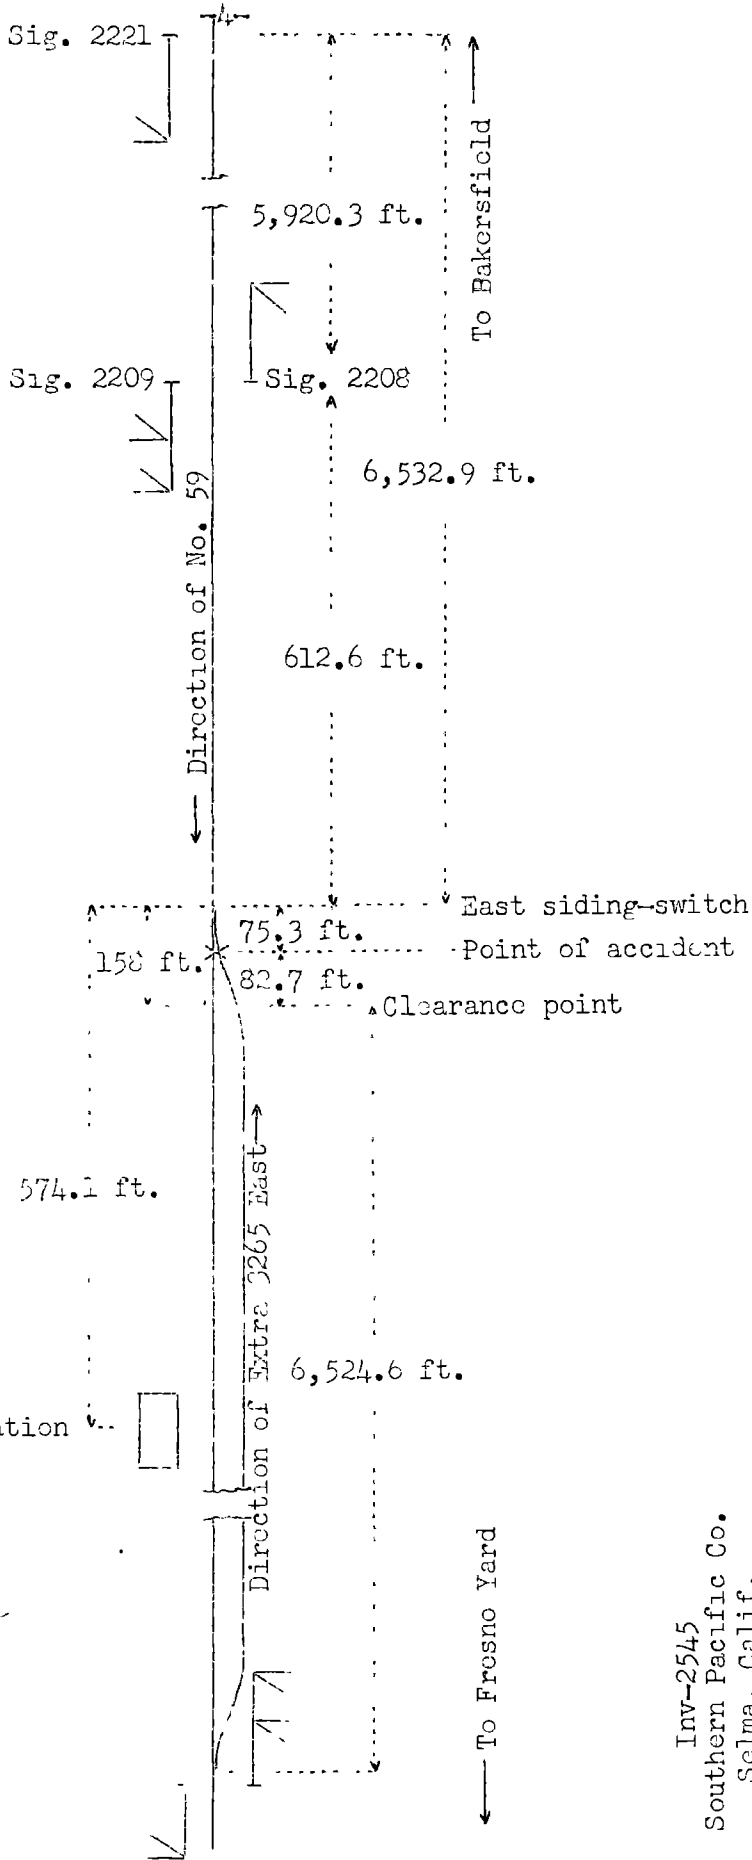
Inv-2545
 Southern Pacific Co.
 Selma, Calif.
 November 20, 1941

- o Bakersfield, Calif. 62.9 mi.
- o Tulare 0.3 mi.
- o Tulare Tower 24.1 mi.
- o Kingsburg 4.9 mi.
- X Point of accident
- o Selma 11.6 mi.
- o Calwa Tower 7.3 mi.
- o Fresno Yard, Calif.

Location of Accident and Method of Operation
