RAILROAD ACCIDENT INVESTIGATION

Report No 3791

SOUTHERN PACIFIC COMPANY

PASO ROBLES, CALIF

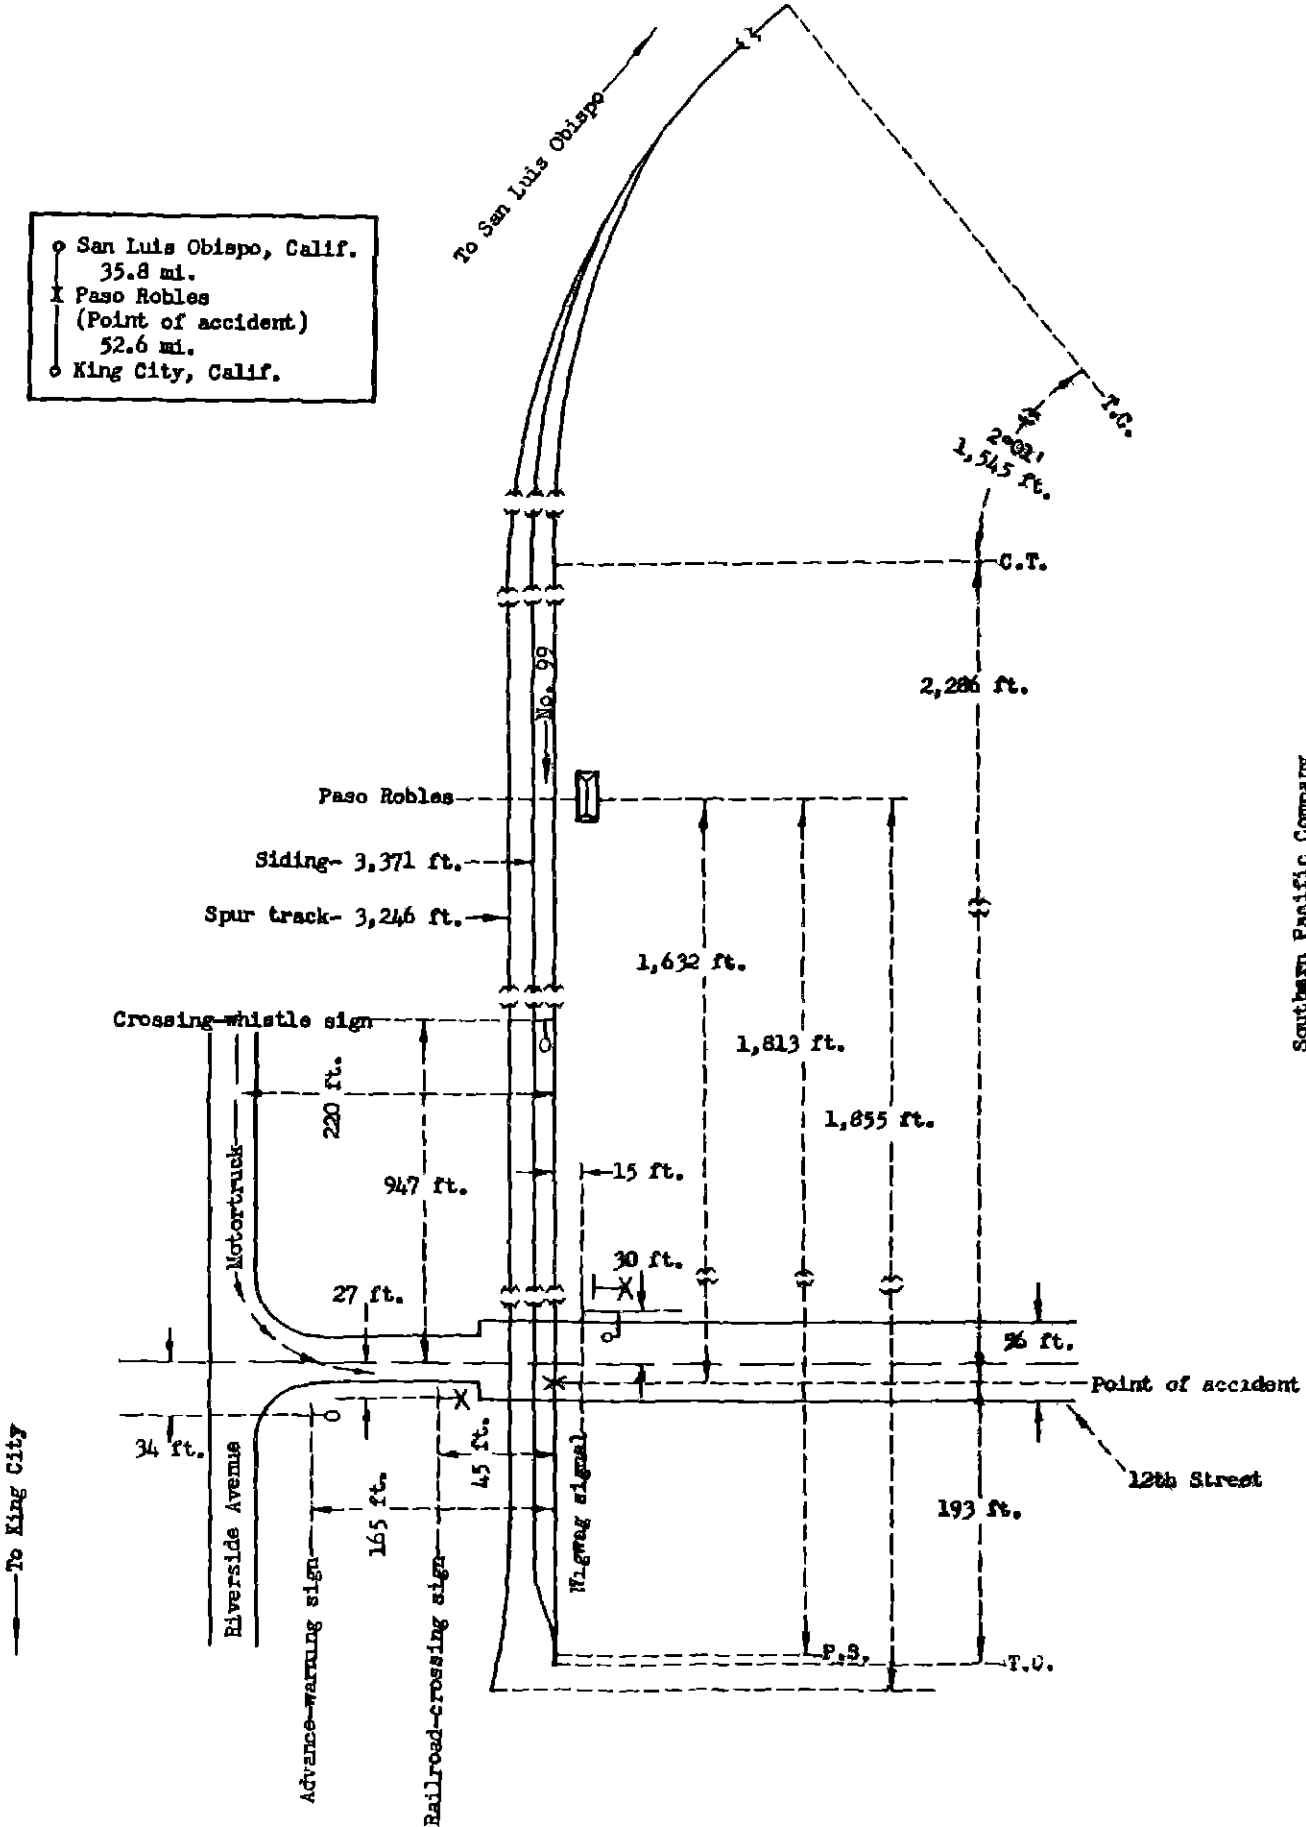
o San Luis Obispo, Calif.
 35.8 mi.
 | Paso Robles
 | (Point of accident)
 | 52.6 mi.
 o King City, Calif.

Southern Pacific Company
 November 25, 1937
 Paso Robles, Calif.

Location of Accident and Method of Operation
