REPORT NO. 3693

SOUTHERN PACIFIC COMPANY

IN RE ACCIDENT

AT STANWIX, ARIZ., ON

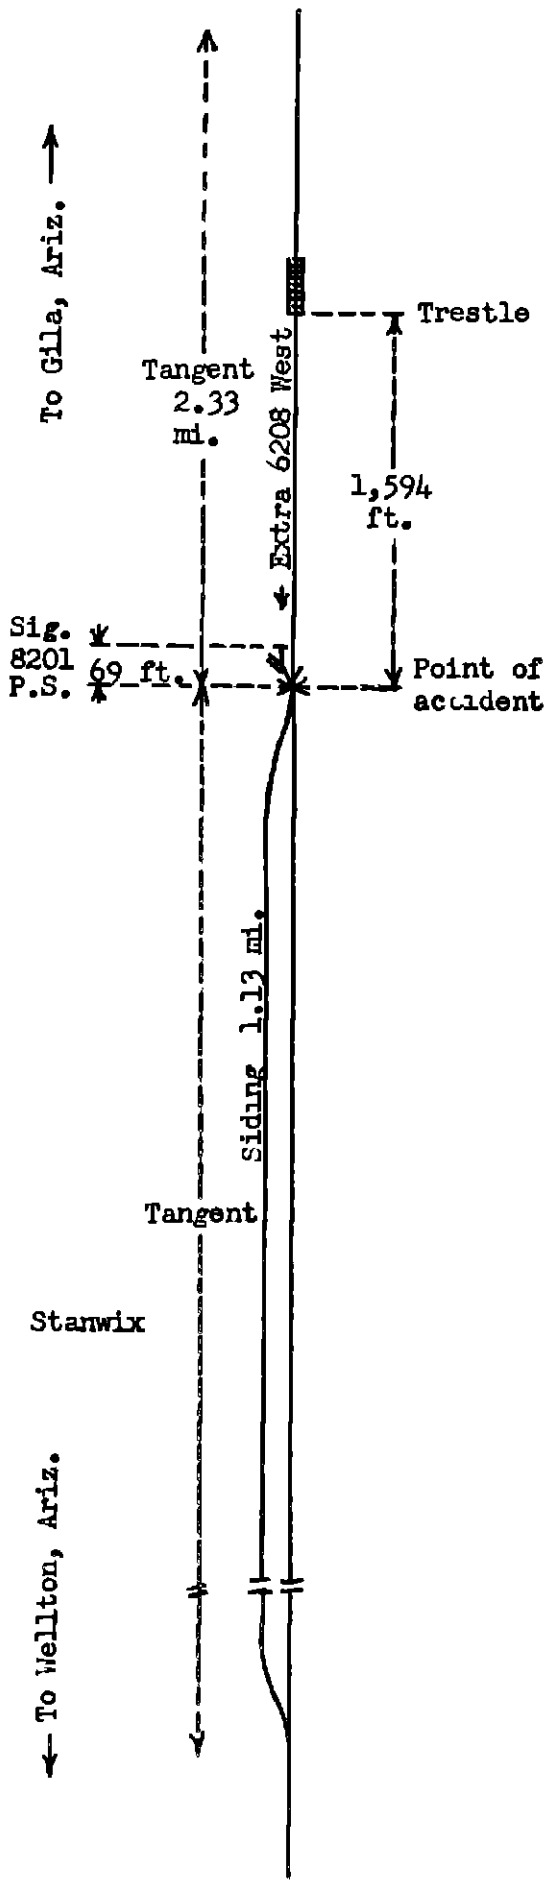
Report No. 3693  
 Southern Pacific Company  
 Stanwix, Ariz.  
 May 5, 1956

Examination of the equipment of Extra 6208 West after the accident occurred disclosed that the right truck side-frame of the front truck of the thirteenth car, S.P. 26999, was broken through both the top and bottom sections. The primary fracture occurred in the bottom member at a point approximately 8 inches in front of the center-line of the side frame. Approximately 52 percent of this break was a progressive fracture on the inner side of the frame. The remainder of the fracture was new. The fracture in the top member occurred approximately 5 inches behind the center-line of the frame. This fracture was new. After the breaks occurred the bottom of the side frame was lowered sufficiently to come in contact with the track structure. Marks and splinters on the bottom of the frame and the marks on the track structure indicate that this occurred 2,390 feet east of the east siding-switch and that the derailment occurred when the car reached the switch.

The progressive fracture in the bottom member of the side frame occurred on the inner side of the frame in a location in which it would not be detected by routine inspection. This car was received in interchange from the Texas and New Orleans Railroad at El Paso, Tex., on May 4, 1956, and was last inspected by members of the mechanical force of the carrier at Tucson, Ariz., 164.2 miles east of the point of accident. No exception was taken to the condition of the car.
