REPORT OF THE DIRECTOR

SOUTHERN RAILWAY

ALLENDALE, S. C.

INVESTIGATION NO. 2042

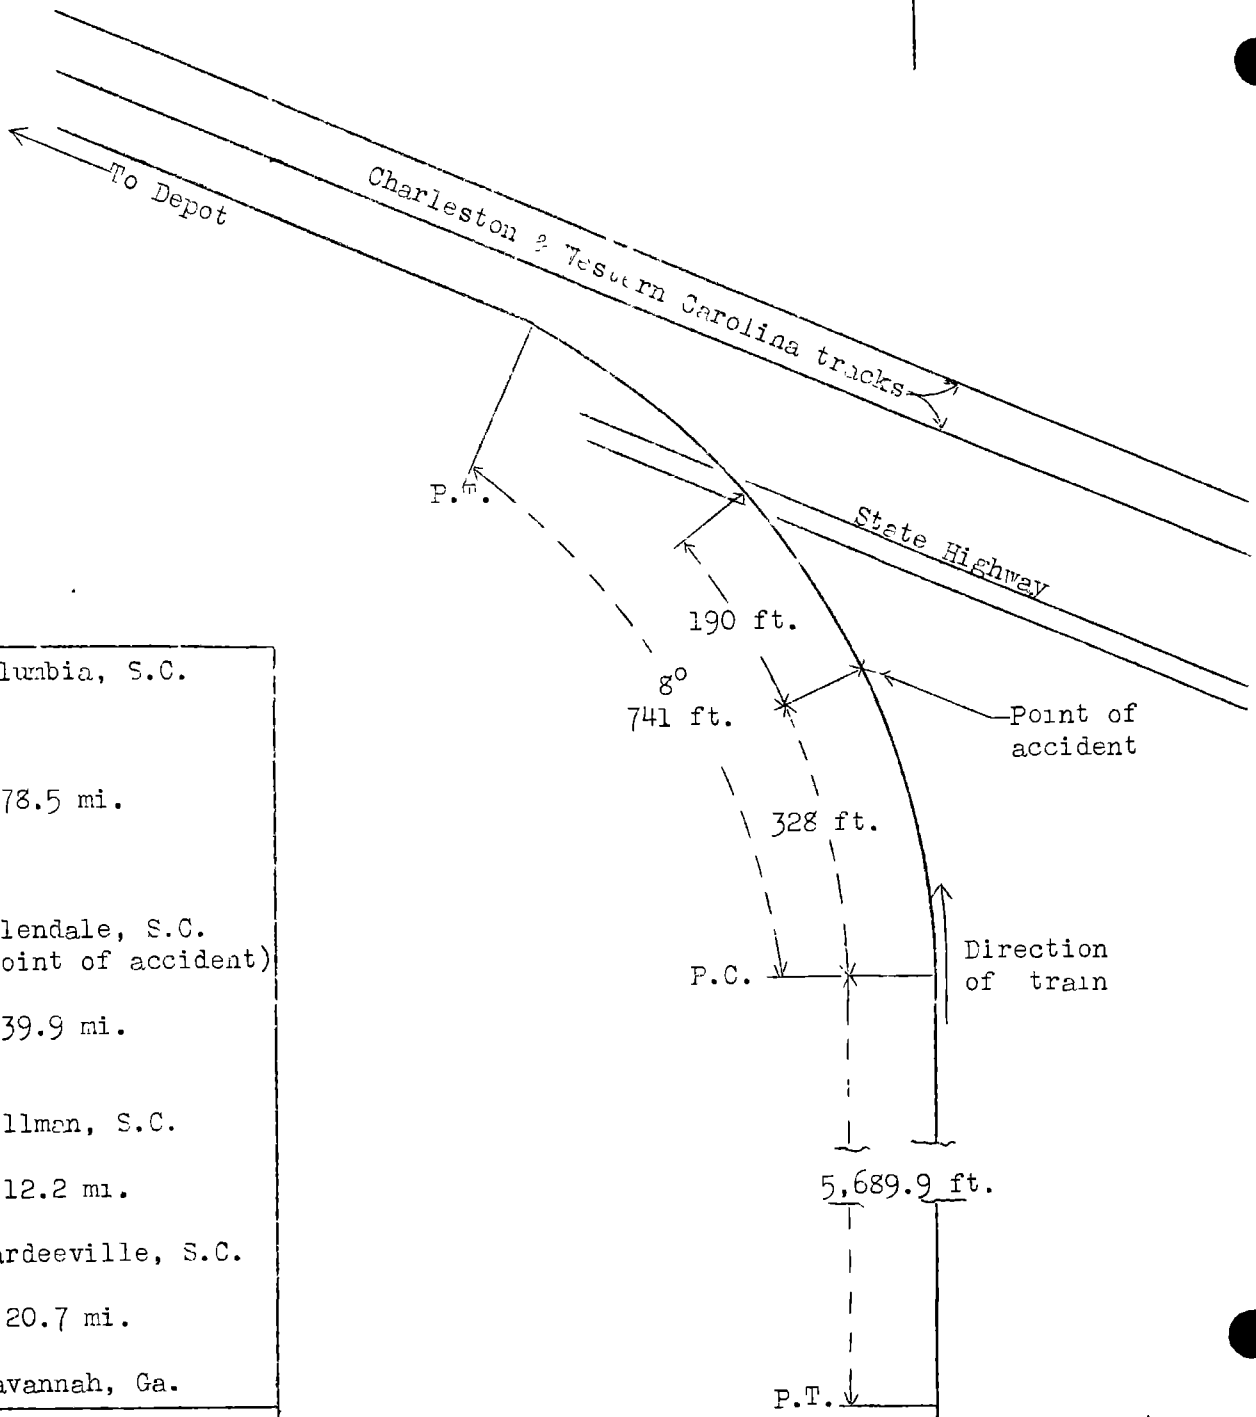
Inv. No. 2042
 Southern Railway,
 Allendale, S.C.
 Feb. 8, 1936

•Columbia, S.C.	
	78.5 mi.
•Allendale, S.C.	
*(Point of accident)	
	39.9 mi.
•Tillman, S.C.	
	12.2 mi.
•Wardeeville, S.C.	
	20.7 mi.
•Savannah, Ga.
